**TECHNICAL SERVICE BULLETIN****400 Watt DC/AC Inverter System Inoperative With B1330:9A In The BCM****26-2230**

24 June 2026

This bulletin supersedes 24-2443. Reason for update: Add/Remove/Update Vehicle Qualifiers/Models

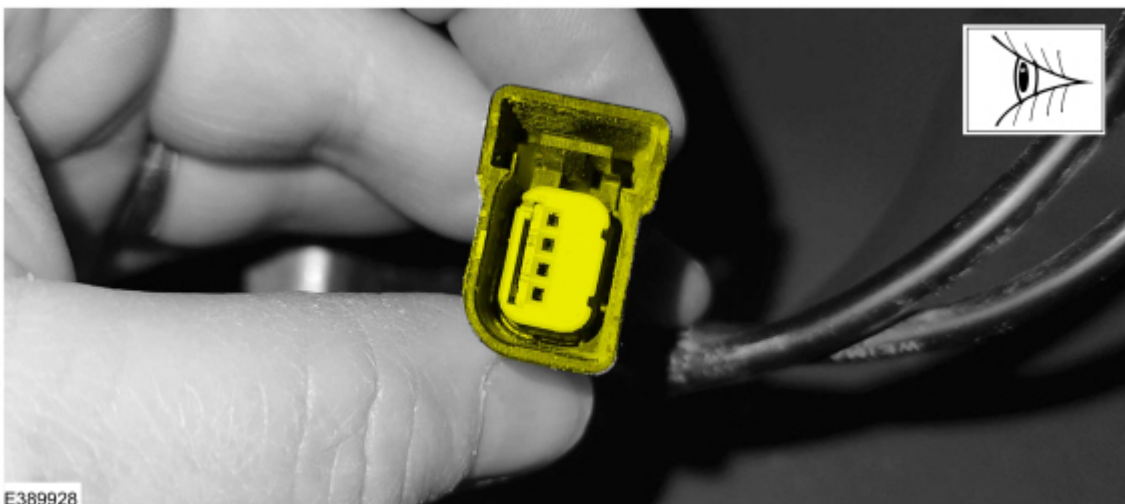
Figure 2

2. Using a suitable tool, carefully cut and remove the pickup bed AC power outlet socket harness retainer from the pickup bed AC power outlet socket harness. Discard the retainer.
3. Is the vehicle a Raptor?
  - (1). Yes - proceed to Step 4.
  - (2). No - proceed to Step 7.
4. For Raptor vehicles, inspect connector C4628 for the presence of corrosion, dirt and/or damage. Is corrosion, dirt and/or damage present in connector C4628? (Figure 2)

7. Inspect connector C4628 for the presence of corrosion, dirt and/or damage. Is corrosion, dirt and/or damage present in connector C4628? (Figure 2)

5. Replace the pickup bed AC power outlet socket assembly. Refer to WSM, Section 414-05. Proceed to Step 6.

(1). Yes - replace the pickup bed AC power outlet socket assembly. Refer to WSM, Section 414-05. Replace the body side harness assembly (13A409) of connector C4628. Proceed to Step 8.

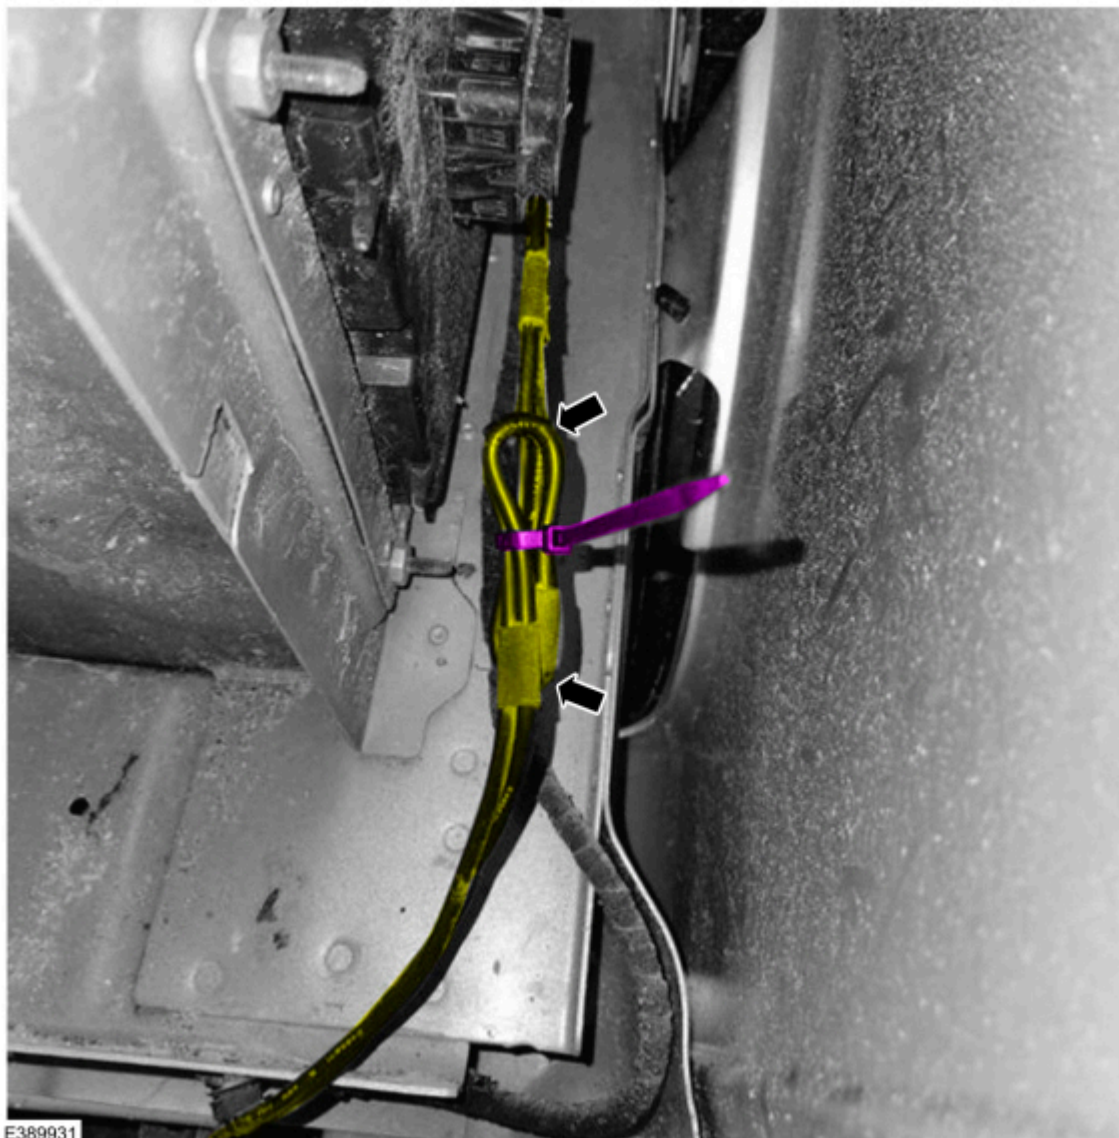
Figure 8

**CAUTION:** The bend radius of the pickup bed AC power outlet socket harness should be no less than 4 mm. Hard kinks and tight bends of the pickup bed AC power outlet socket harness can lead to wire damage.

10. Fold approximately 7 in. (185 mm) of the remaining/loose pickup bed AC power outlet socket harness in 2 bends just behind the pickup bed AC power outlet socket panel. Secure the folded wire with a wire tie. Inspect the routing of the harness to make sure it is not pulled too tight against the body sheet metal near the harness retainer and provides just enough length. (Figure 8)
