### FSA 25SD9

### Final Repair - Safety Recall 25SD9

Certain 2022-2025 Model Year Transit Battery Electric Vehicles (BEV)  
Left-Hand Rear Half Shaft Inspection

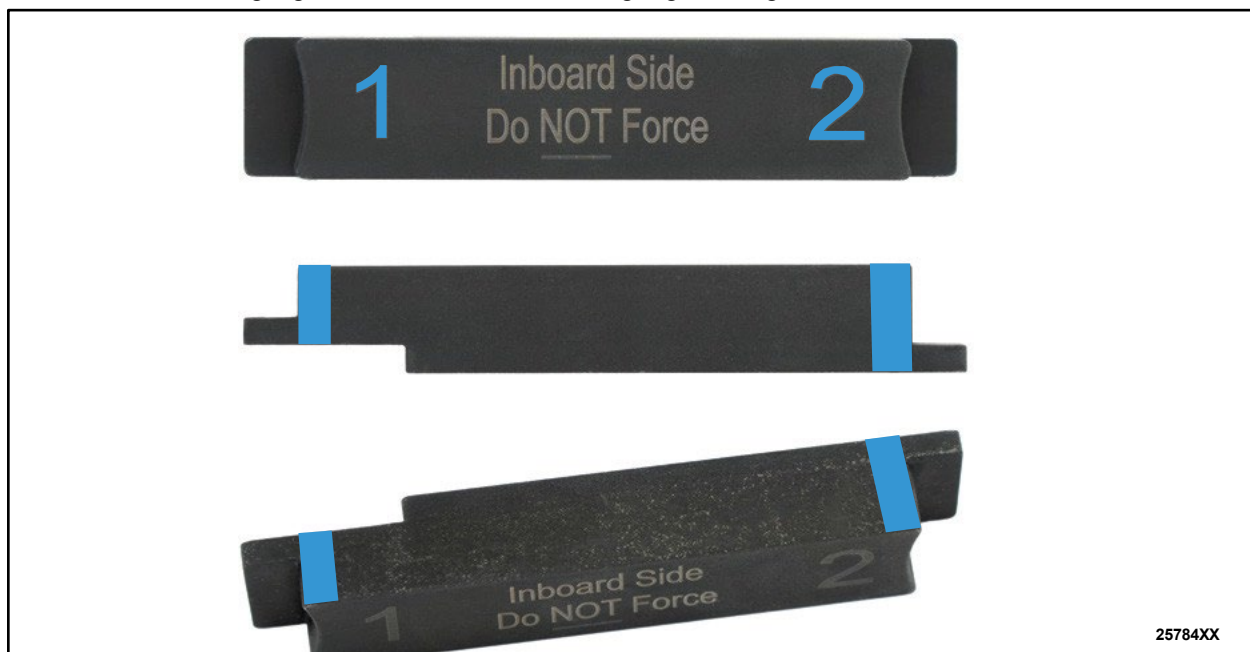
**FIGURE 1**

- Position on a **DRIVE-ON** hoist is recommended. Follow the WSM procedures in Section 100-02.
  - Place the Vehicle in "Stay in Neutral Mode", Follow the WSM procedure in 307-05A.
  - Set the Parking Brake to off and **CHOCK** the wheels.
- Inspect two-sided gauge details and see Figure 1:
  - **Do Not** force gauge to fit.
  - The gauge has two gauging ends (1 and 2).
  - The side with the gauge numbers on it (1 or 2) goes towards the inboard side of vehicle.
  - The blue highlighted areas, on the lower 2 gauges in Figure 1, are the critical measurements.

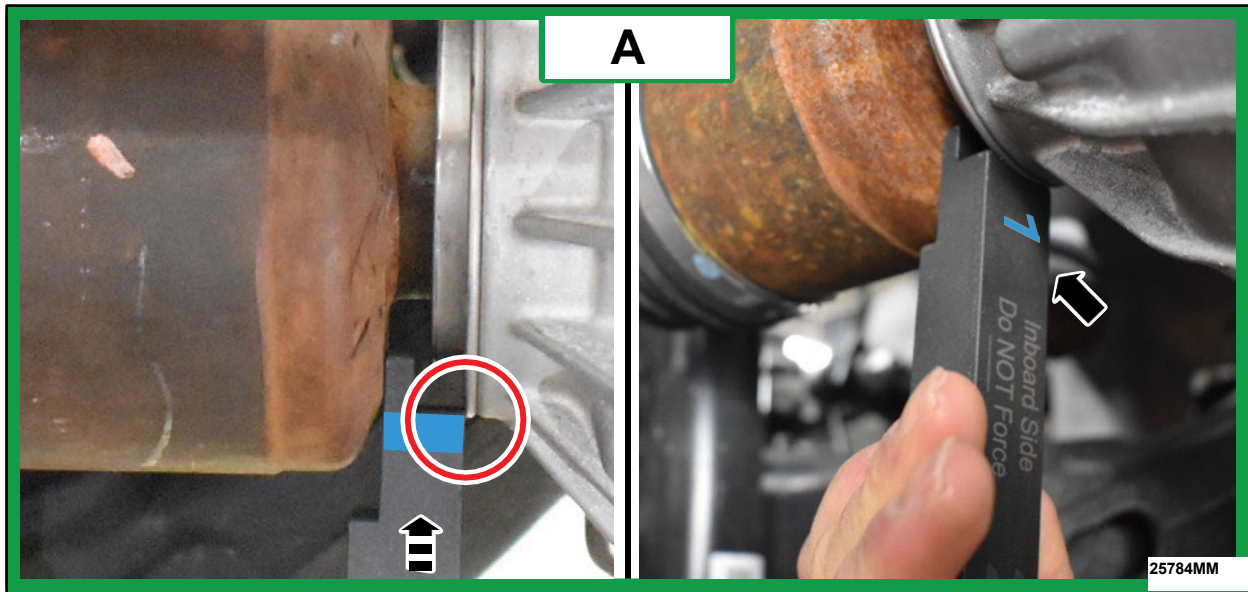
FIGURE 2

[ **A** ] **Does NOT fit** - Side 1 does NOT fit in gap, interference. Proceed to Step 47.

[ **B** ] **Fits** - Side 1 fits in gap. Proceed to the next Step.

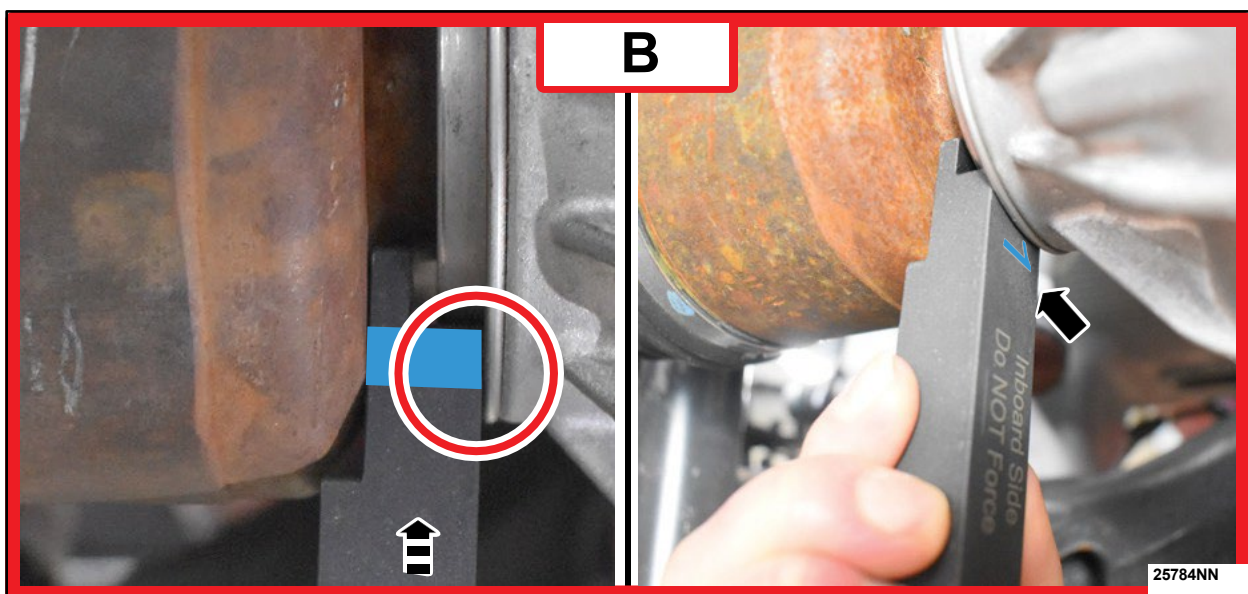
FIGURE 3

4. Without forcing, does gauge **Side 1** fit in the gap as shown in Figures 2 and 3?  
- Between the bottom (6 o'clock position) of the LH rear halfshaft and rear electric drive assembly.

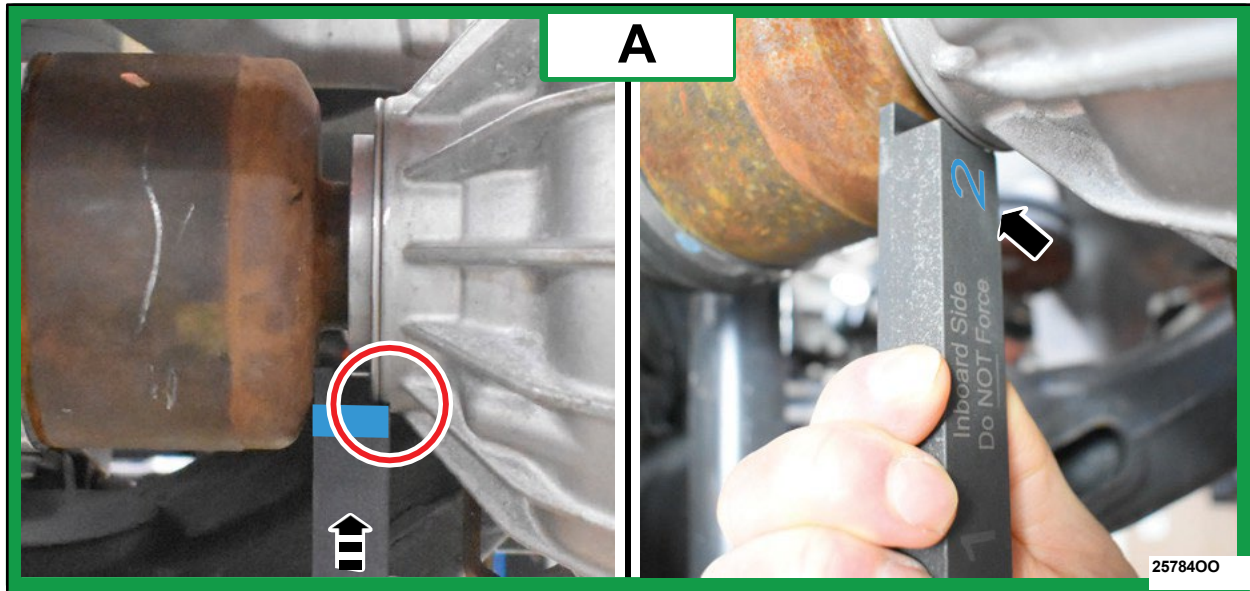
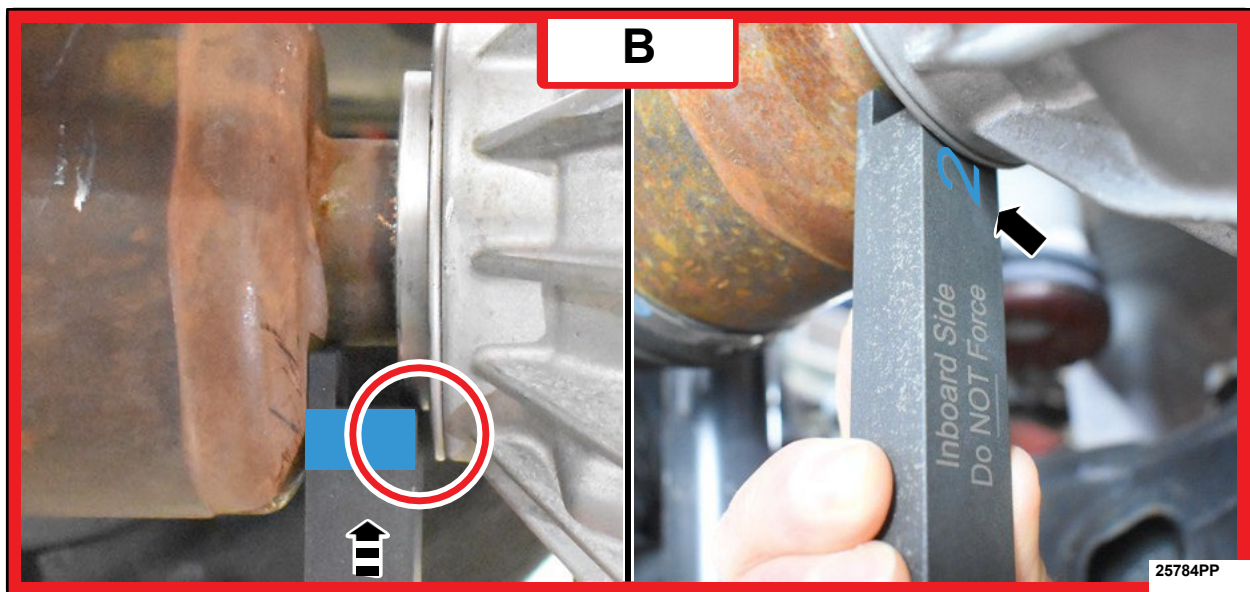
FIGURE 4

5. Without forcing, does gauge **Side 2** fit in the gap as shown in Figures 4 and 5?
- Between the bottom (6 o'clock position) of the LH rear halfshaft and rear electric drive assembly.

[ **A** ] **Does NOT Fit** - Side 2 does NOT fit in gap, interference. Proceed to the next Step.  
[ **B** ] **Fits** - Side 2 fits in gap. Proceed to Step 9 (Page 6).

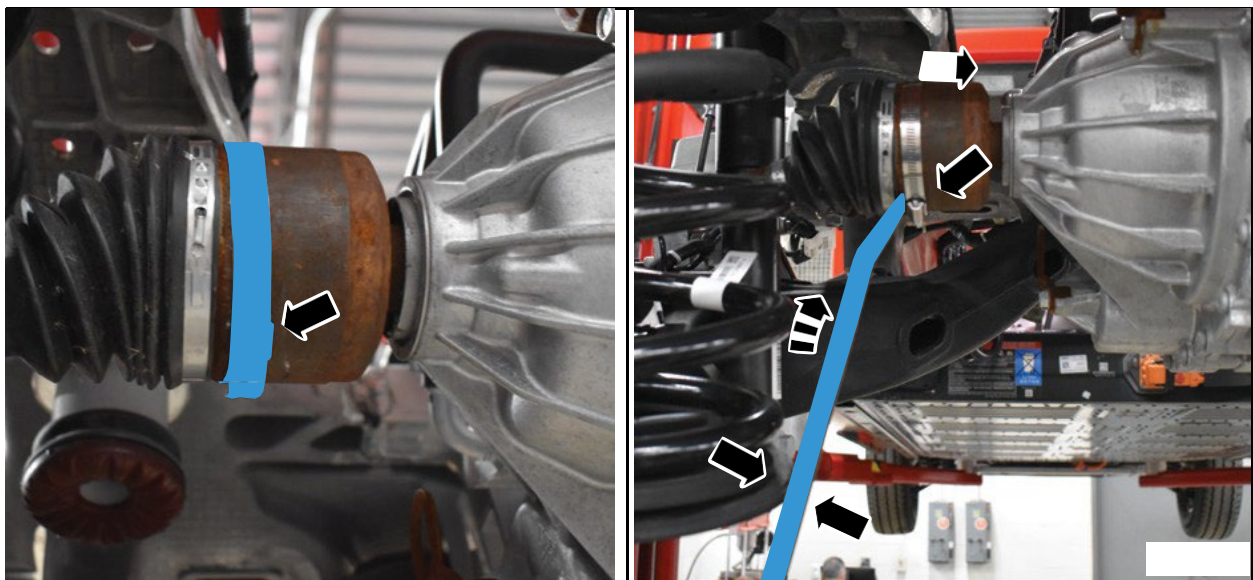
**FIGURE 6**

- Position a long pry bar, to pivot off of the rear lower spring plate.
- The halfshaft should visibly move inboard and a noticeable click from circlip may be heard.
- If resistance, rotate halfshaft and readjust clamp position.
- See Figure 6. Proceed to next Step.

**NOTE:** Position worm nut as shown in Figure 6 to avoid damage to rubber boot.

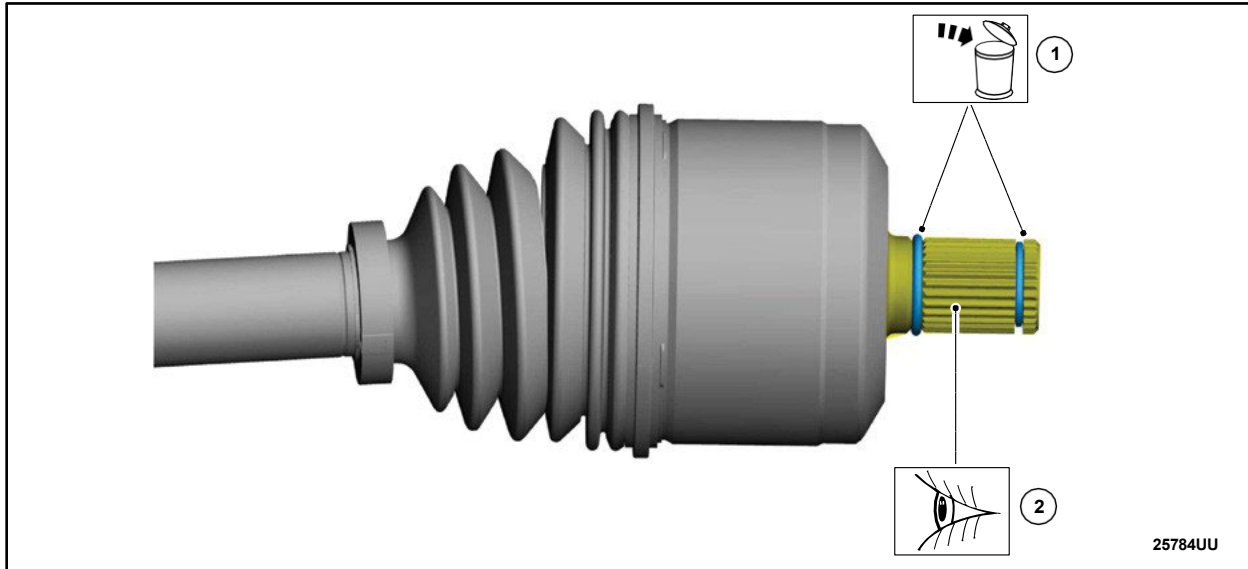
**FIGURE 19**

1. Remove and discard the retaining circlip and O-ring on the RH halfshaft.
2. Inspect the halfshaft end for damage.

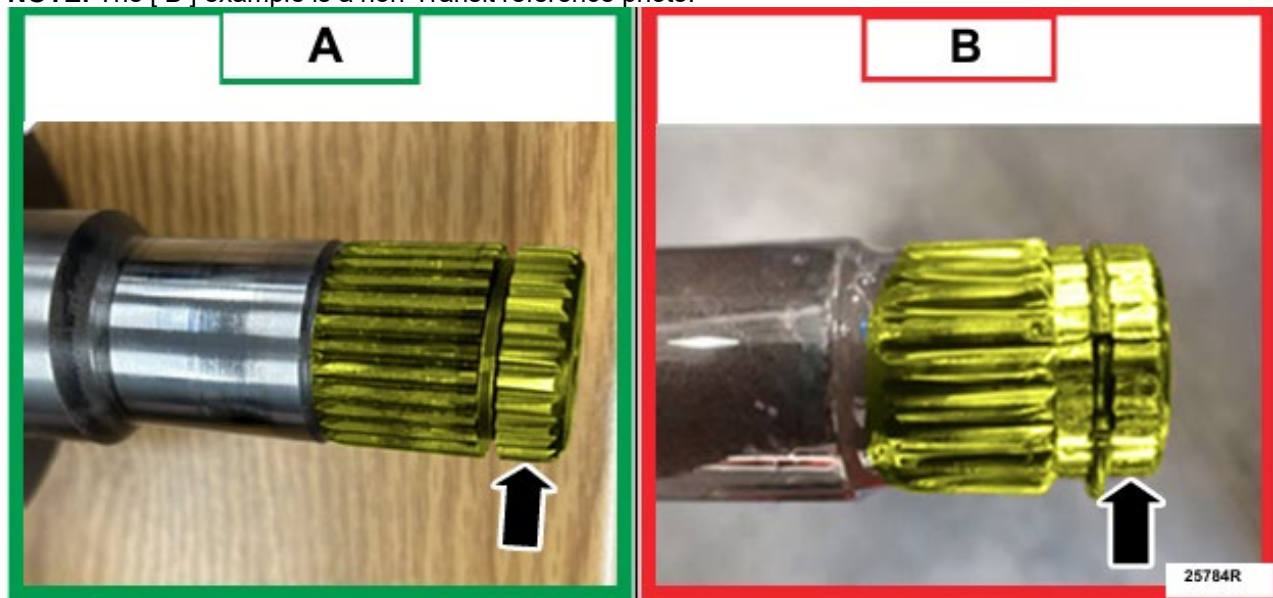
**FIGURE 22**

26. Inspect the LH halfshaft splines to the rear electric drive assembly. Are any of the splines damaged?  
See Figure 22.

**[ A ] -No damage of splines-** See Parts **List A** below then Proceed to Step 36.

**[ B ] - Damaged of splines.-** Proceed to the next Step.

**NOTE:** The [ B ] example is a non-Transit reference photo.

- Bolts - Front and Rear, Electric Drive Assembly Mounting
- LH and RH Halfshaft circlips
- O-Ring, RH Halfshaft
- Seal - Rear LH Halfshaft to Drive Assembly
- Coolant as needed
- Corrosion protection

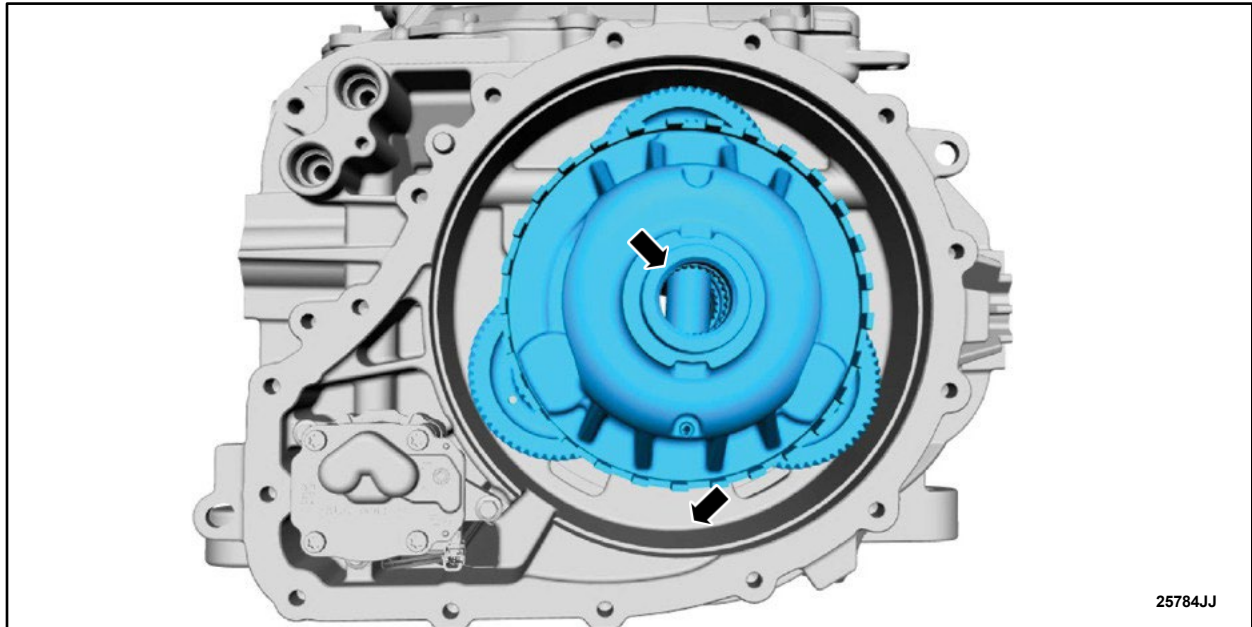
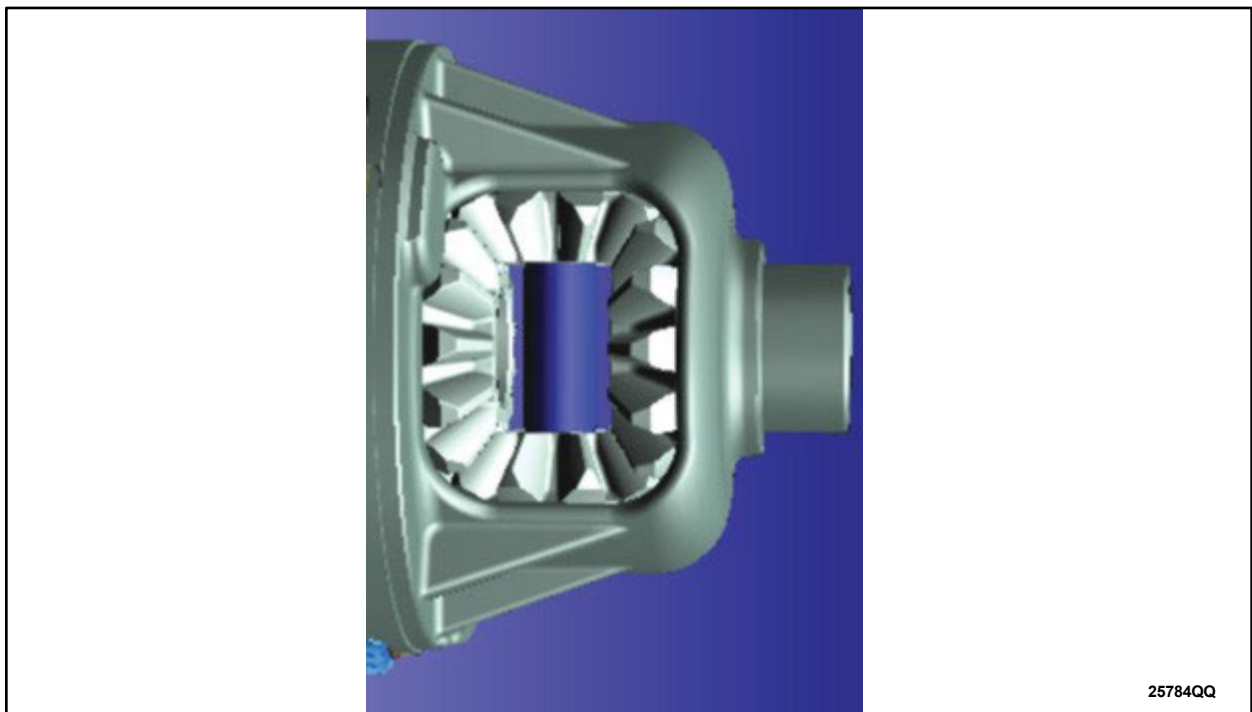
FIGURE 27

32. Inspect the differential gearing. Does the differential gearing show signs of excess wear, contamination, or debris? See Figures 27 and 28.

**PASS** - No excess wear, contamination or debris. No further tear-down required. Proceed to the next step.

**FAIL** - Take pictures of suspect parts for requested replacement and contact the Special Service Support Center (SSSC) for further direction.

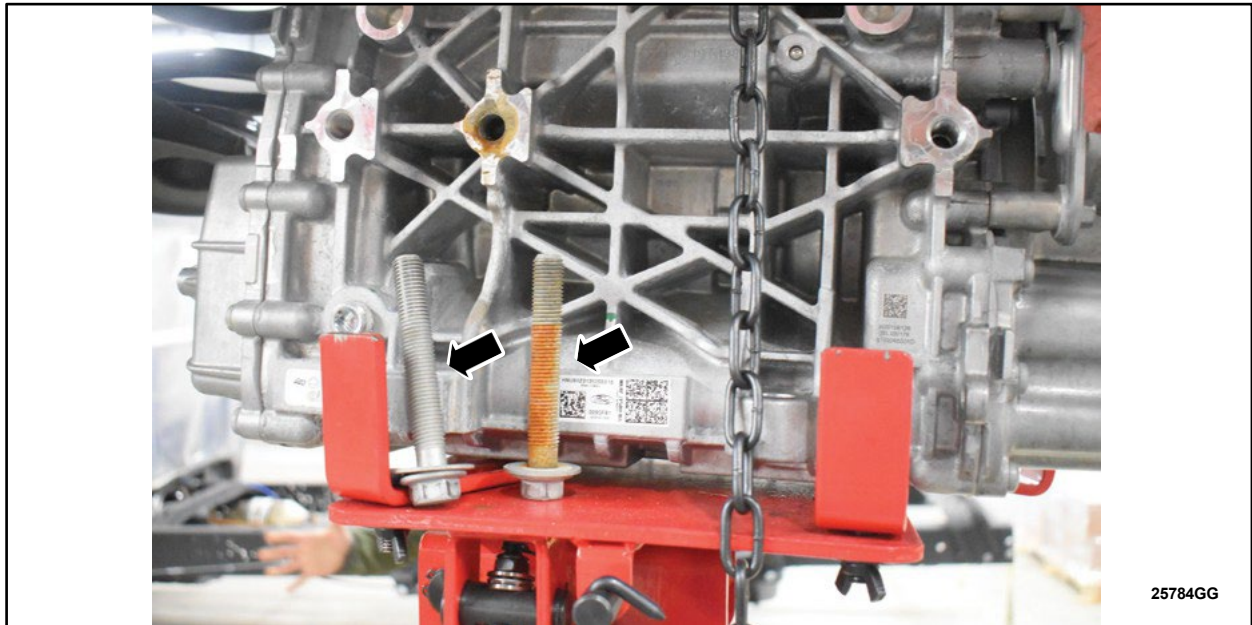
**FIGURE 42**  
[END]

**NOTE:** Example of why the corrosion protection is needed after assembly.

47. Using an approved corrosion protectant listed in the bulletin, seal the 4 (four), rear electric drive assembly, mounting surfaces between the rear electric drive assembly and the mounting plates. Read the bullet points below and See Figures 39, 40, 41, and 42.
