## TECHNICAL SERVICE BULLETIN

### Transmission Not In Park Message When Driving Below 10kmph

**26-2159**

20 May 2026

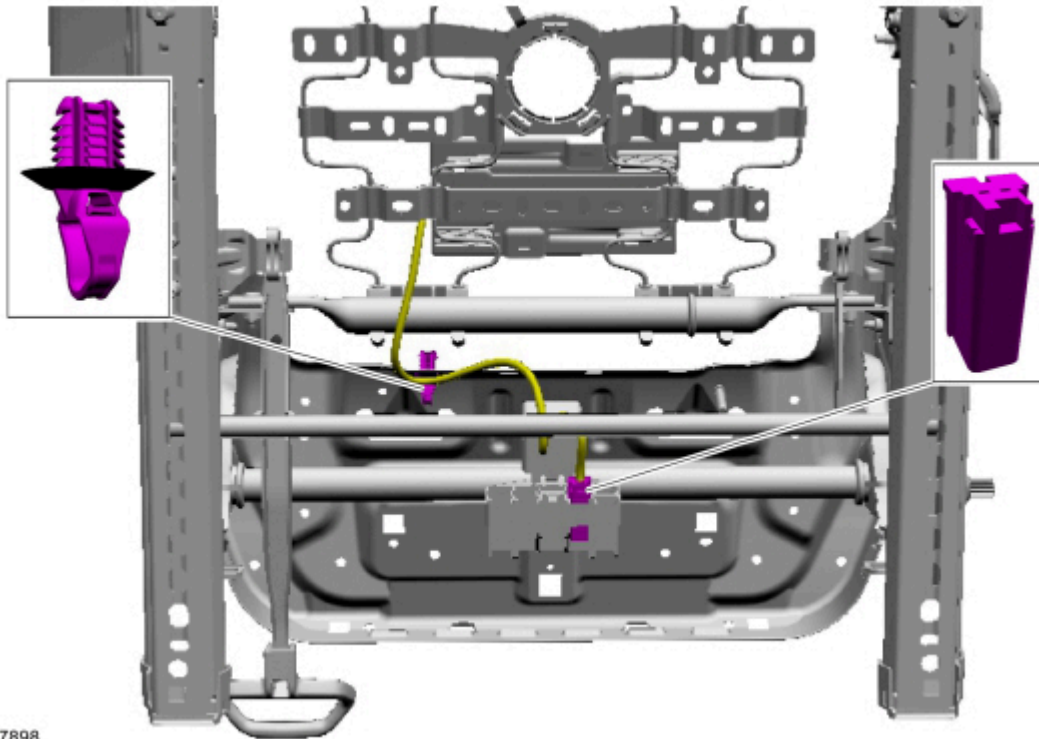
1. Install a new seat occupant sensor **and** front seat cushion foam (see Parts Required). For additional information, refer to 2024 Transit Custom / Tourneo Custom Workshop Manual Section 501-10A.
  - Make sure that the edge clip is located at the indicated position. If required, move the edge clip away from the seat occupant sensor channel in the foam (approximately 40-50 mm).

- Install a new seat heater mat (see Parts Required). The installation of the plastic bracket under the suspension mat is required. Refer to section: **Plastic bracket - Installation**

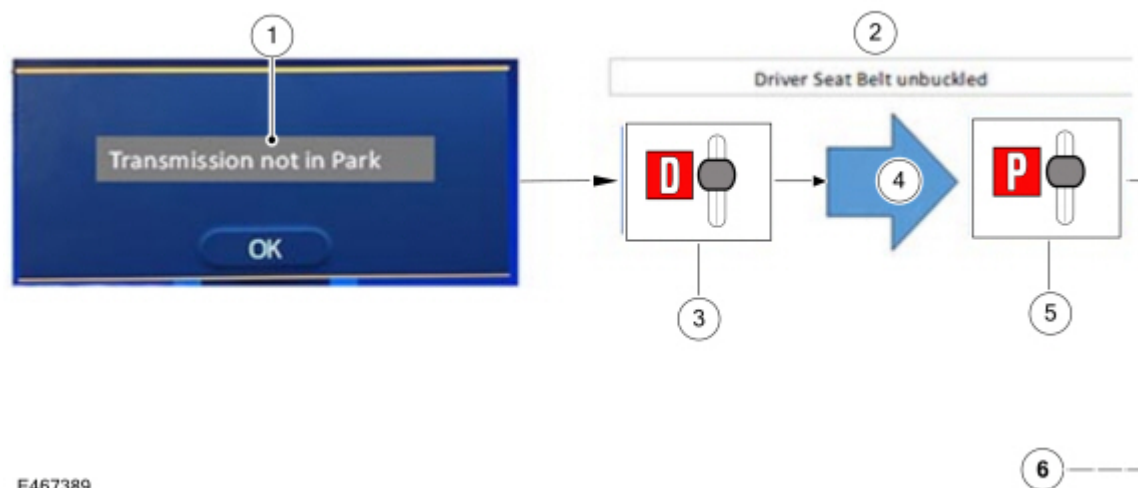
E467389

- Driver seat occupancy status / Seat occupance sensor => occupied ; un-occupied
- Seat belt buckle status => buckled ; un-buckled
- Vehicle speed <8 km/h ; >8 km/h (5 mph)

## Functionality - Chart: Driver egress detected &amp; Shifter not in Park (P) &amp; Vehicle speed &lt;8 km/h
