## TECHNICAL SERVICE BULLETIN

**26-2303**

### Illuminated Airbag Warning Lamp With Diagnostic Trouble Codes (DTCs) B1405-13 And/or B1408-13

30 June 2026

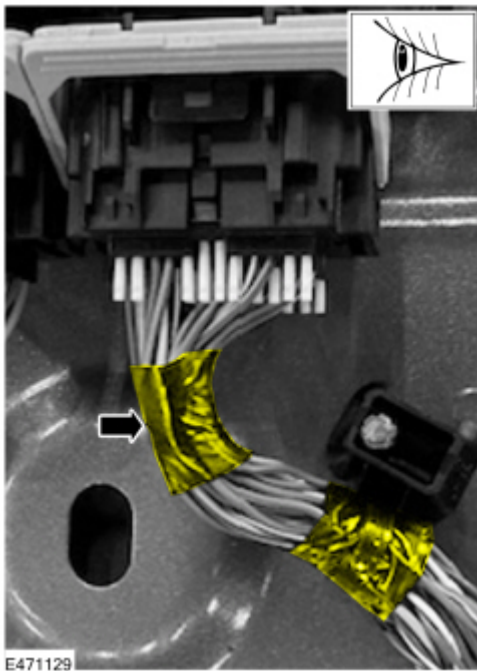
Figure 1 - Non-Plug-in Hybrid Electric Vehicle (PHEV)

**4. Inspect the wiring harness directly behind connector C310B for the presence of "Black Spot Tape" between the connector and the first clipping point (Figure 1 and 2). Is tape present?**

5. Use an appropriate tool to remove the black spot tape.
