## TECHNICAL SERVICE BULLETIN

### Illuminated MIL In Conjunction With Intermittent Transmission Shift Concerns In FORWARD Or REVERSE Gear With DTCs Stored - Transmission Wiring Harness With Wire Insulation Abrasion

**26-2215**

05 June 2026

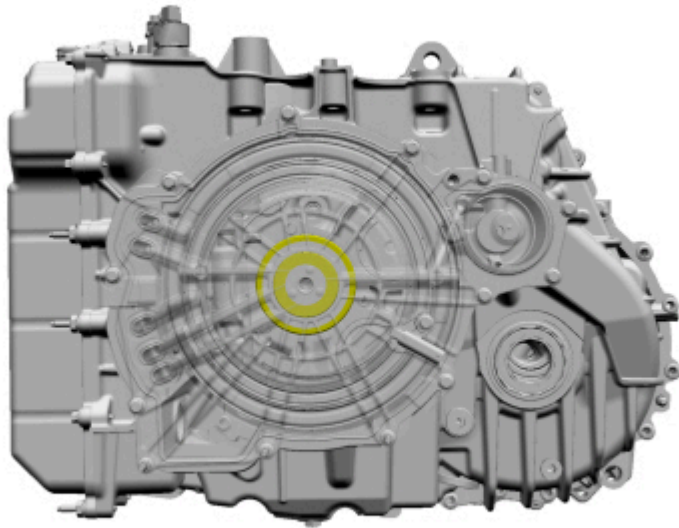
E453994

**CAUTION: Be extremely careful when removing the end cover. Take extra care not to drop / lose / damage the bearing sitting in behind (refer to next image).**

**NOTE: Make sure that no component falls off during removal. Make sure the bearing is installed with flat side facing outwards.**

Remove the transmission end cover. For additional information, refer to Transit Custom / Tourneo Custom Workshop Manual Section 307-01.

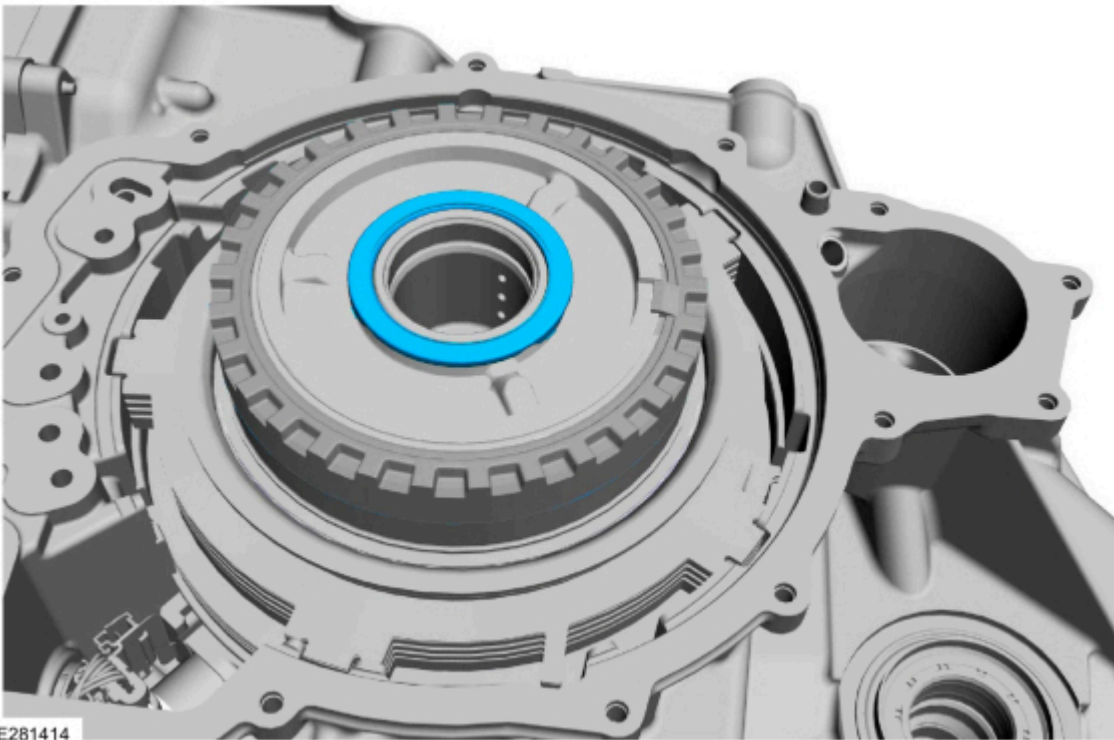
E281414

2. Take extra care not to drop / lose / damage the bearing sitting in behind.

3. Inspect the exposed wiring for damage. If required disconnect the electrical connectors.

- If the abrasive damage to the wire is more significant, repair as required. For additional information refer to the corresponding workshop Manual Section on PTS.

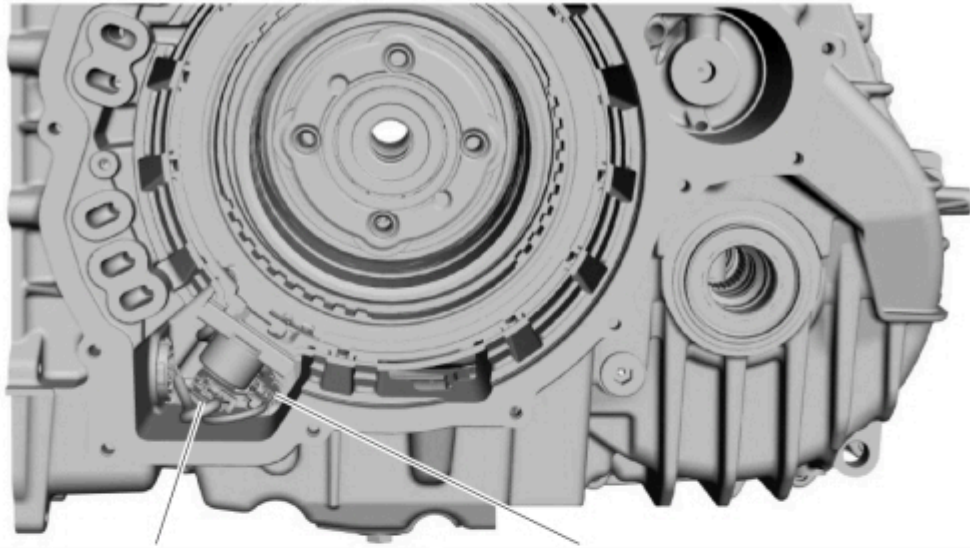
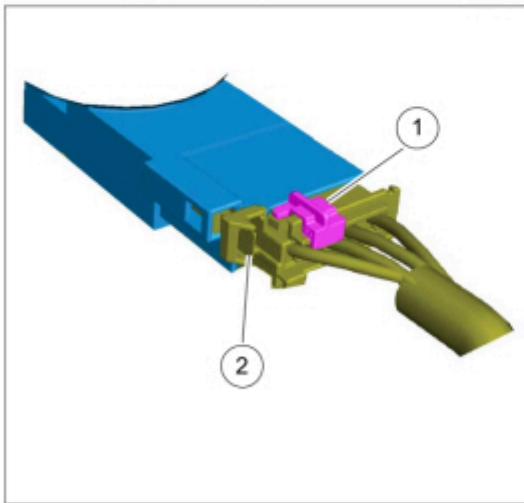
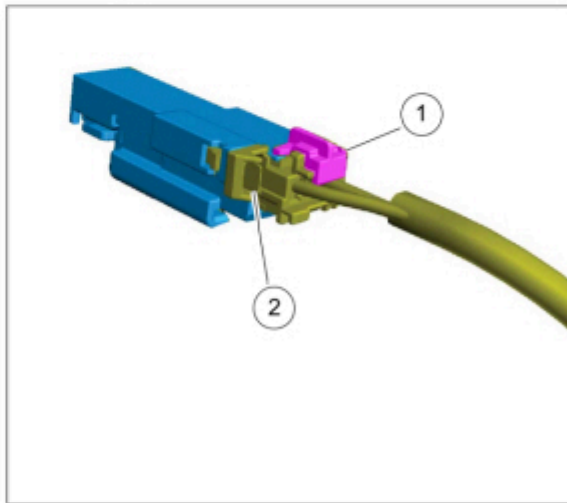
E281624

4. Example for transmission wiring harness with wire insulation abrasion.

(1). Electrical connectors connected to the transmission.

(2). Wire insulation abrasion.
