## TECHNICAL SERVICE BULLETIN

### Transmission Not In Park Message When Driving Below 10kmph

**26-2159**

20 May 2026

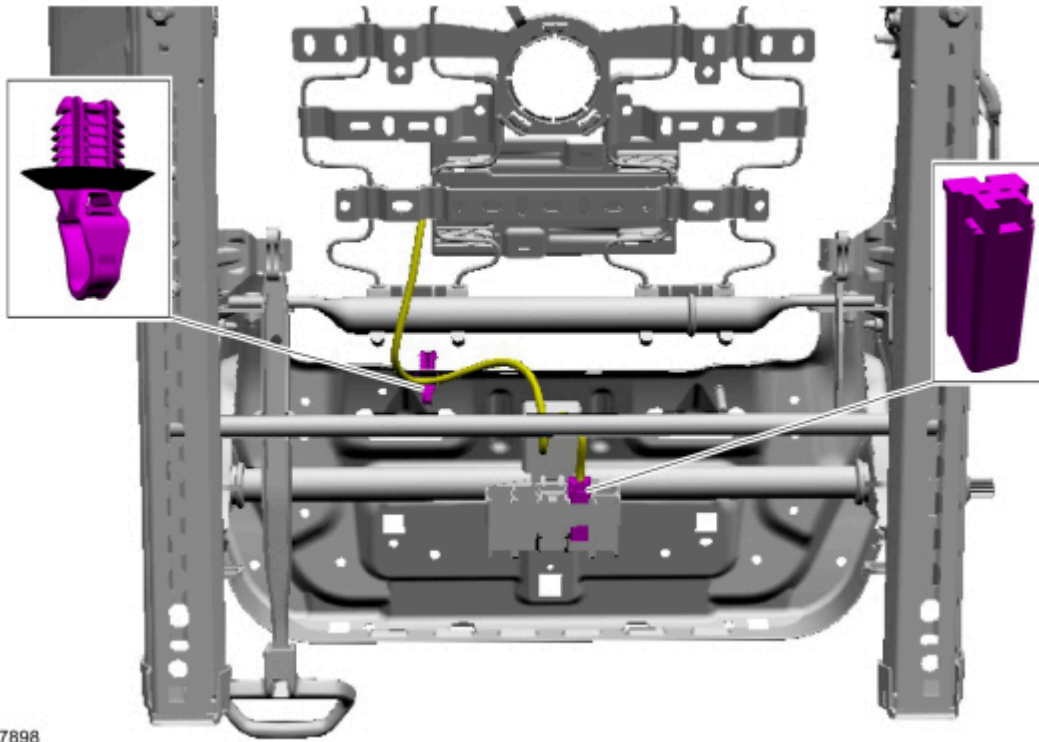
1. Install a new seat occupant sensor **and** front seat cushion foam (see Parts Required). For additional information, refer to 2024 Transit Custom / Tourneo Custom Workshop Manual Section 501-10A.
  - Make sure that the edge clip is located at the indicated position. If required, move the edge clip away from the seat occupant sensor channel in the foam (approximately 40-50 mm).

- Install a new seat heater mat (see Parts Required). The installation of the plastic bracket under the suspension mat is required. Refer to section: **Plastic bracket - Installation**
