**FSA 25S39**

Safety Recall 25S39 *Reissue 2*

Certain 2022-2025 Model Year Ranger/Everest 3.0L Lion Engine  
Camshaft Sprocket Failure – **Final Repair**

**SUBJECT: 25S39 *S2* – Ranger / Everest 3.0L Lion Engine - Camshaft Sprocket Failure – Final Repair**  
**NEW VEHICLE DEMONSTRATION / DELIVERY HOLD**

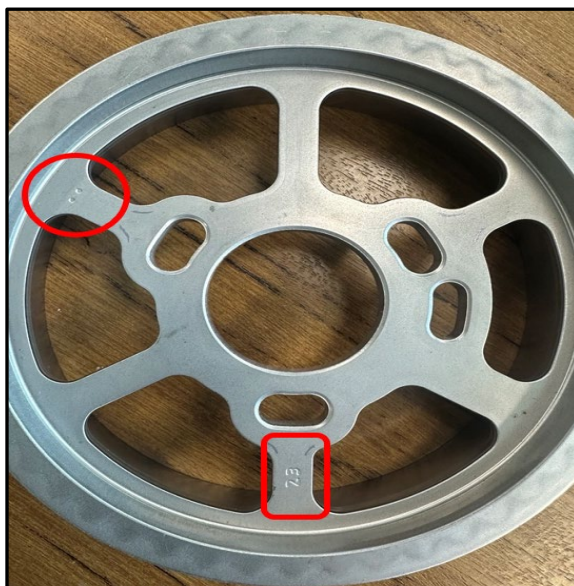
Figure 4

4. Does the sprocket show **two** dots only and the year **23**? (example Figure 4)

| If Yes | Vehicle <b>FAIL</b> , Move to Step 6 (sprocket replacement required) |

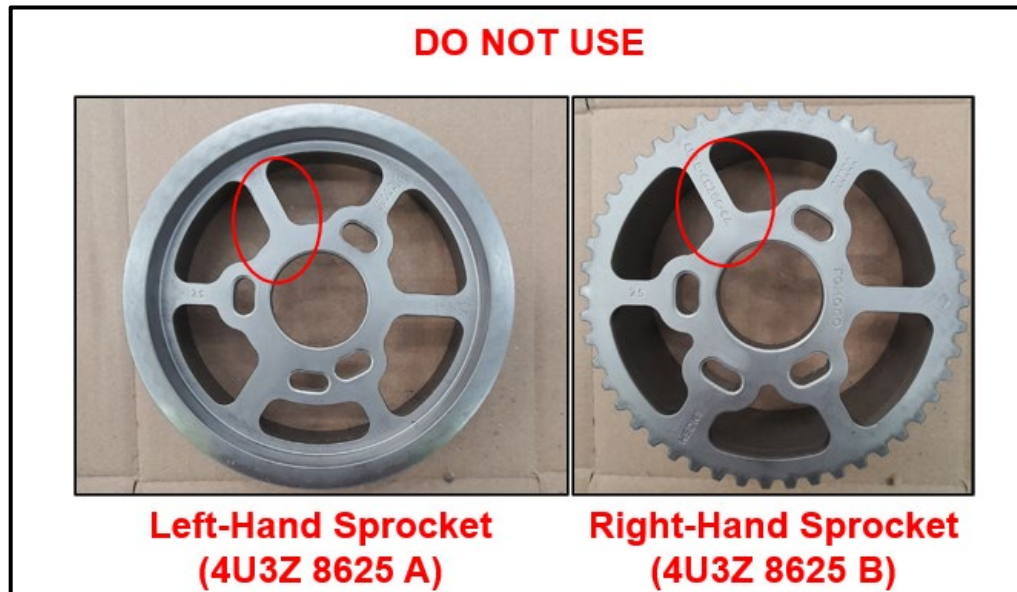
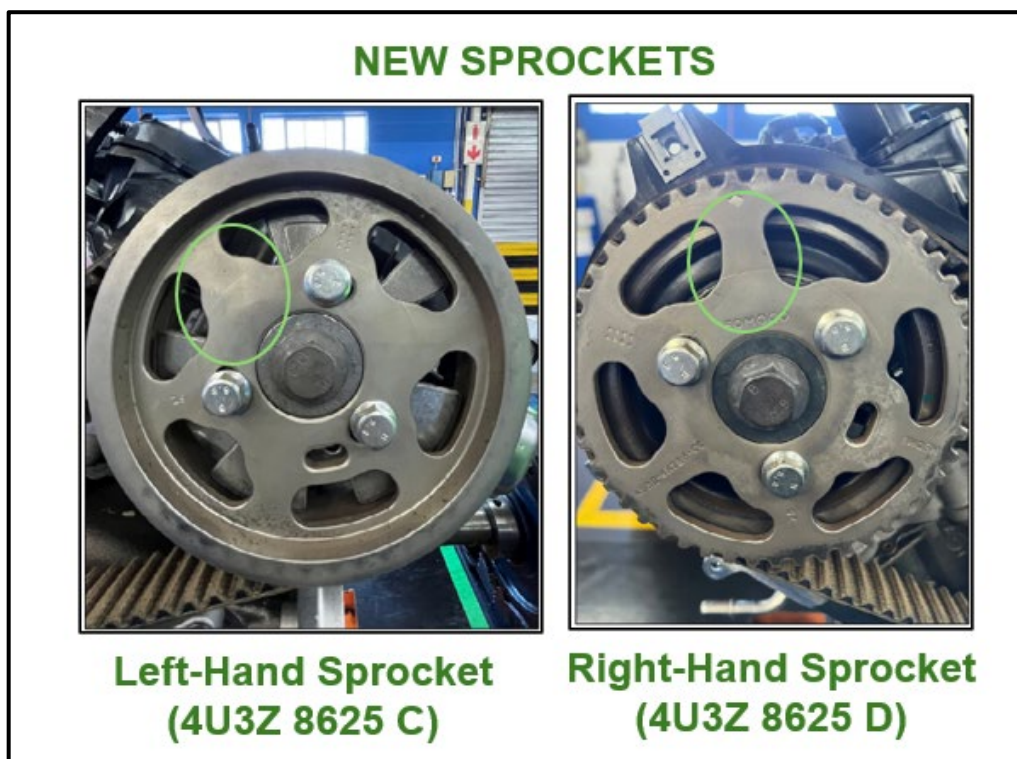
**NOTE:** Physical characteristics can be noticed on the old v/s new sprocket parts – circled. Hub and spoke of new design has additional material. Figure 16A & 16B.

K. Install new crankshaft sprockets (ensure latest level sprockets are used, if old level parts are supplied return them to Ford PDC – Parts Distribution Centre, see below for pictures of new sprockets) and bolts. Figure 16A, 16B & 16C.
