## TECHNICAL SERVICE BULLETIN

### No Start/No Crank In Cold Condition

**26-2072**

27 May 2026

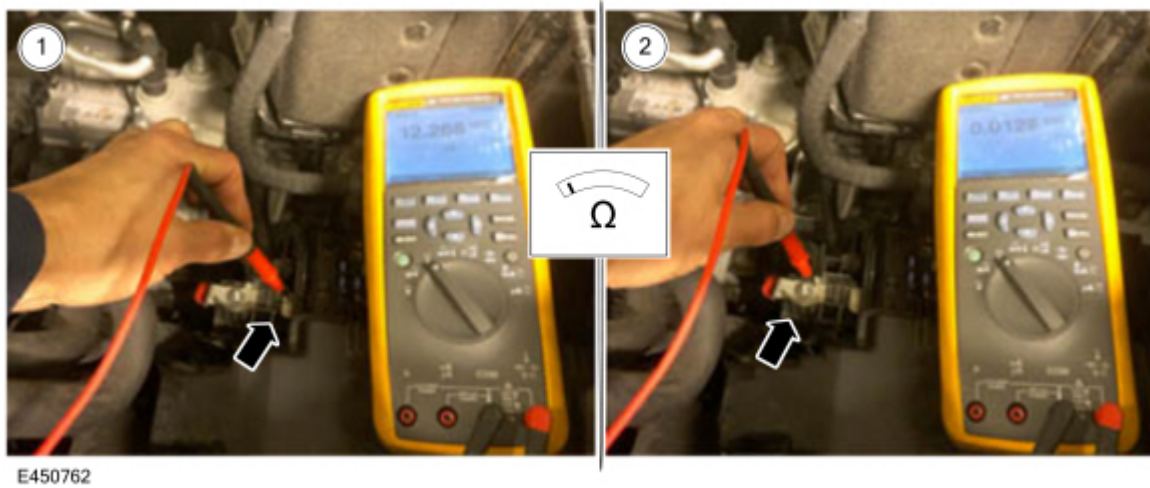
E450762

Check the starter/alternator fuse located in the Auxiliary Battery Fuse Box (275 A) - Installation position: Front left engine compartment next to the front fender splash shield.

- If fuse is OK follow the Diagnosis and Testing procedure for the starter system on PTS.
- If fuse is blown continue with next step. **Don't start the engine.** Do not push the start button before next checks are carried out.

2. Install a new fuse (see Parts Required).
  - Go to next step.
3. Manually rotate the crankshaft two full turns (clockwise) with a ratchet.
  - If not rotating, go to **next step**..
  - If rotating normally, go to **step 6**.
4. Remove the glow plugs and rotate the engine (clockwise) with a ratchet to drain the water from the cylinders. For additional information, refer to 2023 Transit Custom / Tourneo Custom Workshop Manual Section 307-01.
  - Manually rotate the crankshaft two full turns (clockwise) with a ratchet. Afterwards crank engine for approx. five sec.(1-2 times) so that rest of residual condensate water turns out.
