## TECHNICAL SERVICE BULLETIN

### Sliding Door Exterior Handle Does Not Release Rear Latch When The Door Is Locked

**26-2105**

09 June 2026

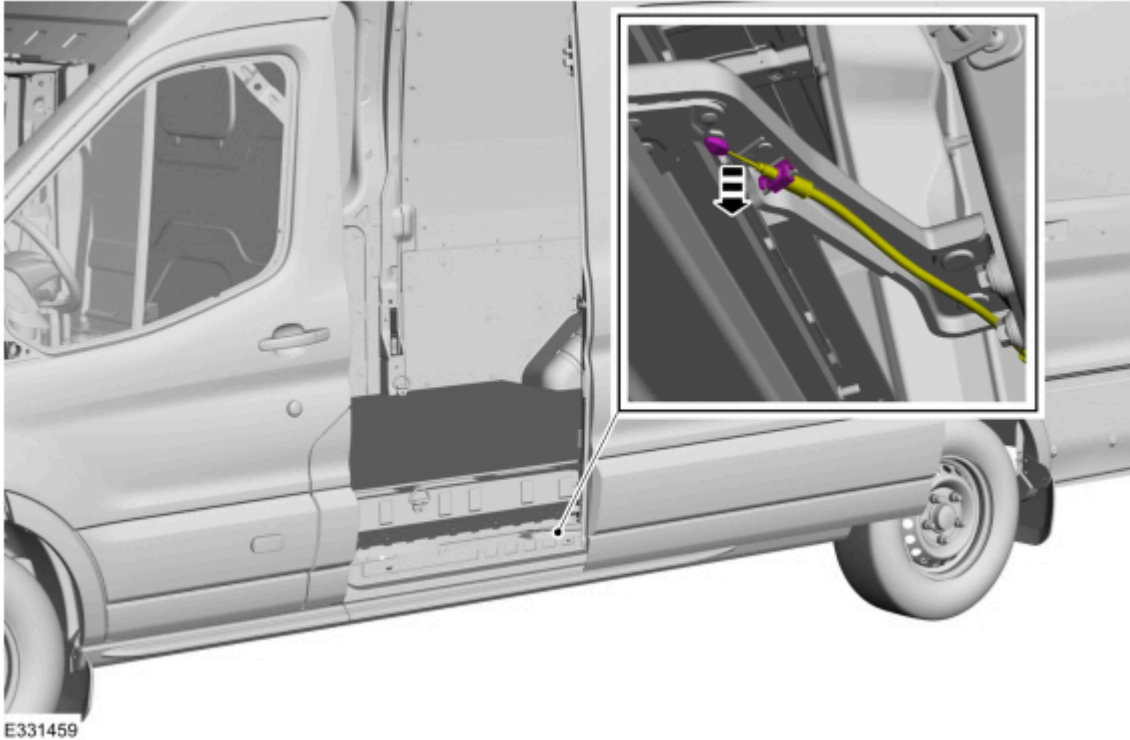
1. Unhook the latch cable from the lower roller mechanism.

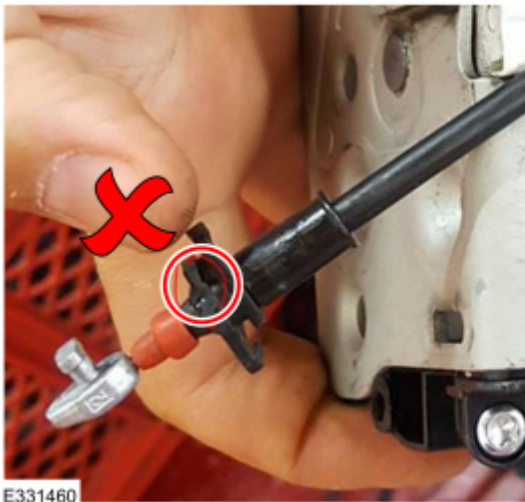
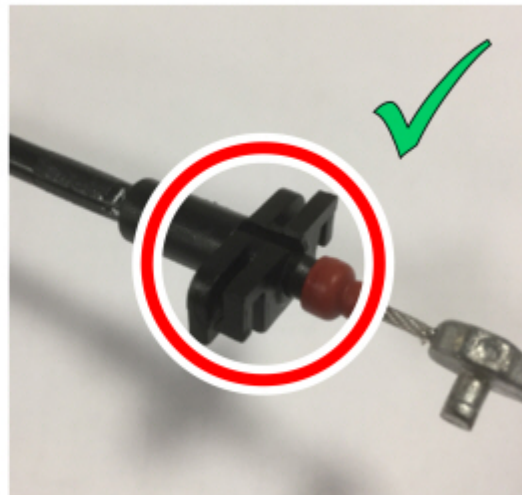
2. Check for a broken or cracked clip.

- If the clip is damaged, go to next step.
- If the clip is **not** damaged, cracked or broken, perform the sliding door alignment procedure. For additional information, refer to Transit Custom 2012.75; Transit 2019.75; Transit Custom 2024 Workshop Manual Section 501-03. Go to step 5.

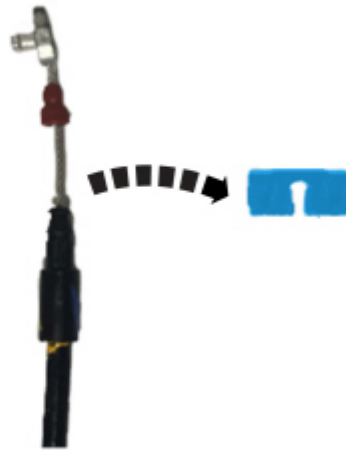
E331462

3. Remove and discard the damaged clip.

- (1). Push up the red/brown soft plastic cap by hand.
- (2). Remove and discard the clip.
