## TECHNICAL SERVICE BULLETIN

### B-Pillar Ticking Sound With NEW Grab Handle Design

**reissue**  
**26-2221**  
10 June 2026

**Issue:** Some 2023-2026 Ranger double cab and Everest vehicles with the new style grab handle bracket design may experience a ticking type sound at the B-pillar area.

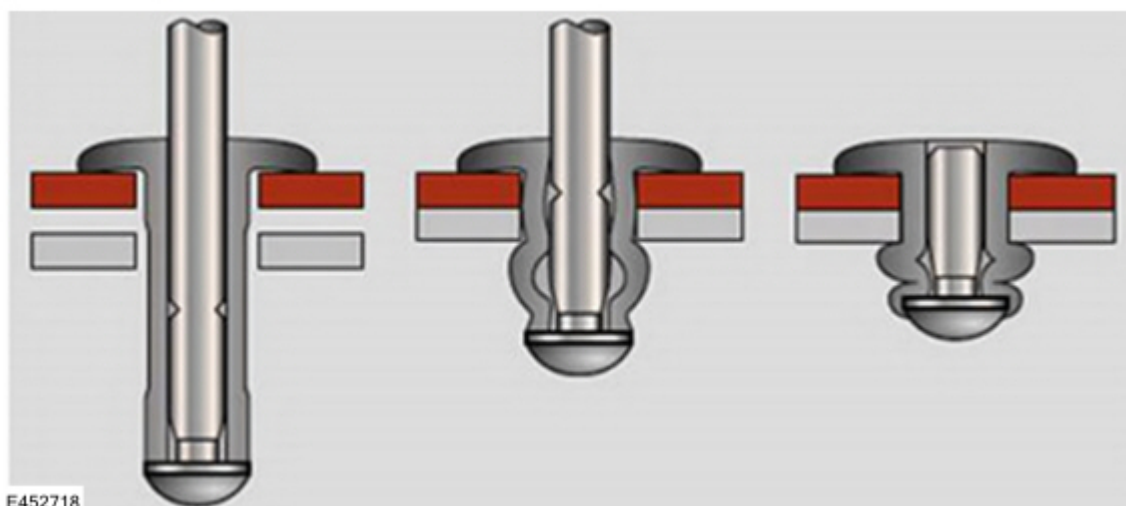
Figure 1 - Rivet condition before and after correct installation.

**CAUTION:** Any rivets installed as a part of this TSB must meet the following installation requirements:

- Must sit on the panel completely with 360° surface contact to the panel.
- Must not be installed in inclined/angular position.
- Must not have any gap between the rivet and panel after installation.

**NOTE:** The correct rivet tool is required to ensure the rivets are installed properly to obtain effectiveness of the repair. Do not use a hand tool. If Dealers do not have a blind rivet tool meeting these requirements, they are recommended to outsource to a body shop to install the rivets using a blind rivet tool that does meet these requirements. Dealers can submit payment as a sublet cost in the warranty claim. (Figure 1)

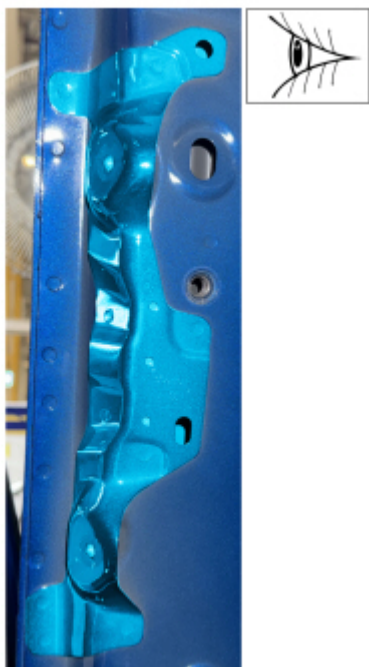
Figure 2

1. Remove the B-pillar trim panel. For additional information, refer to Workshop Manual (WSM) Section 501-05.
2. Check to ensure the vehicle is fitted with the new grab handle bracket design. (Figure 2)
  - (1). Yes - proceed to the relevant repair procedure below (refer to Scope below for further information).
  - (2). No - this TSB does not apply, refit the B-pillar trim panel and refer to the WSM for diagnosis/repair.

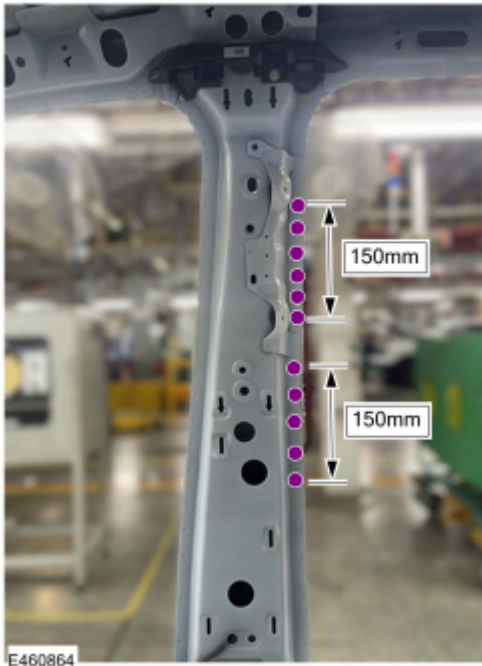
Figure 3 - AB Flange area for checking the gap and clamping

1. Initial Gap Check: Before clamping, use a feeler gauge to check for any existing gaps on the AB flange within the specific segments extending 150mm above and 150mm below the points where the grab handle bracket lower leg attaches to the B-pillar structure and note any observed gaps.
2. Identify Clamp Locations: Apply clamping force to the AB Flange within the specific segments extending 150mm above and 150mm below the points where the grab handle bracket lower leg attaches to the B-pillar structure. (Figure 3)

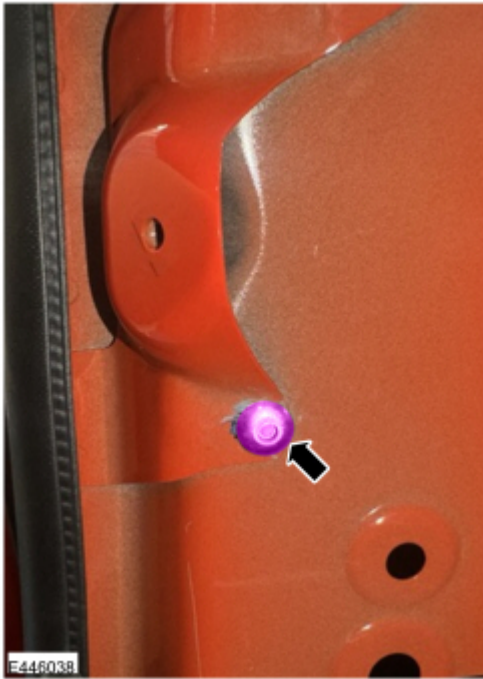
Figure 5

The following steps outline the procedure to add rivets to the B-pillar panel to eliminate the ticking noise. Due to manufacturing tolerances, spot weld locations can vary between vehicles. Rivets should be located within the zones highlighted, at a maximum distance from spot welds to achieve maximum effect. (Figure 5)

**NOTE:** Remove any swarf from the drilling process. Swarf will likely drop down into the lower area of the bodyside/rocker and/or into the carpet and create a red rust appearance and may cause a rattle noise if swarf is stuck between the grab handle bracket and B-pillar panel.

Install 1 rivet in the area shown above. (Figure 5)

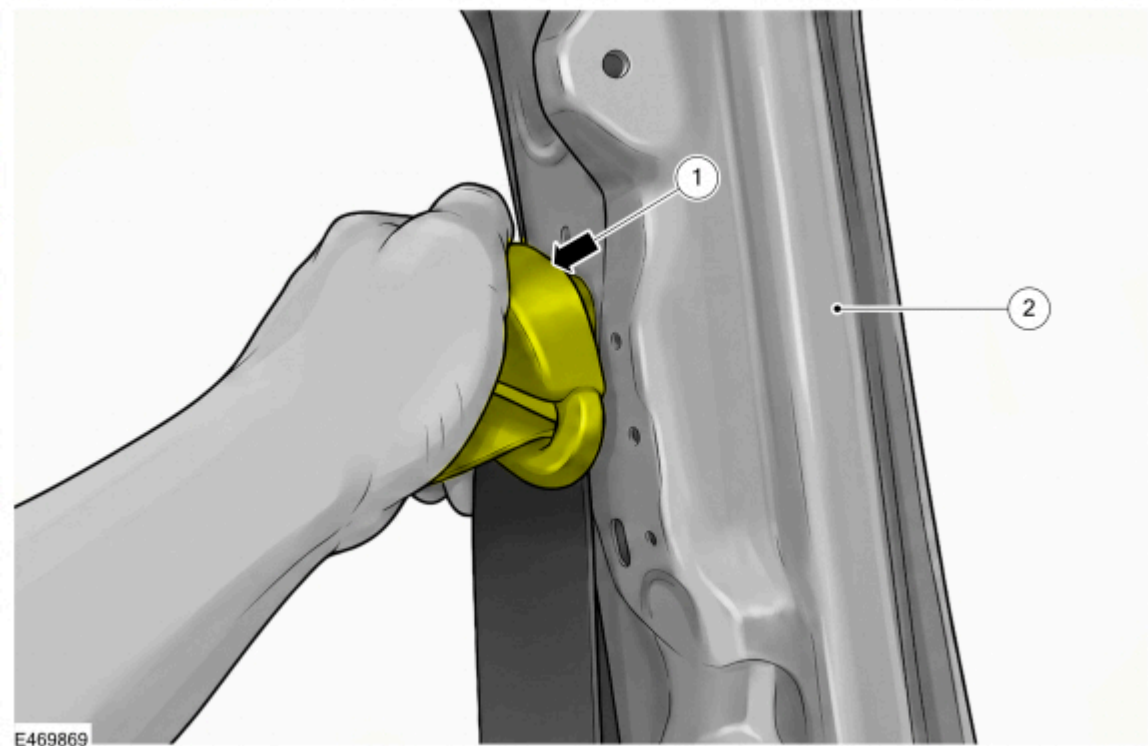
4. While the noise condition is present, apply firm manual pressure by tightly gripping the seat belt D-ring assembly, exactly as depicted in Figure 7 below.

- 1. If the noise ceases completely while holding the D-ring: The source is isolated to the anchor plate assembly. Do not attempt repair. Contact the Technical Assistance Hotline for the detailed repair procedure.
- 2. If the noise persists while holding the D-ring: The source lies elsewhere in the B-pillar. Continue standard diagnosis to locate the root cause.

| Item | Description |
|---|---|
| 1 | Hold the D-ring tightly to cut off the tick noise |
