**TECHNICAL SERVICE BULLETIN****26-2253****Illuminated Airbag Warning Lamp With Diagnostic Trouble Codes (DTCs)  
B1405-13 And/or B1408-13**

27 May 2026

| 2022-2026 Next-Generation Everest |
| 2022-2026 Next-Generation Ranger |

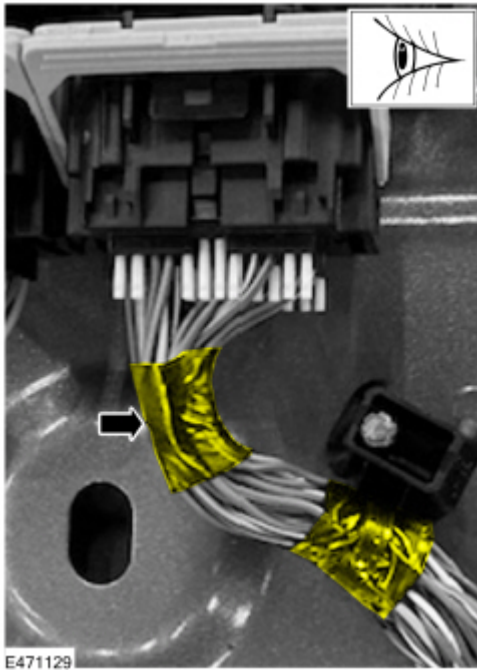
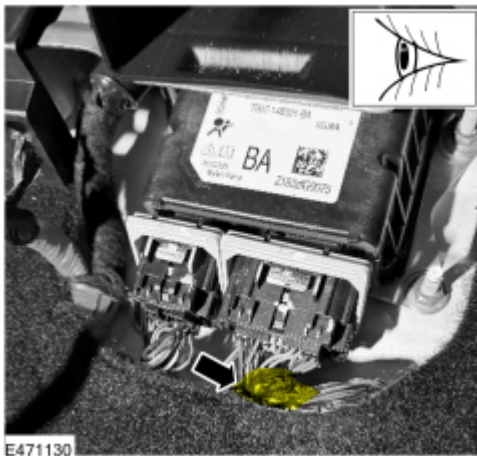
#### 4. Inspect the wiring harness directly behind connector C310B for the presence of "Black Spot Tape" between the connector and the first clipping point (Figure 1 and 2). Is tape present?

5. Use an appropriate tool to remove the black spot tape.

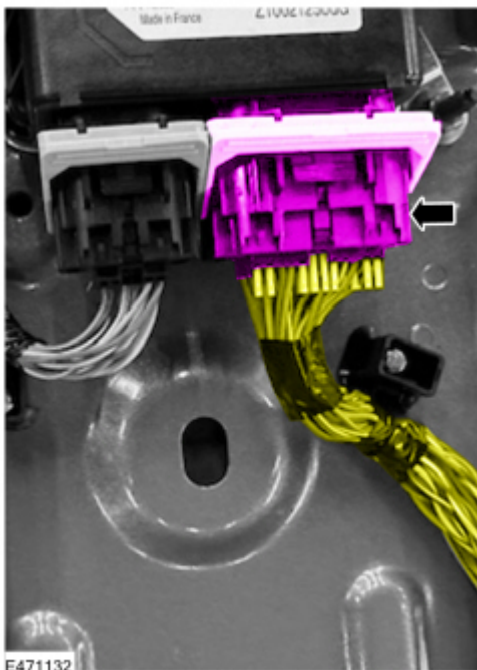
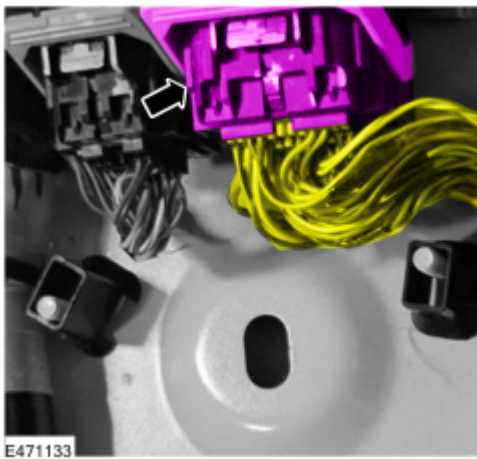
1. Disconnect RCM Connector C310B to assess. (Figure 4 and 5)

4. Perform a visual and physical inspection of the wiring harness for open or damaged circuit(s) based on the logged DTCs;

- If DTC B1405:13 is logged, check RCM connector C310B and driver side curtain airbag connector C9031.
  - If DTC B1408:13 is logged, check RCM connector C310B and passenger side curtain airbag connector C9032.
  - If both DTC B1405:13 and DTC B1408:13 are logged, check RCM connector C310B, driver side curtain airbag connector C9031 and passenger side curtain airbag connector C9032.
5. If damage is found on circuits within the first 270mm, repair the damaged wiring using the following service kits;
- Service kit part number DU2Z-14474-CA to replace terminals on the RCM connector C310B side and;
  - Service kit part number BU2Z 14S411 BHA to replace driver side curtain airbag connector C9031 and/or passenger side curtain airbag connector C9032.

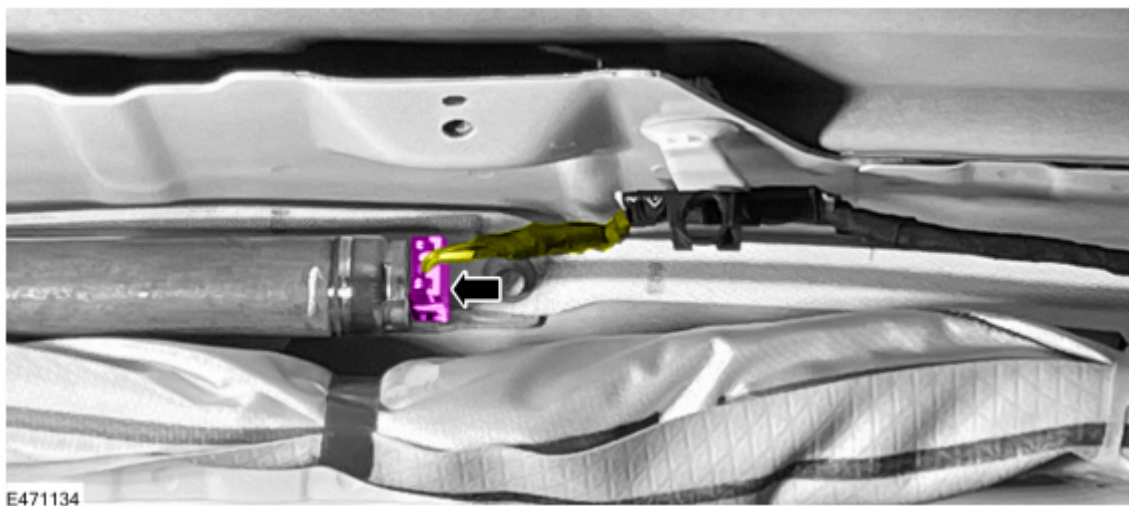
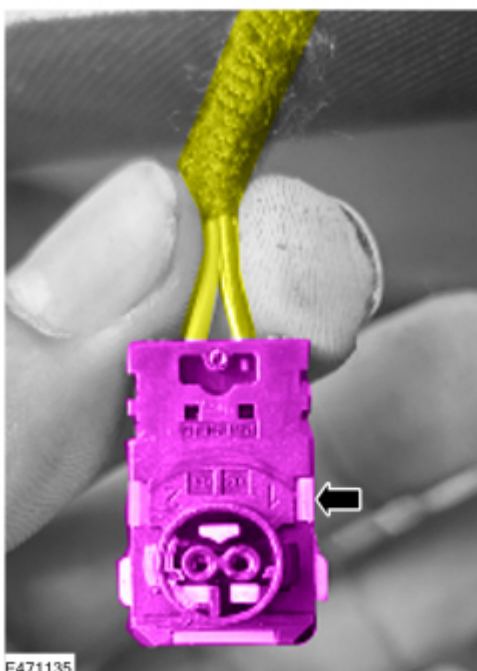
2. Lower the headliner to access the driver side curtain airbag connector C9031 and passenger side curtain airbag connector C9032. Refer to WSM Section 501-05.
3. Disconnect driver side curtain airbag connector C9031 and passenger side curtain airbag connector C9032. (Figure 6 and 7)
