## EXTENDED WARRANTY SERVICE PROGRAM

### SUBJECT:22N17 ESCAPE - Power Window Switch Chrome Tip Replacement - Single Repair

## 22N17 ESCAPE - Power Window Switch Chrome Tip Replacement - Single Repair

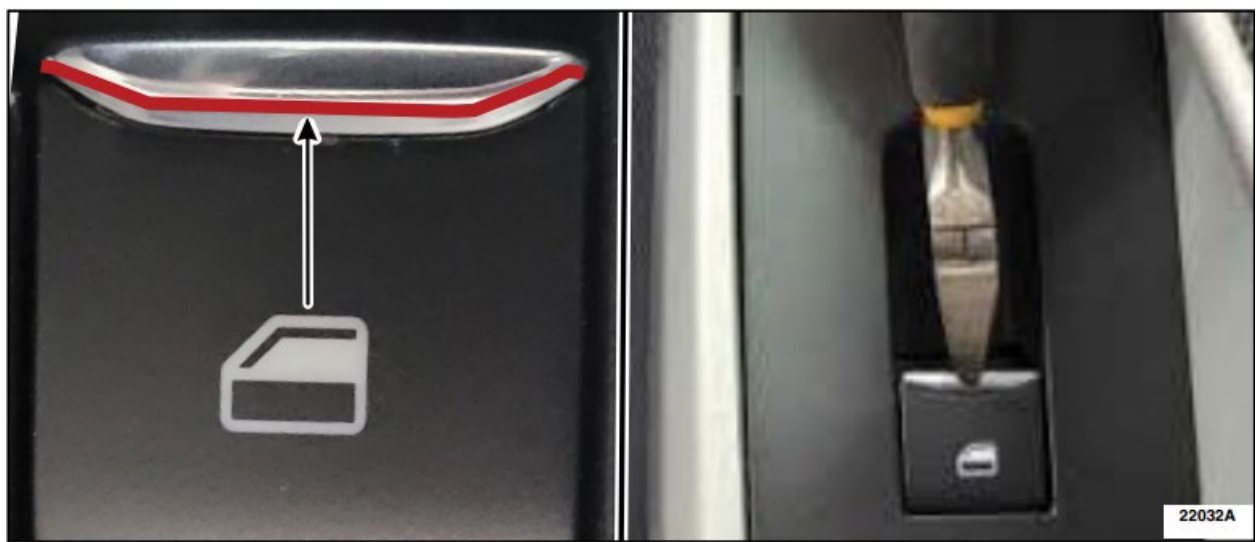
FIGURE 1

NOTE: Passenger side window switch assembly shown, all other window switch assemblies are similar.

1. Using a pair of diagonal cutting pliers, cut halfway through the chrome tip with taking care to not damage the black painted part of the window switch assembly. Refer Figure 1.

NOTE: If the black painted part of the window switch assembly is damaged the window switch assembly must be replaced. Refer to the Workshop Manual (WSM) procedures in Section 501-11.

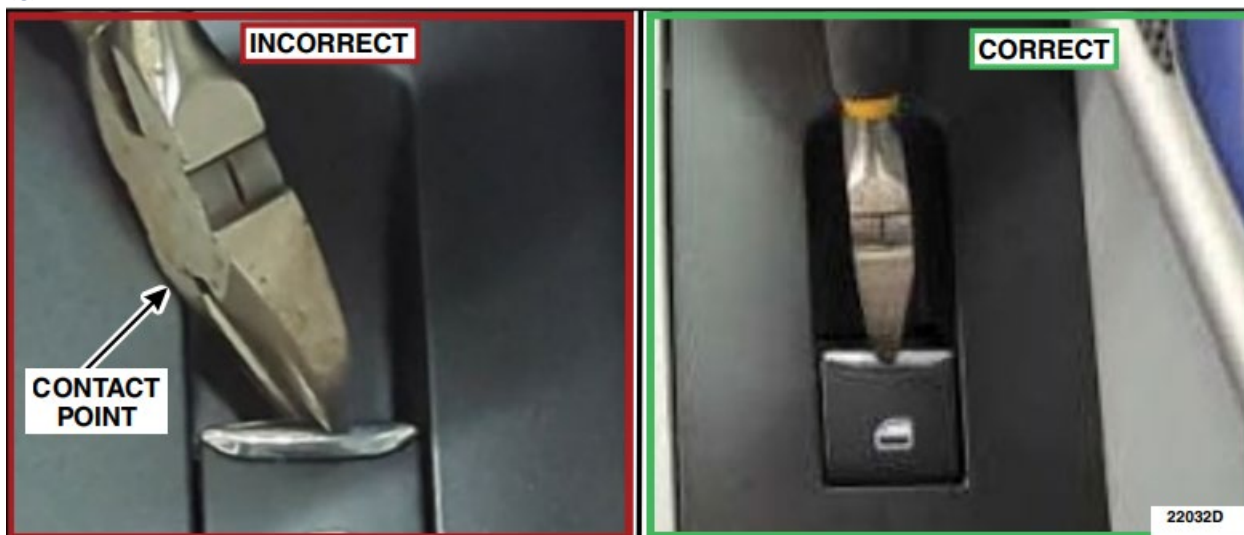
FIGURE 2

NOTE: Passenger side window switch assembly shown, all other window switch assemblies similar.

NOTE: The diagonal cutting pliers must be inserted at a 90° angle to the window switch assembly to prevent damage to the window switch assembly. Refer Figure 2.

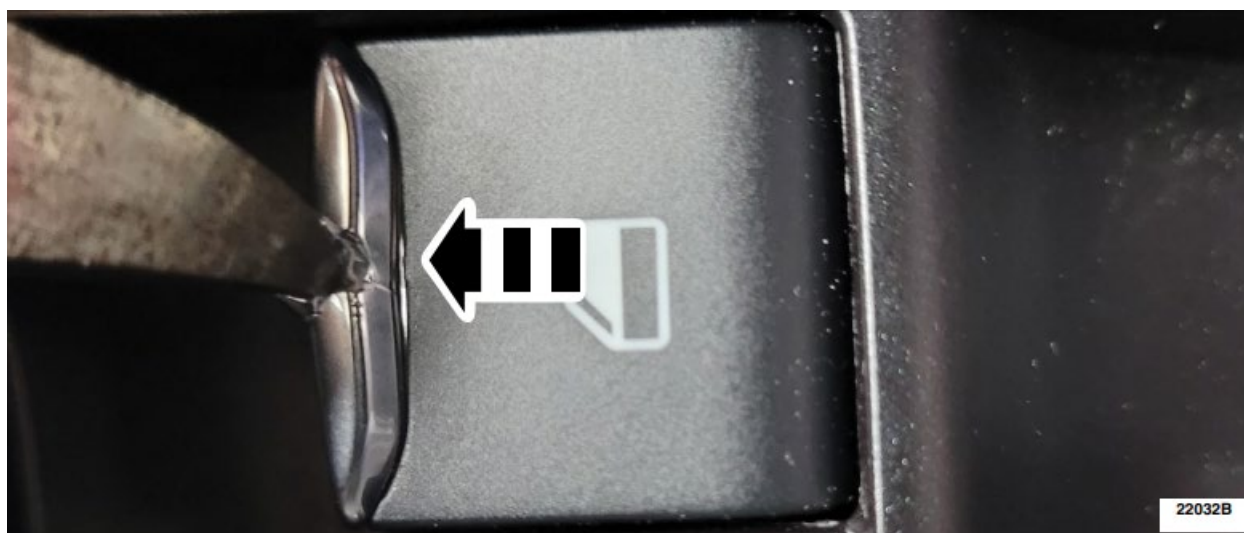
FIGURE 3

NOTE: Driver side window switch assembly shown, all other window switch assemblies are similar.

2. Using the diagonal cutting pliers remove the chrome tip. Refer Figure 3.

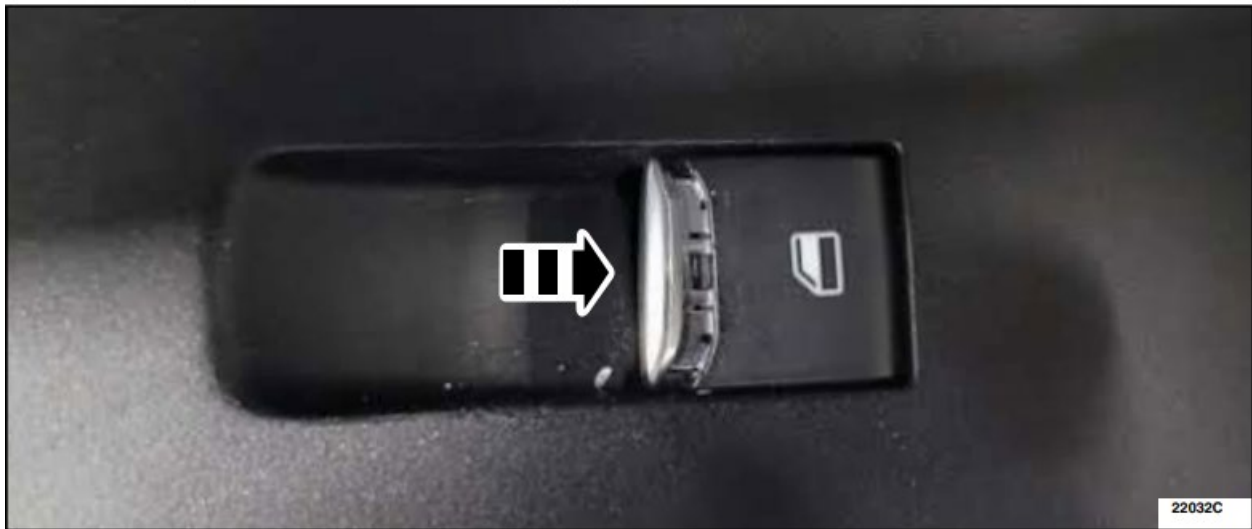
NOTE: Passenger side window switch assembly shown, all other window switch assemblies are similar.

4. Align the new window switch tip with the window switch assembly and press firmly until the new window switch tip locks into place. Refer Figure 4
