# St. Joseph's Hospital Savannah GA (US)

## St. Joseph's Hospital Cooling Tower Performance report -May 2026

31 May 2026

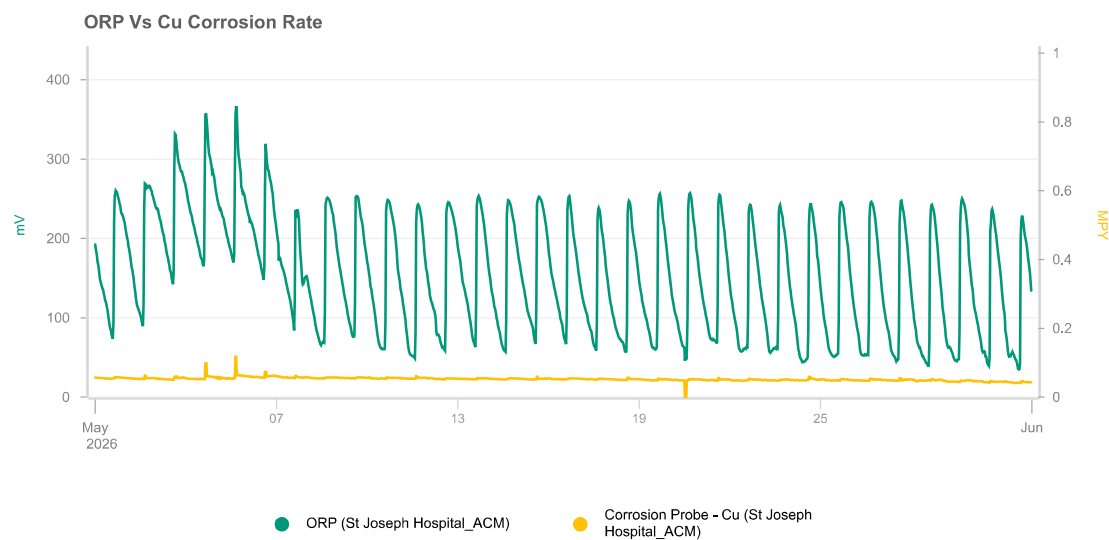
## ORP VS Cu Corrosion Rate

1. The Copper corrosion rate reading is maintained on an average of 0.05 mpy which is within the recommended range of 0.3 mpy.
2. The delta ORP of 150 mV indicates the system has good microbial control. This indicates that the oxidizing biocide is being dosed appropriately based on the chlorine demand of the water. As a result, adequate free residual chlorine is consistently maintained.

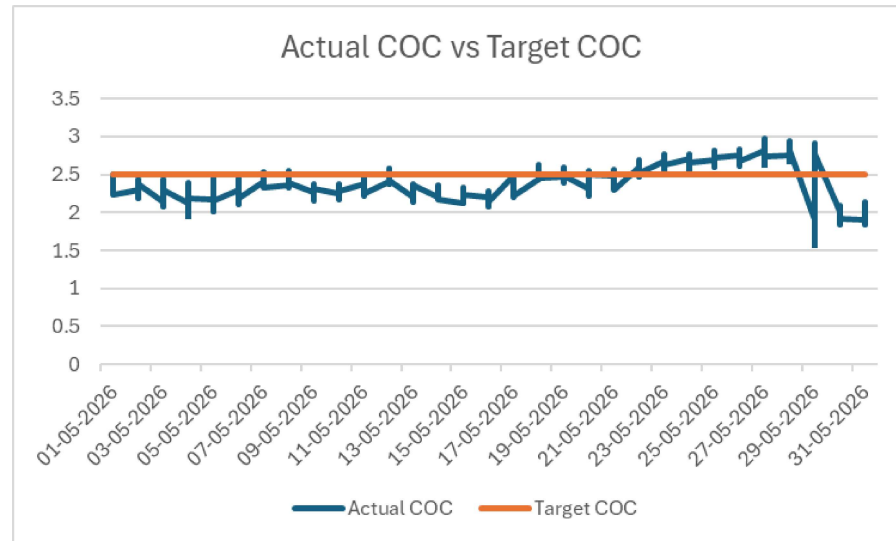
## Actual COC Vs Target COC

1. During May, conductivity was consistently maintained at an average of 700 S/cm, which is maintaining in the operating range of 600  $\mu$ S/cm. The actual COC is maintained well with the target COC of 2.5.
2. The flow through the skid is maintained around 3.5 gpm throughout the reporting period indicating stable and reliable system operation.
