Semi-Automated Bridge Inspection using Drones and Deep Learning

Master of Science in Civil Engineering for Risk Mitigation

Case Study

- **Reinforced concrete overpass** located in Lombardy, Italy
- Selected for: **medium-span layout, visible deterioration, and accessibility**
- Drone Survey targeted **two spans of the bridge**

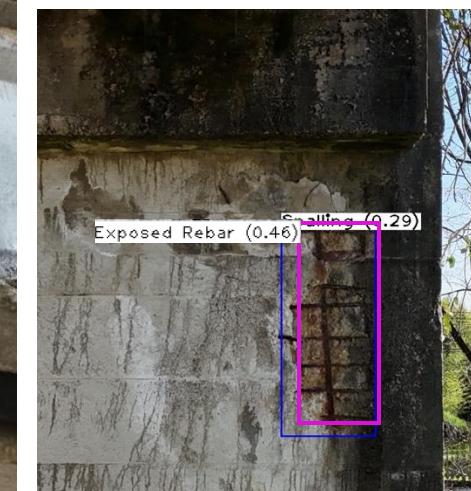
Output frames showing accurate bounding box predictions for structural defects across bridge components.

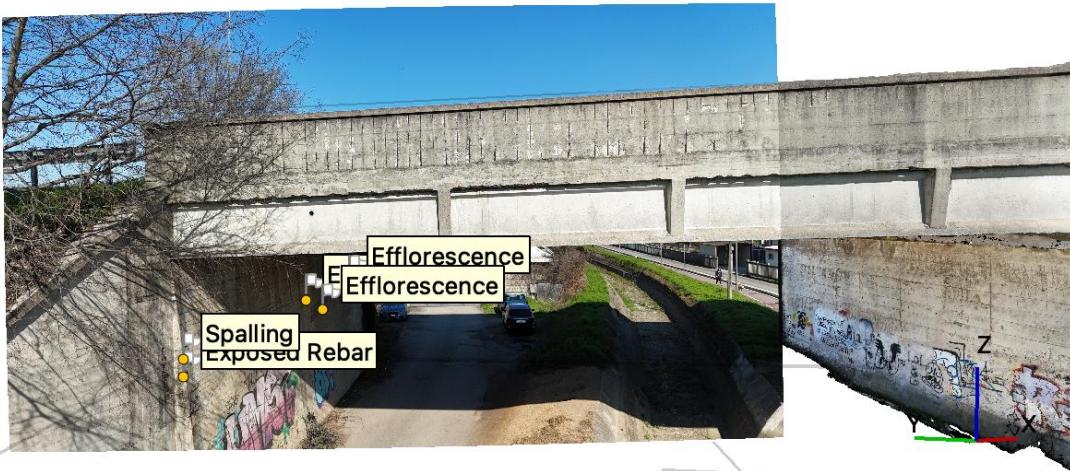
Defects Localized on 3D Photogrammetry Meshed Model

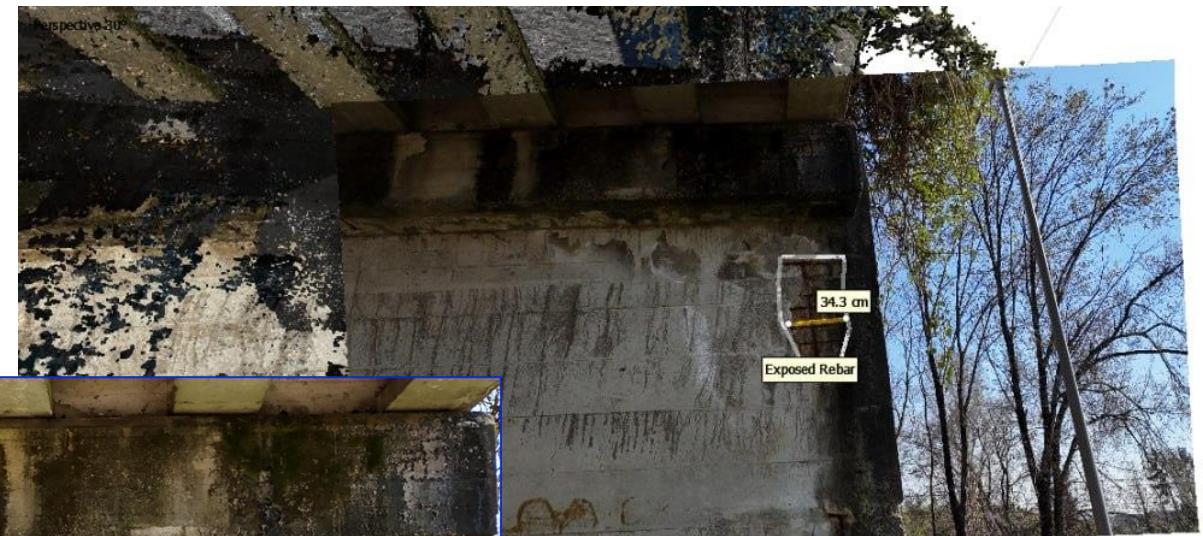
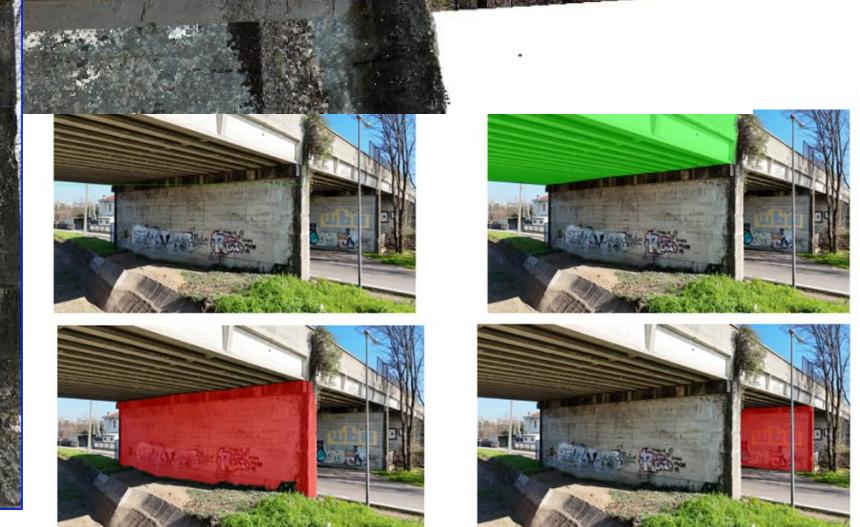
Case Example: Exposed Rebar

- YOLO11 detection resulting → Severity Grade:
 - **G = 5**
 - Real Coordinate measurement on 3D localized model
 - **defect length: 34.3 cm**
 - Severity Indexes:
 - **K1 = 0.2** → limited surface extension
 - **K2 = 0.2** → bar section affected
