# Casa Grande Ruin

Cosmos Mindeleff

# CASA GRANDE RUIN

# COSMOS MINDELEFF

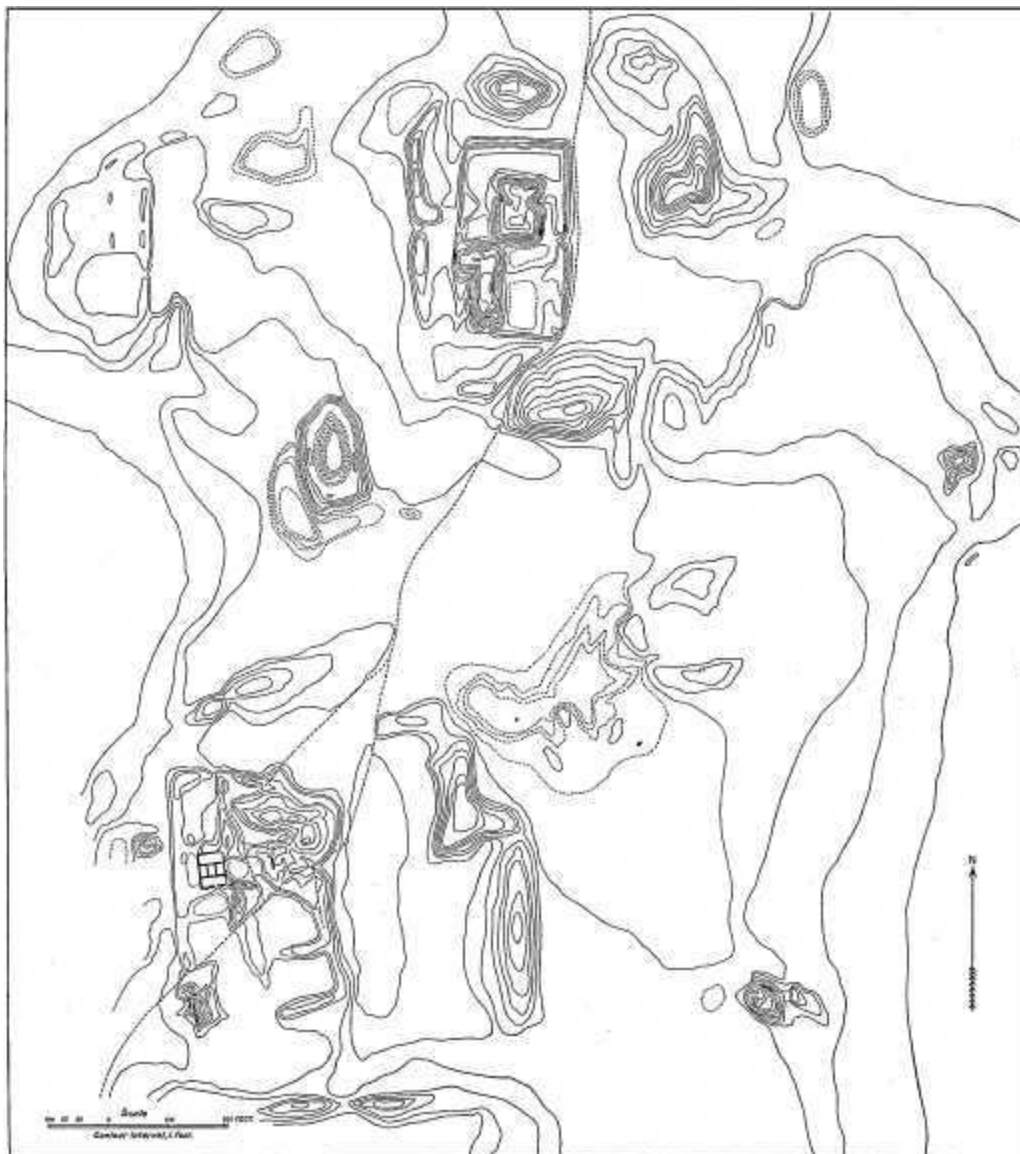
PLATE LI

MAP OF CASA GRANDE GROUP

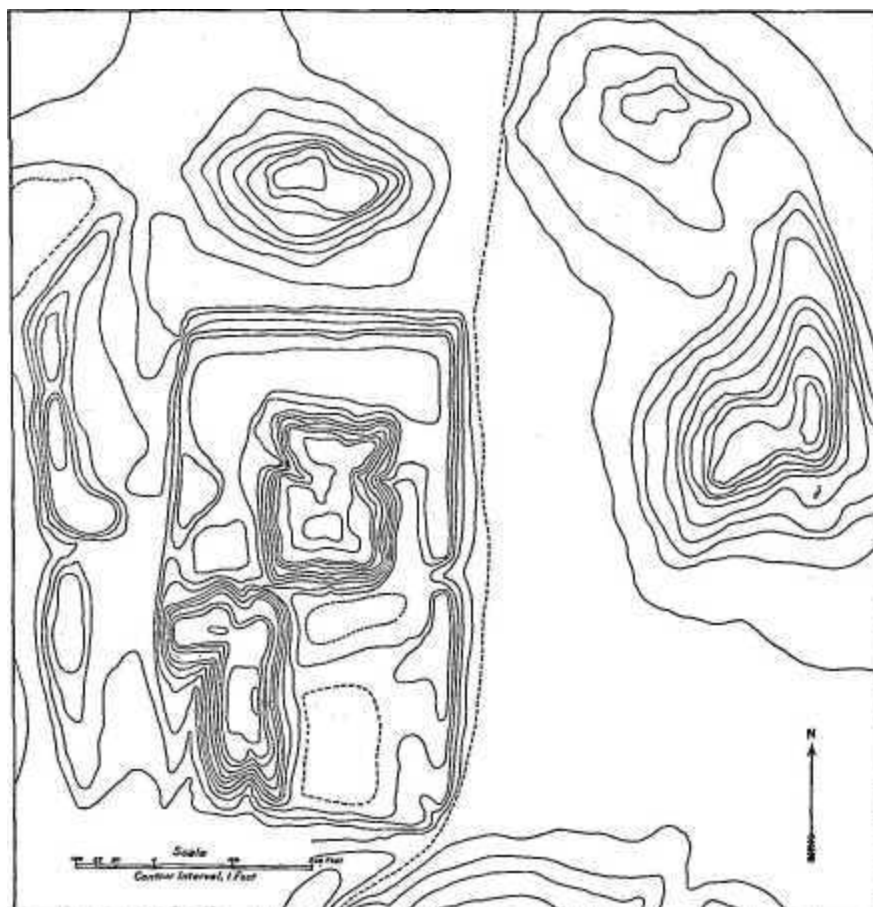
Fig. 328.—Map of large mound.

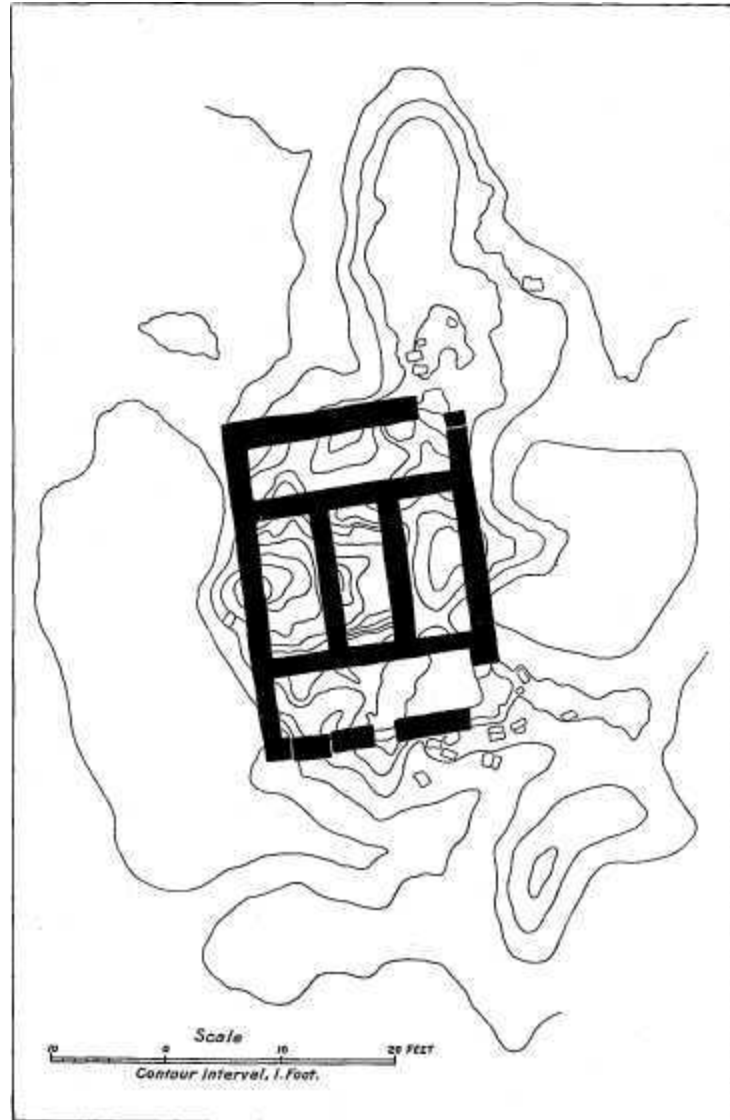
PLATE LII

GROUND PLAN OF CASA GRANDE RUIN

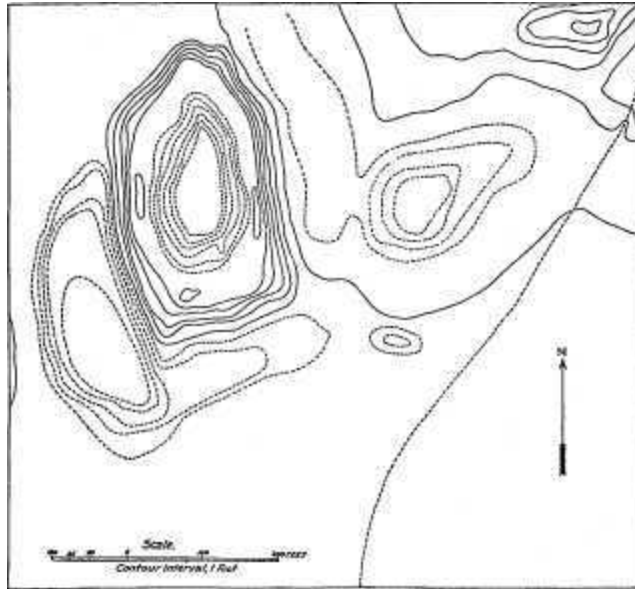
Fig. 329.—Map of hollow mound.

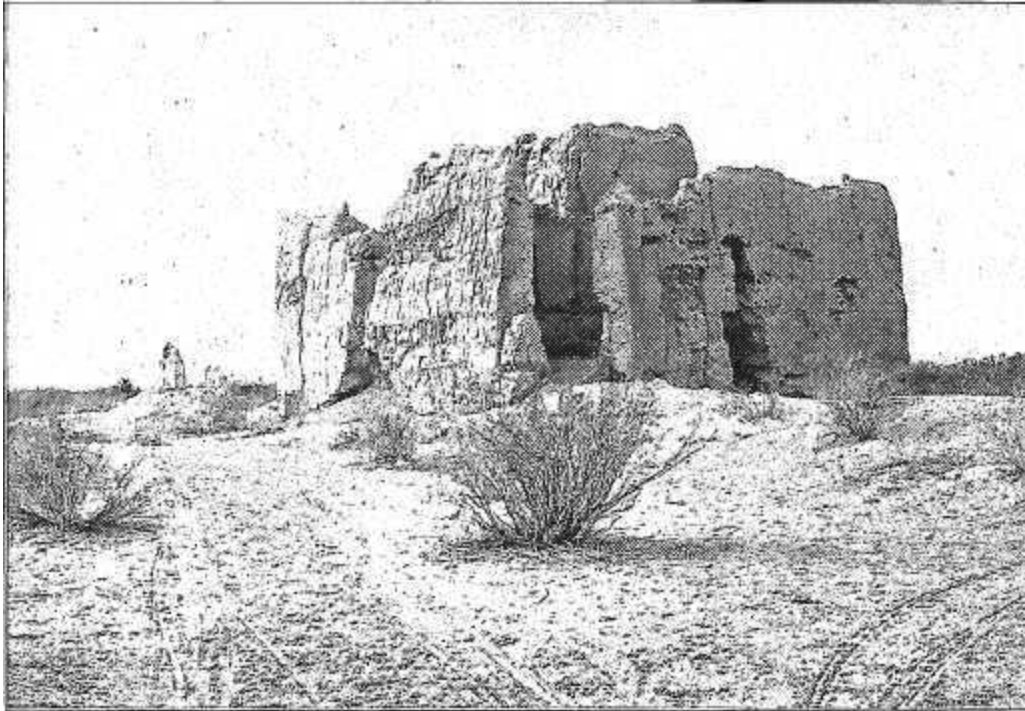
PLATE LIII

GENERAL VIEW OF CASA GRANDE.

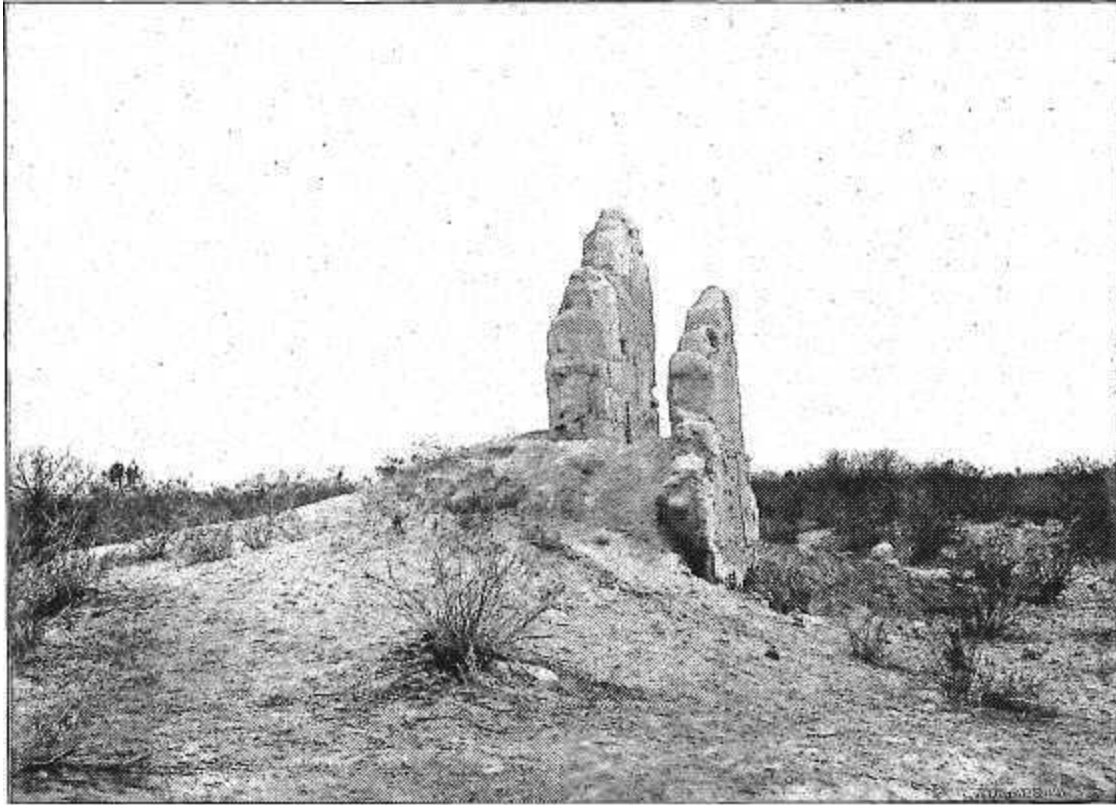
PLATE LIV

STANDING WALL NEAR CASA GRANDE

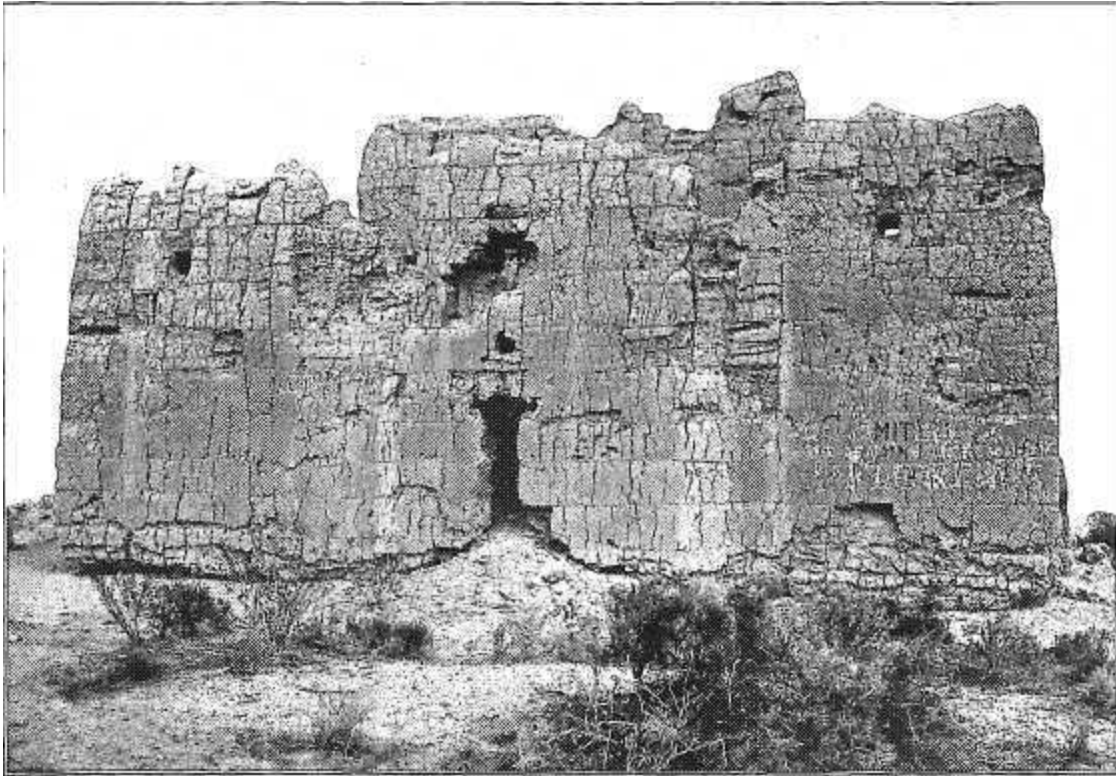
PLATE LV

WEST FRONT OF CASA GRANDE RUIN

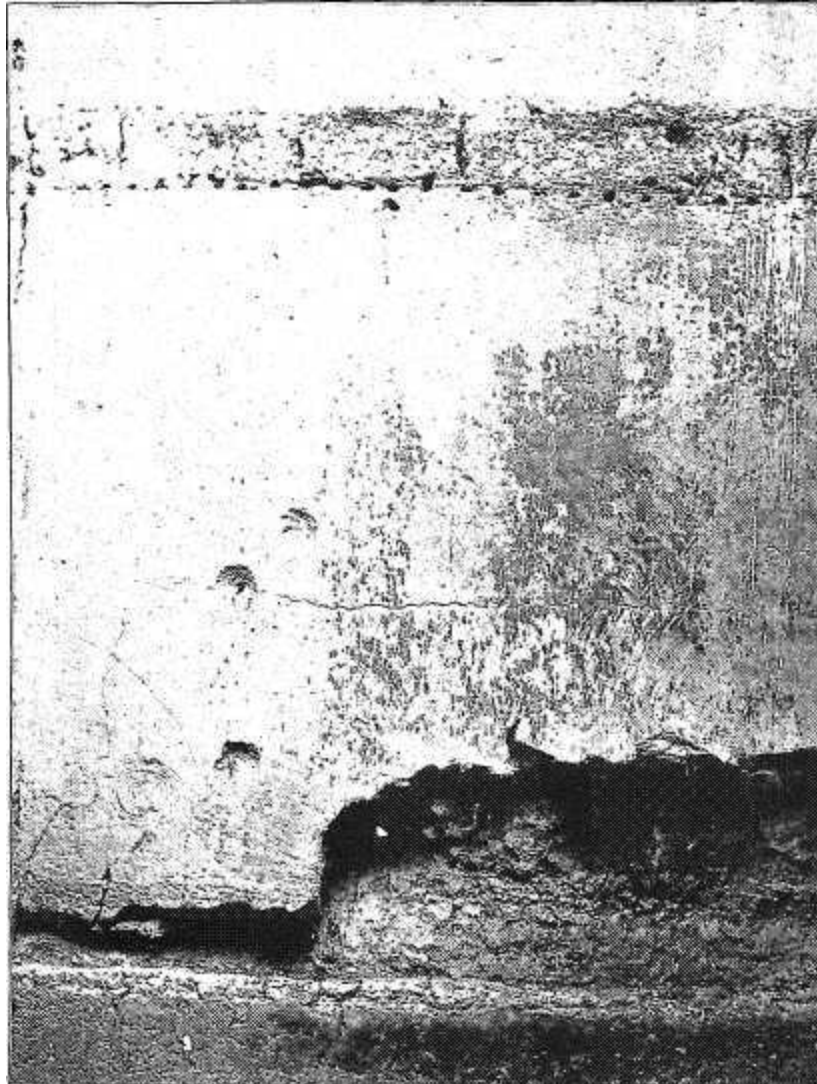
INTERIOR WALL OF CASA GRANDE RUIN

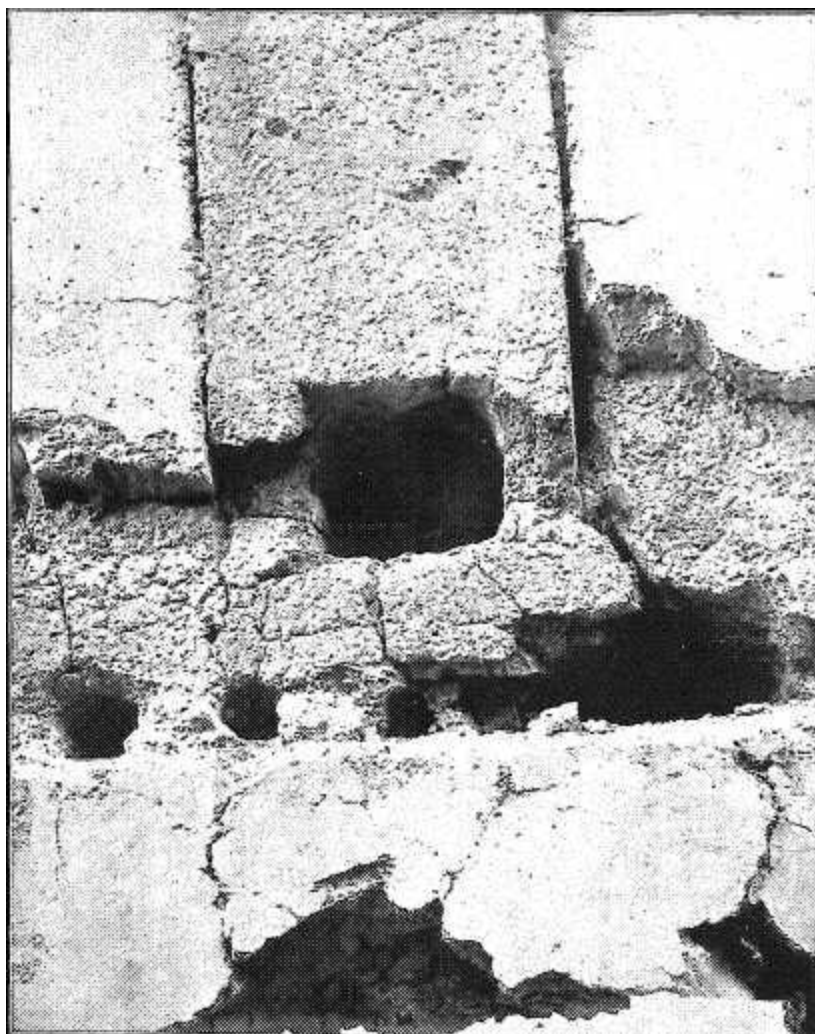
PLATE LVII

BLOCKED OPENING IN WEST WALL

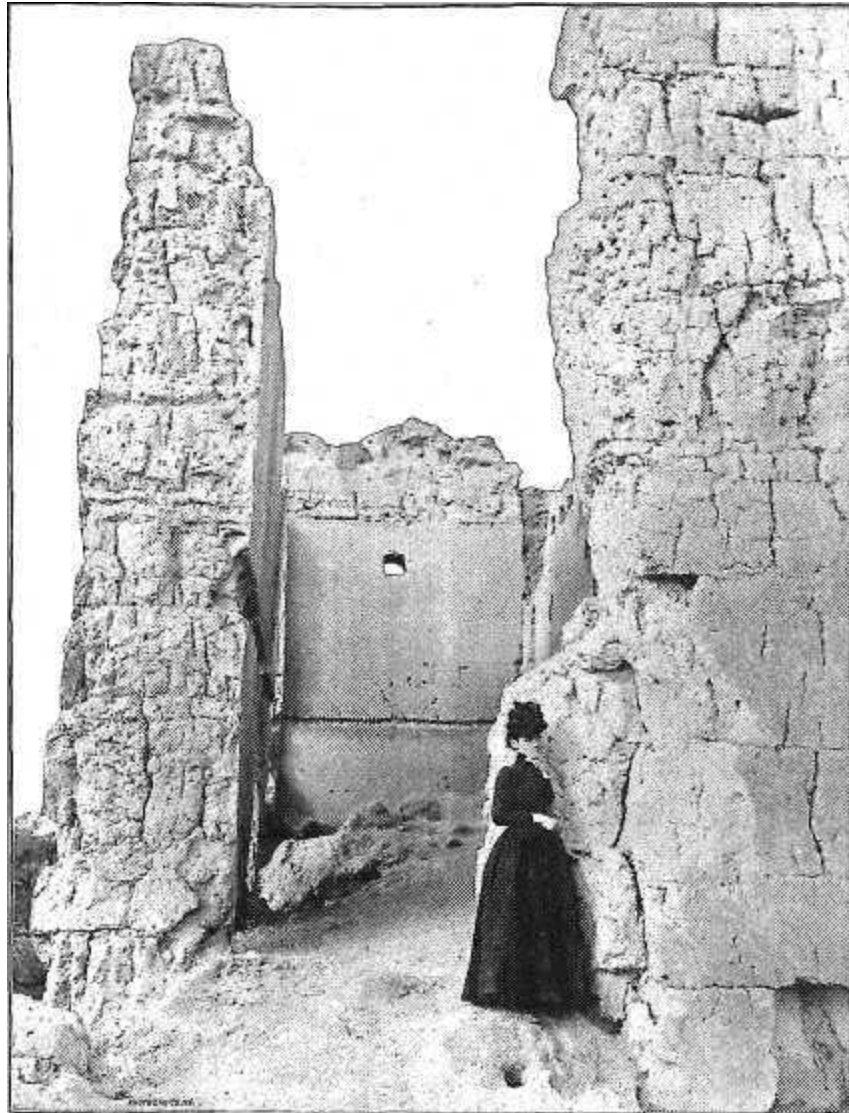
PLATE LVIII

SQUARE OPENING IN SOUTH ROOM

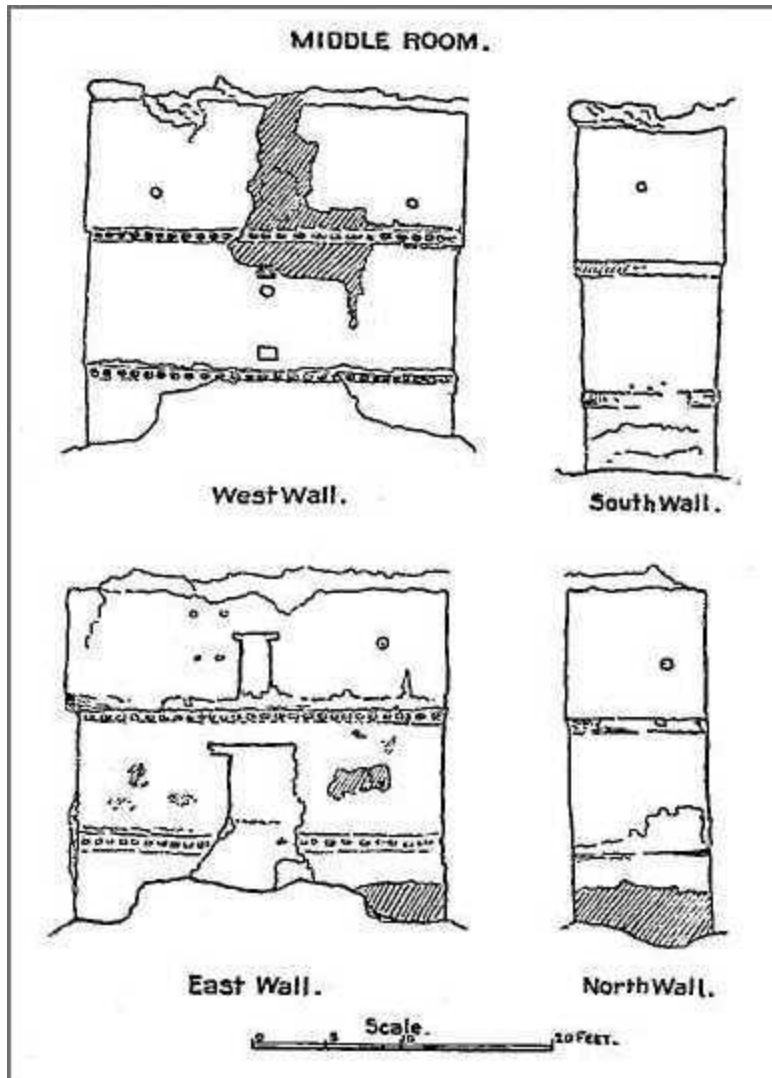
Fig. 330.—Elevations of walls, middle room.

The lower doorway, shown in figure 330, is much broken out, and although now but 2 feet 1½ inches wide at its narrowest part, no trace of the original surface remains on the northern side. The opening was 4 feet 6½ inches high and probably less than 2 feet wide, with vertical sides.

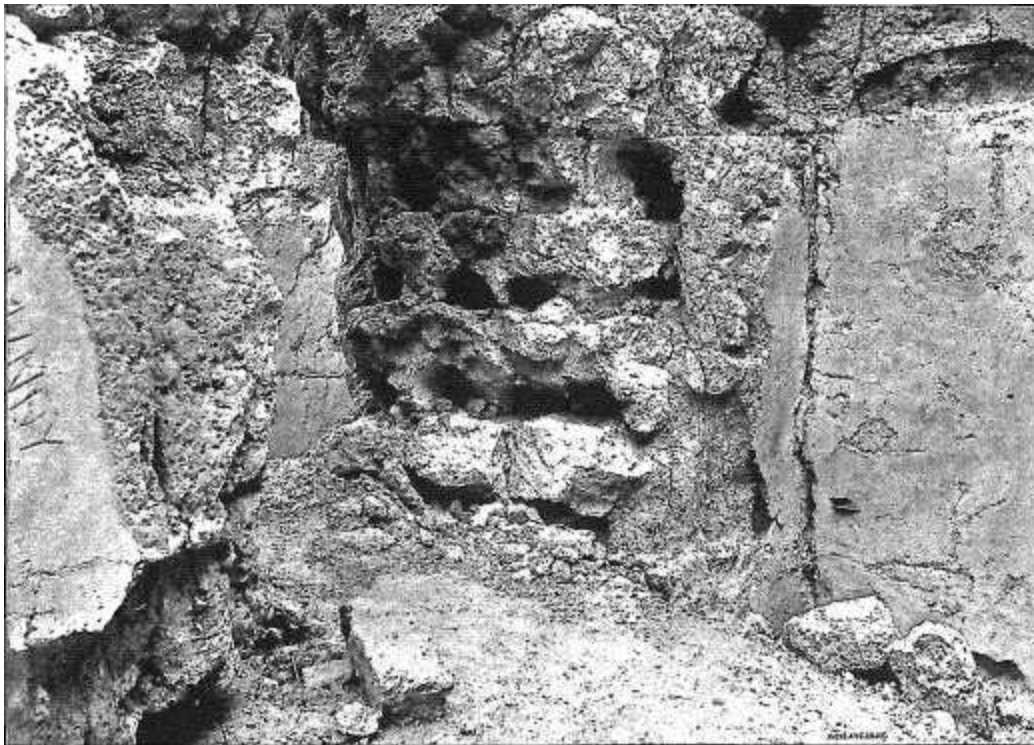
PLATE LIX

REMAINS OF LINTELS

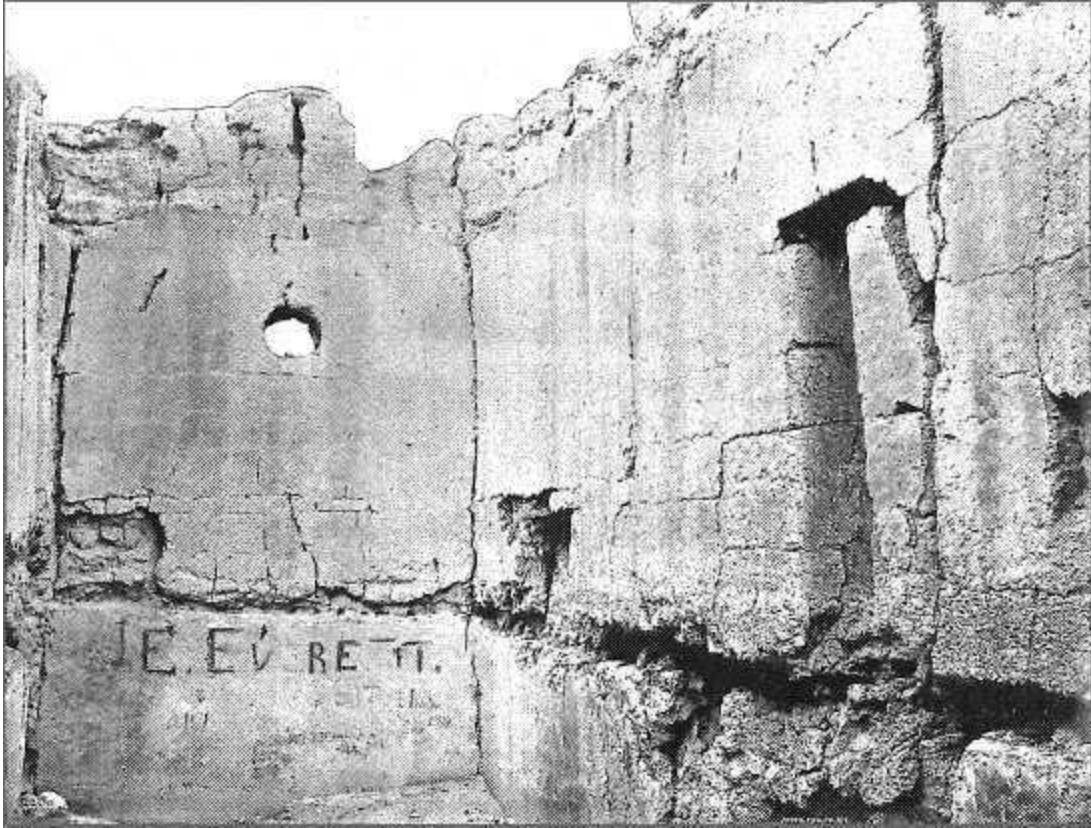
PLATE LX

CIRCULAR OPENING IN NORTH ROOM
