# The Repair of Casa Grande Ruin, Arizona, in 1891

Cosmos Mindeleff

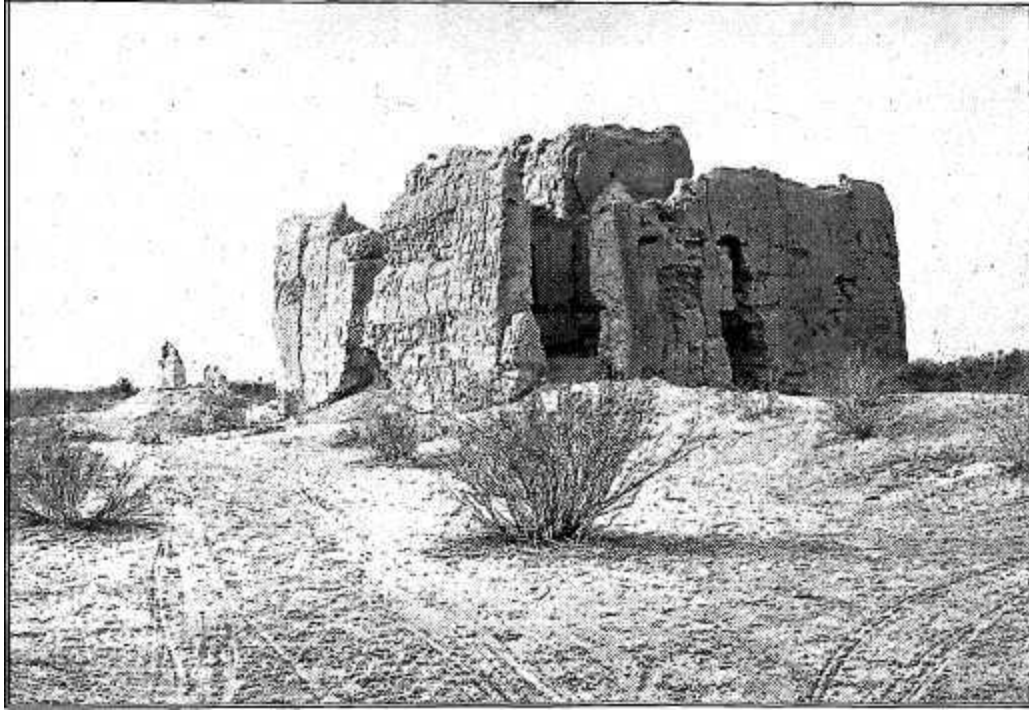
PLATE CXIV

GENERAL VIEW OF CASA GRANDE RUIN

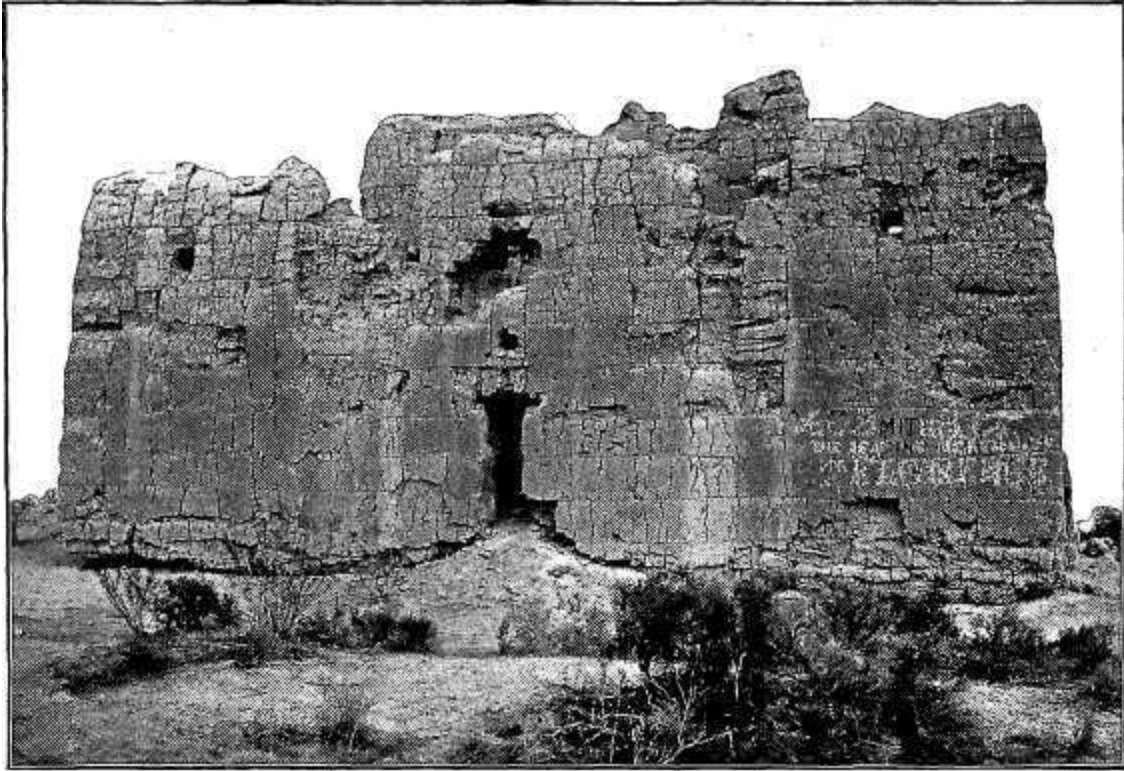
Plate [CXVI](#) shows the character of these blocks. The material employed was admirably suited for the purpose, being when dry almost as hard as sandstone and nearly as durable. A building with walls of this material would last indefinitely, provided a few slight repairs were made at the conclusion of each rainy season. When abandoned, however, sapping at the ground level would commence and would in time bring down all the walls; yet in the two centuries which have elapsed since Padre Kino's visit to this place—and Casa Grande was then a ruin—there has been but little destruction from the elements, the damage done by relic hunters during the last twenty years being, in fact, much greater than that due to all causes in the preceding two centuries.

WEST FRONT OF CASA GRANDE RUIN, SHOWING BLOCKS OF MASONRY

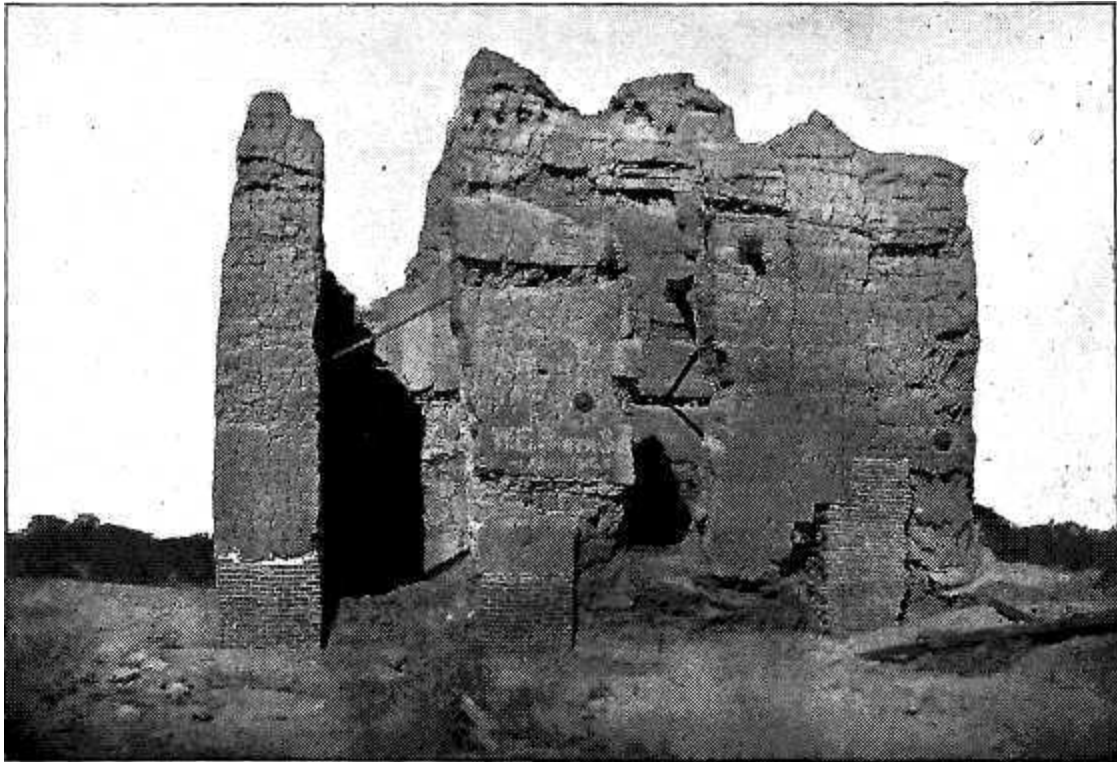
PLATE CXX

SOUTH FRONT OF THE RUIN, SHOWING UNDERPINNING AND ENDS OF TIE-RODS

west extremity. These breaches maybe observed as shown in two of the six accompanying photographs [plates [CXX](#), [CXXI](#)]. These photographs were taken ten days before the work was completed. There being no professional photographer in that vicinity I was compelled to take advantage of the kind offer of Mr H. H. Burrell, an amateur photographer, who happened to be there at that time. Thus the views I secured failed to show all the brickwork done. The coating of mortar was not applied until after the date on which the views were taken, in consequence of which the bare bricks are shown in the views.

I also find the amount of underpinning done by the contractors to be 919 cubic feet, and the amount of filling in openings to be 1,161 cubic feet. The underpinning is done with hard-burned brick laid in good cement mortar extending to a depth of 12 inches below the original ground level. The face of the brickwork is set back from 1 to 2 inches from the face of the wall and plastered with a coat of good cement mortar, making it flush with the outer wall.

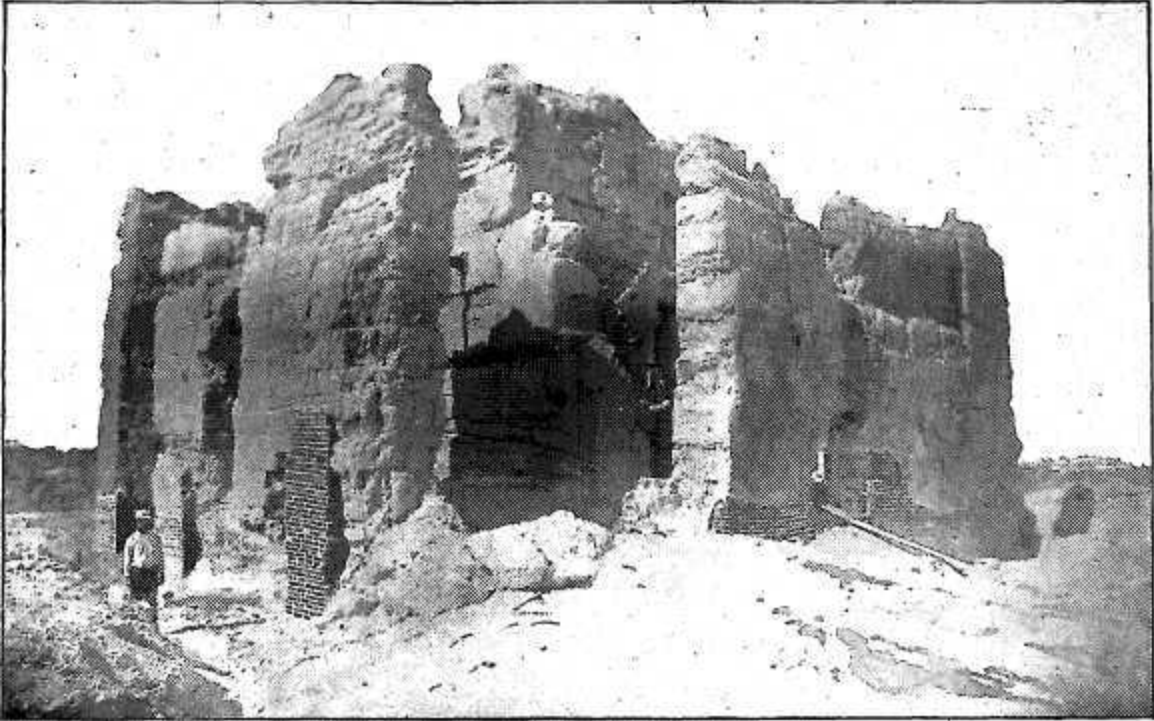
VIEW FROM THE SOUTHEAST BEFORE THE COMPLETION OF THE WORK
