# LOSS OF THE STEAMSHIP "TITANIC"

REPORT  
OF A FORMAL INVESTIGATION INTO THE  
CIRCUMSTANCES ATTENDING THE  
FOUND-  
ERING ON APRIL 15, 1912, OF THE BRITISH  
STEAMSHIP "TITANIC," OF LIVERPOOL,  
AFTER STRIKING ICE IN OR NEAR LATI-  
TUDE 41° 46' N., LONGITUDE 50° 14' W.,  
NORTH ATLANTIC OCEAN, AS  
CONDUCTED  
BY THE BRITISH GOVERNMENT

REPORT OF A FORMAL INVESTIGATION INTO THE CIRCUMSTANCES ATTENDING THE FOUNDERING ON APRIL 15, 1912, OF THE BRITISH STEAMSHIP TITANIC, OF LIVERPOOL, AFTER STRIKING ICE IN OR NEAR LATITUDE 41° 46' N., LONGITUDE 50° 14' W., NORTH ATLANTIC OCEAN, WHEREBY LOSS OF LIFE ENSUED.

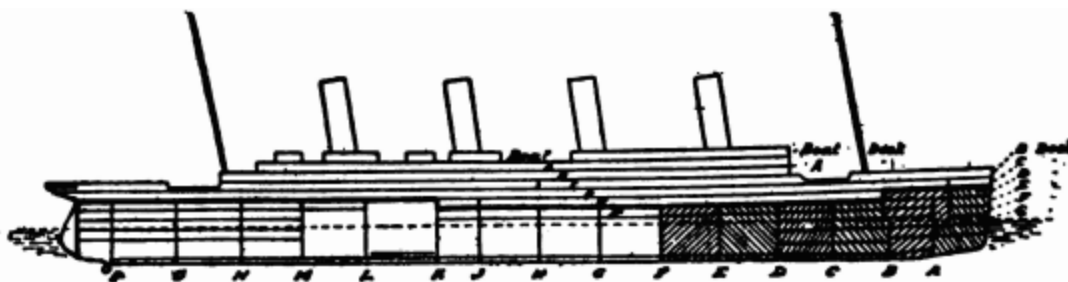
### S.S. "TITANIC."

The collision with the iceberg, which took place at 11.40 p. m., caused damage to the bottom of the starboard side of the vessel at about 10 feet above the level of the keel, but there was no damage above this height. There was damage in—

The damage extended over a length of about 300 feet.

It will thus be seen that all the six compartments forward of No. 4 boiler room were open to the sea by damage which existed at about 10 feet above the keel. At 10 minutes after the collision the water seems to have risen to about 14 feet above the keel in all these compartments except No. 5 boiler room. After the first ten minutes the water rose steadily in all these six compartments. The forepeak above the peak tank was not filled until an hour after the collision, when the vessel's bow was submerged to above C deck. The water then flowed in from the top through the deck scuttle forward of the collision bulkhead. It was by this scuttle that access was obtained to all the decks below C down to the peak tank top on the orlop deck.

NOTE.—The vertical letters signify the different decks. The horizontal letters signify the water-tight bulkheads. The heavy line shows the top of the water-tight bulkheads. The crosshatched compartments are those opened to the sea at the time of the collision with the iceberg.
