# WELD DEFECT INSPECTION REPORT

| Report ID | RPT-2026-00002 |
| Sample ID | 1213 |
| Joint Configuration | Double V Butt Joint |

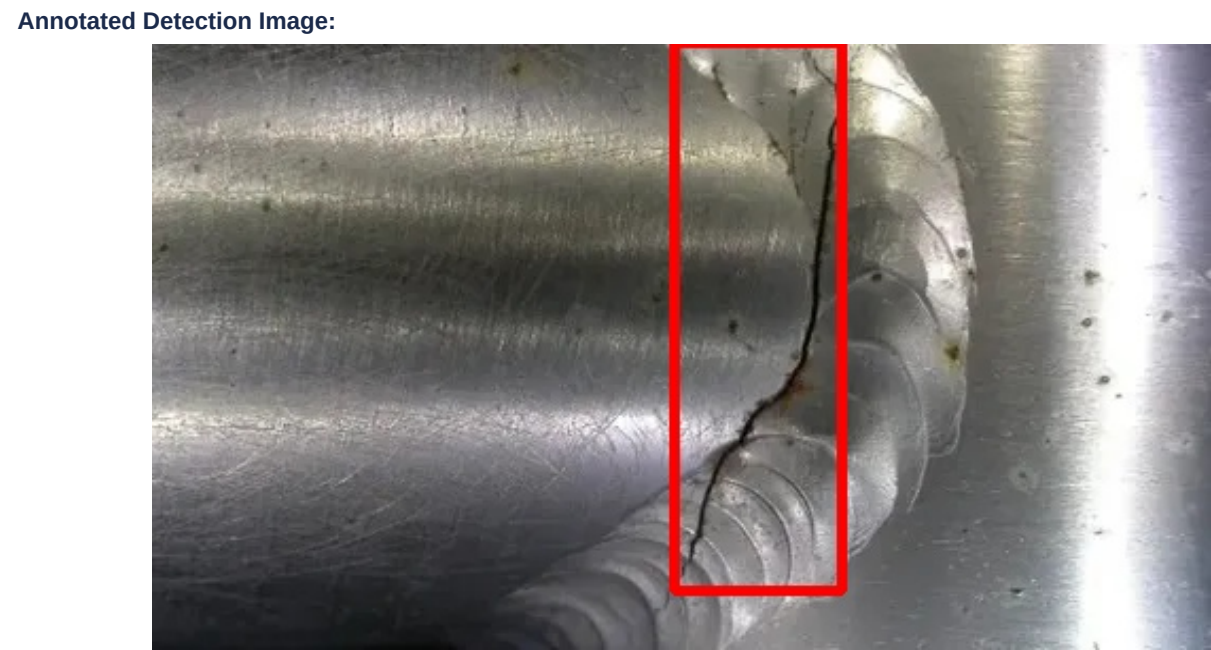
| 2.1 Crack | CRITICAL | RPN: 400 |

**Description:**  
Linear discontinuity caused by rapid cooling, thermal shrinkage, or base material incompatibility. Can propagate under cyclic loading and cause catastrophic failure.

**Primary Causes:**  
Rapid cooling, high residual stress, hydrogen embrittlement, incompatible filler material, improper preheat.

**Applicable Standards:**  
Rejected per ISO 5817 Level B; AWS D1.1 rejects all cracks; ASME BPVC Section VIII - no cracks permitted.

**Recommended Action:**  
Immediate repair required. Grind out defective area and re-weld. Perform supplementary NDT (UT/RT) to verify full removal before re-welding.
