# Root Cause Analysis Report — Ford Recall 22V454

## ROOT CAUSE ANALYSIS OF AUTOMOTIVE STRUCTURAL COMPONENT FAILURE

Case Study: Ford Front Subframe Recall (NHTSA 22V454)

A Materials & Quality Engineering Study

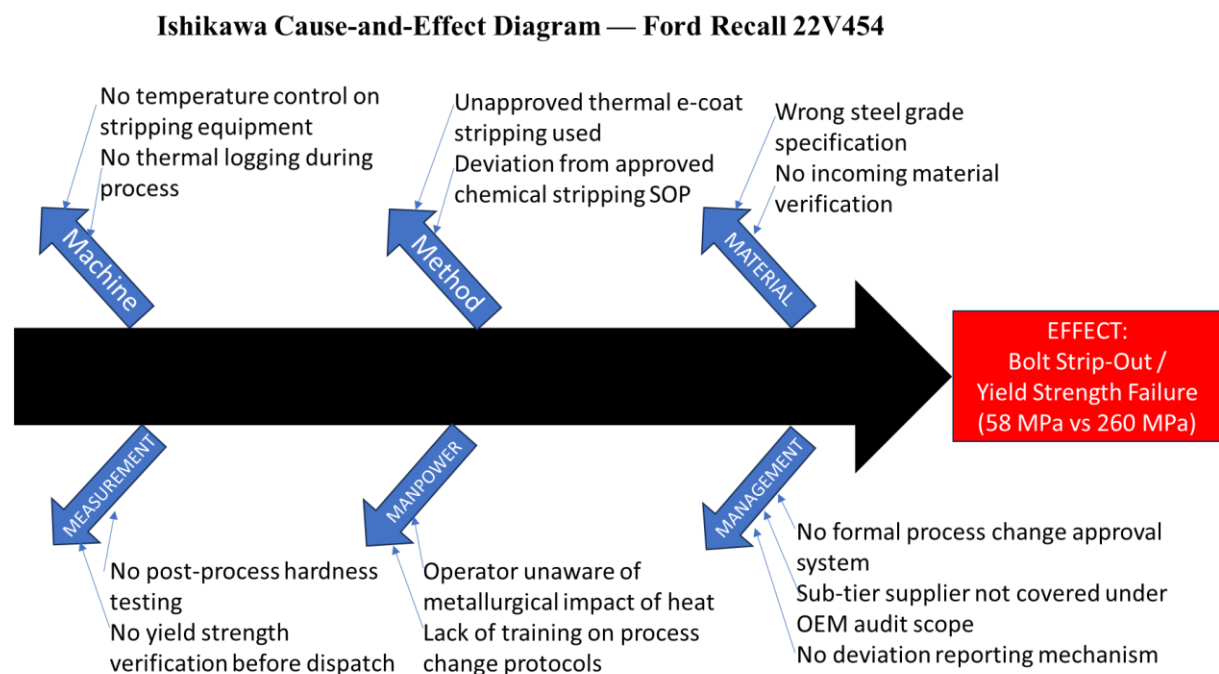
The following Ishikawa diagram maps all potential contributing factors to the subframe bolt strip-out failure across the six standard categories of the 6M framework.

*Figure 1: Ishikawa Cause-and-Effect Diagram for Ford Recall 22V454 Front Subframe Failure*
