| | | <b>CEINSYS TECH LTD.,</b><br><b>10/5, IT Park, Nagpur 440022</b><br><b>EHS LINE WALKTHROUGH</b> | | | <b>Doc no:-</b> IMS/EHS/FR/ELW<br><b>Version:-</b> 1.0<br><b>Issue Date:-</b> 16.09.2025 | |
| <b>Location :</b> - Ceinsys Tech Ltd ,Head office | | | | | | |
| <b>Members Present During visit :-</b> Anil Selkari( EHS Head -CS TECH Ai), Smita Ragenwar(Quality Head -CS TECH Ai)<br><b>Date :-</b> 02.04.2026 | | | | | | |

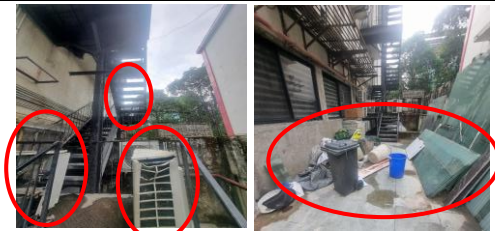
| | | <b>CEINSYS TECH LTD.,</b><br><b>10/5, IT Park, Nagpur 440022</b><br><b>EHS LINE WALKTHROUGH</b> | | | <b>Doc no:-</b> IMS/EHS/FR/ELW<br><b>Version:-</b> 1.0<br><b>Issue Date:-</b> 16.09.2025 | |
|---|---|---|---|---|---|---|
| 1 | Emergency exit route blocked due to storage of AC compressors on exit route. | HIGH | | Admin dept | Immediate Basis | Emergency exit routes to be kept clear all time. |
