## Tangail kiln signal

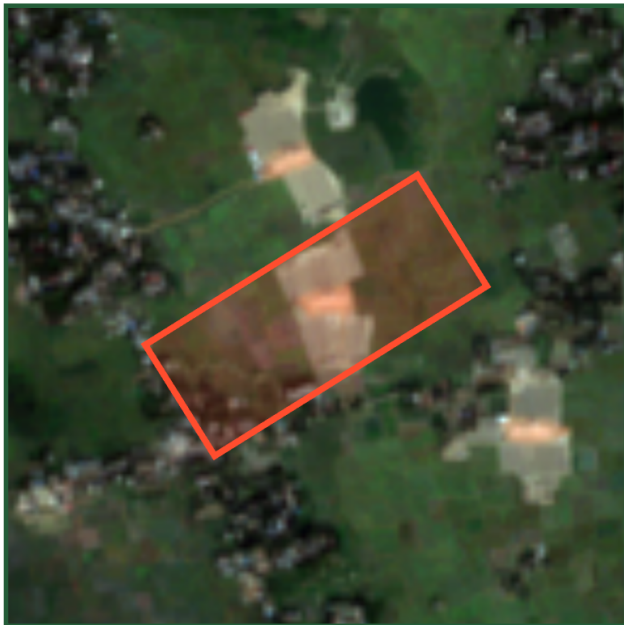
CFCBK

| FLAGGED | Potential residential buffer conflict | Section 8(3)(a) |
| FLAGGED | Kiln technology screen | DoE cleaner-technology guidance |

Prepared settlement proximity: 0.7 km

This brief contains replayed model outputs and screening rules. It does not determine that a kiln is illegal. Verify identity, location boundaries, household counts, licence and clearance records, field conditions, exceptions, and current law before action.
