EAST CENTRAL RAILWAY

L. No. 17/TRS/MEMU/JAJ/POH

Sub: Defect / deficiency found during joint inspection of MEMU rake no. 188186+188004+188177+11TC received after POH by KPA workshop on date 15.11.24.

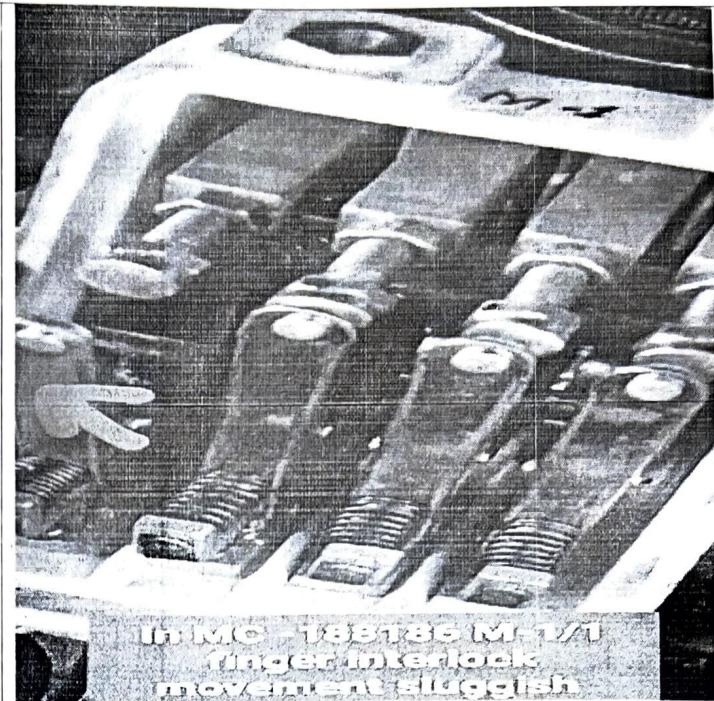
5. In MC no. 188186, 1st finger tips of M-1 is not operated freely.

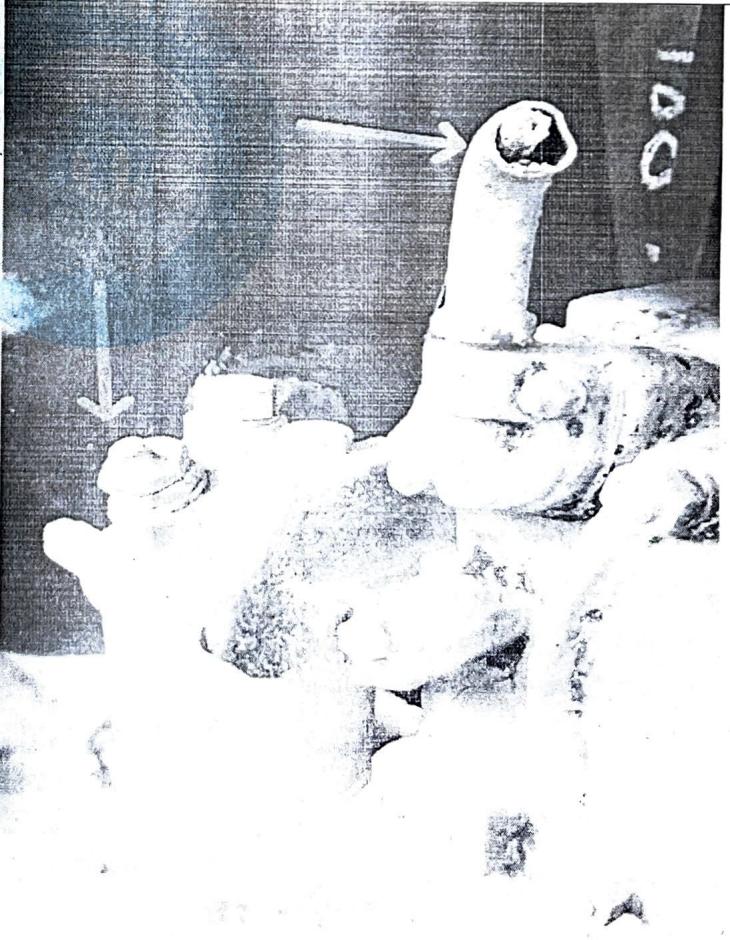
10. In MC 188177, in MCP breather found chocked with wooden piece and its oil regulating valve cap found deficient.

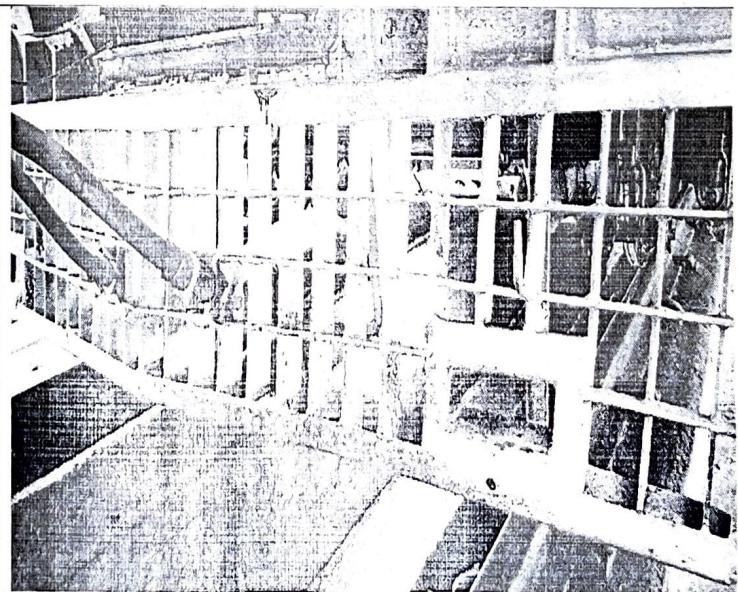
16. Cattle guard painting not done in MC 188004.
