EAST CENTRAL RAILWAY

Sub:- Inter Railway Audit of EMU, MEMU crashed.

SAFETY AUDIT REPORT OF EAST CENTRAL RAILWAY

Inter railway audit report of MEMU CS JHAJHA

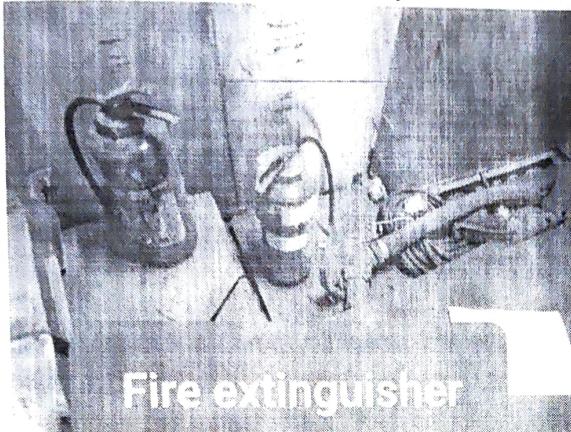
iii)- Fire extinguishers were placed in driving cabs. No any instruction for operation of fire extinguishers was pasted near fire extinguishers. However, as per para 8.4.3 of Code of practice for prevention of fires on EMUs & MEMUs no. RDSO/PE/CP/EMU/0001-2003(Rev. 0) with Amendment no. 1, all the fire extinguishers shall carry an instruction plate wherein the clear instruction for operation shall be written in English & hindi and any other regional language. Checking and refilling date also not clearly mentioned on the fire extinguishers. Fire extinguishers were not properly clamped and was found in dirty condition. In one of the cab only one fire extinguisher was provided.

No any instruction for operation of fire extinguishers was pasted

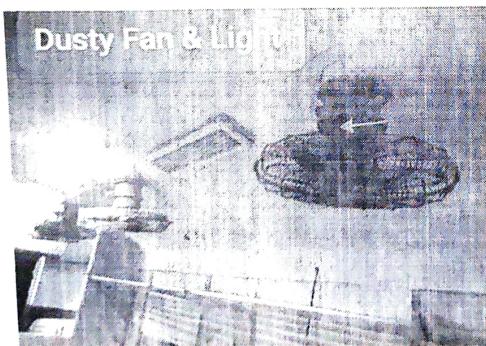
Light fittings & fans in maximum coaches were found very dusty. Some lights & fan were found out of order

Light fittings & fans in coaches were found very dusty
