Solar PV & Battery Storage Survey

Complete
Score	0 / 0 (0%)	Flagged items	1	Actions	0
Job Number					
Customer Surname					Patel Sr
Conducted on					19 Oct 2023 13:53 BST
Prepared by					Matt mcmunn
Property Address				30 Wea	atherall drive, HA72HN

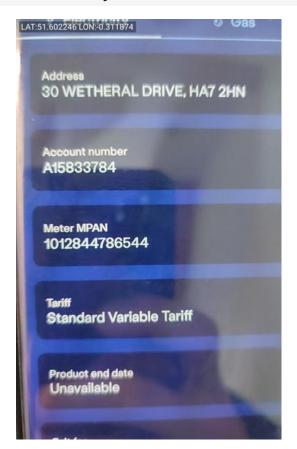
Photo 1

Electricity Bill Photograph

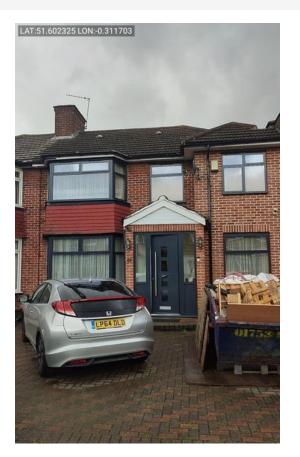
Photo 2

Street View Photograph

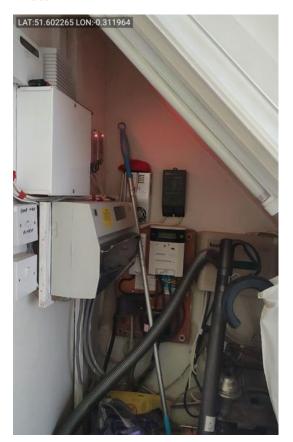
Photo 21

AC supply cable to run outside down the garden

AC swa 10mm to run from under the stairs and down outside the garden fence. Will need an AC supply to the inverter, cat5 for the CT clamp.

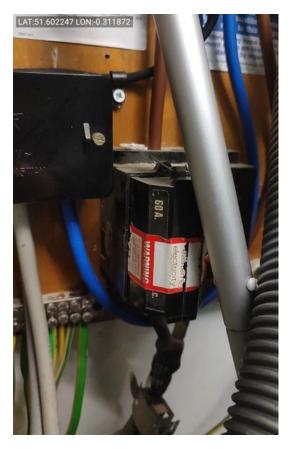
Photo 24

A supply cable will be required to run from the main CU in the house to the cabin where there inverter is going at the back of the garden. There is an existing 2.5mm flex connected directly into the Henley block supplying the sub board!! (Not regulation) very unsafe. We need to run in a 10mm swa to supply the shed Sub board, replacing the existing cable. If the customer is having a manual change over switch. The 10mm swa will need to be a 5core.

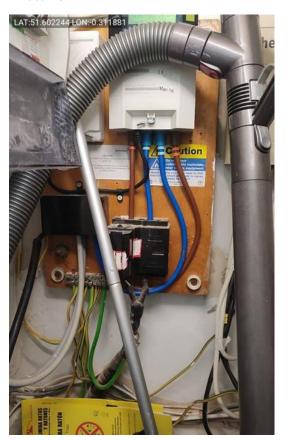
Photo 28

The existing sub board in the garage need to be replaced with a new 6way board.

There is space and a spare way in the main DB to connect in the garage supply, just need a 40amp wylex MCB
