# Static and Fatigue Full-Scale Tests on a Lightweight Ship Balcony Overhang with Al/Fe Structural Transition Joints

**Citation:** Palomba, G.; Corigliano, P.; Crupi, V.; Epasto, G.; Guglielmino, E. Static and Fatigue Full-Scale Tests on a Lightweight Ship Balcony Overhang with Al/Fe Structural Transition Joints. *J. Mar. Sci. Eng.* **2022**, *10*, 1382. <https://doi.org/10.3390/jmse10101382>

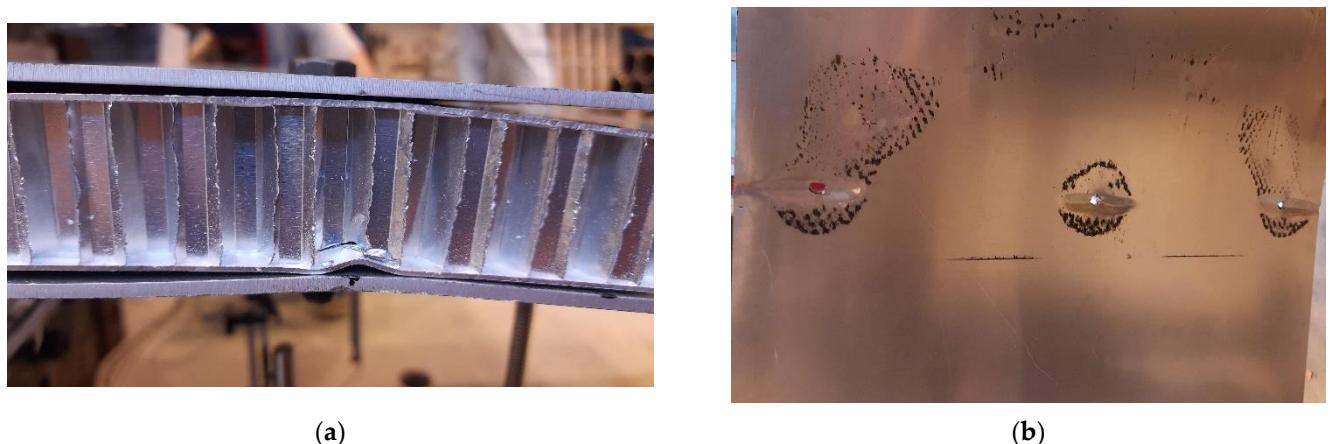
The failure modes observed after the second fatigue tests are similar to those already described for the first fatigue test. Some details are displayed in Figure 14.

As visible in Figure 14a, similarly to the first fatigue test, a local shear crack across one of the lateral cell walls was detected, nearby the bolted connection. At the same location, skin wrinkling was visible during the test. Local skin wrinkling occurred in the surrounding area of all bolted joints, on the compressed face of the panel, as shown in Figure 14b.

**Figure 14.** Failed honeycomb panel after the fatigue test at constant amplitude displacements:  
(a) shear crack across a later cell wall; (b) skin wrinkling around the bolted connections.
