### DEFECTS AND SCRATCH

→ Project Report Presentation ←

## EICHER TRACTOR MODEL 380

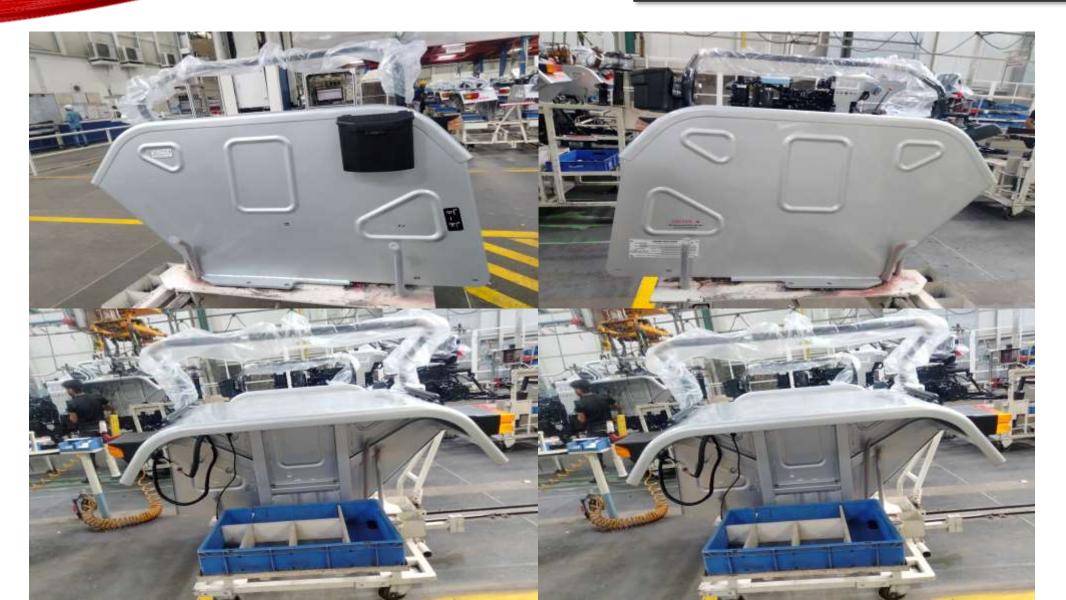
## **MUD GUARD IMAGES**

### Mud Guard Scratch

- Forcely Pulling By Worker To Save Time
- > Transportation and Fitting Time
- Loading And Unloading Time
- ➤ Worker Wearing Unusual Accessories

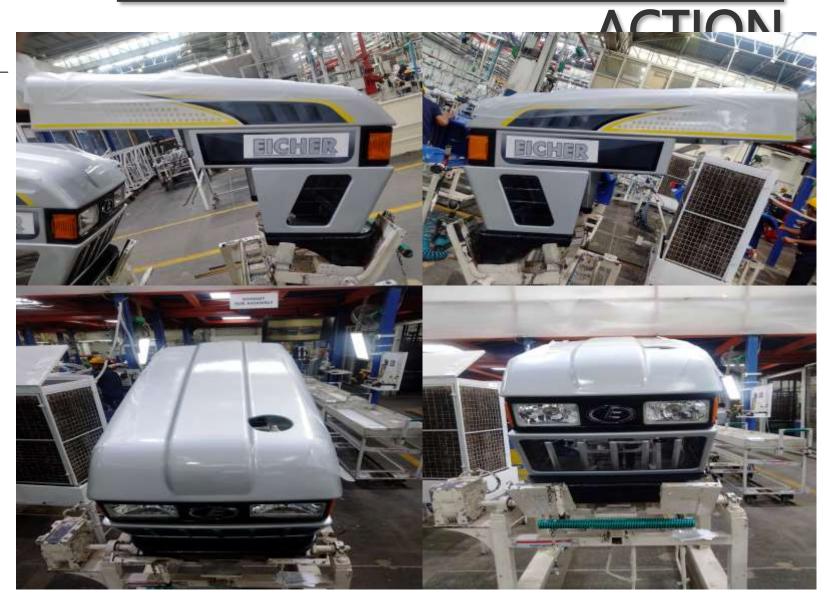
## **BONNET SECTION SCRATCH**

### » Bonnet Scratch

- Loading Unloading Time irresponsibility From Workers
- Ignoring Minor Scratches
- Fitting Time

### **Action Performed To Reduce**

#### : tmproved Handling Procedures :-

► Implementing Careful Handling Procedures During Assembly To Minimize The Risk Of Scratches During Transportation and Installation.

#### **Protective Coverings:-**

Utilizing Temporary Protective Coverings Or Coating On Fuel Tanks During Assembly And Transportation To Shield Them.

#### **Protective Kitting Trollies:-**

Provide Rubber Or Tapping On The Edges Of Kitting Trollies To Reduce The Scratch From Their Sharp Edges Or Knob.

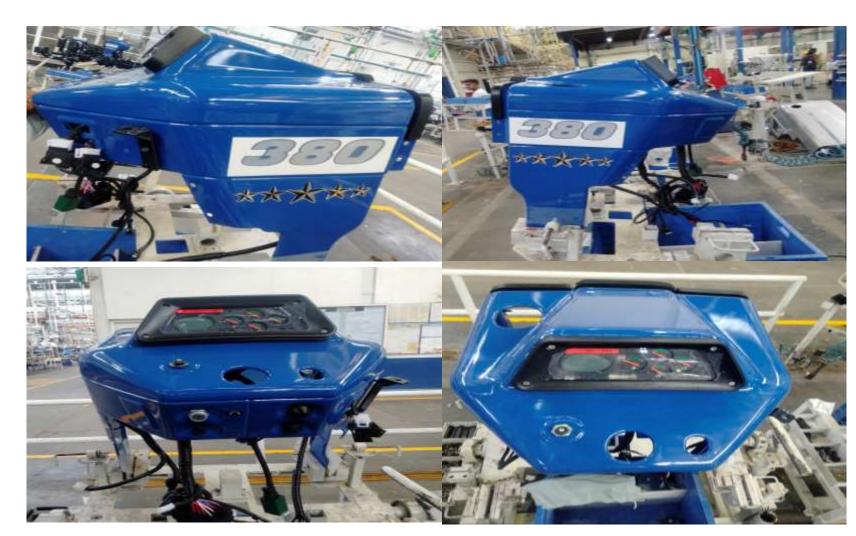
## **FUEL TANK SCRATCH ACTION**

### Fuel Tank Scratch

- Mishandling During Assembly
- > Improper Handling Equipment
- ➤ Rough Handling By Workers
- Kitting Trolleys Sharp Locking Knob

#### **Action Performed To Reduce**

#### **Improved Handling Procedures:**

► Implementing Careful Handling Procedures During Assembly To Minimize The Risk Of Scratches During Transportation and Installation.

#### **Protective Coverings:-**

Utilizing Temporary Protective Coverings Or Coating On Fuel Tanks During Assembly And Transportation To Shield Them.

#### <u>Pre-Assembly & Post-Assembly</u> <u>Inspection :-</u>

▶ Inspect The Fuel Tank Before And After The Installation To Ensure That The Are Scratch Free And Undamaged.
