Accident at Russia's Biggest Hydroelectric

Sayano-Shushenskaya – 2009 August 17

Objetive

Note

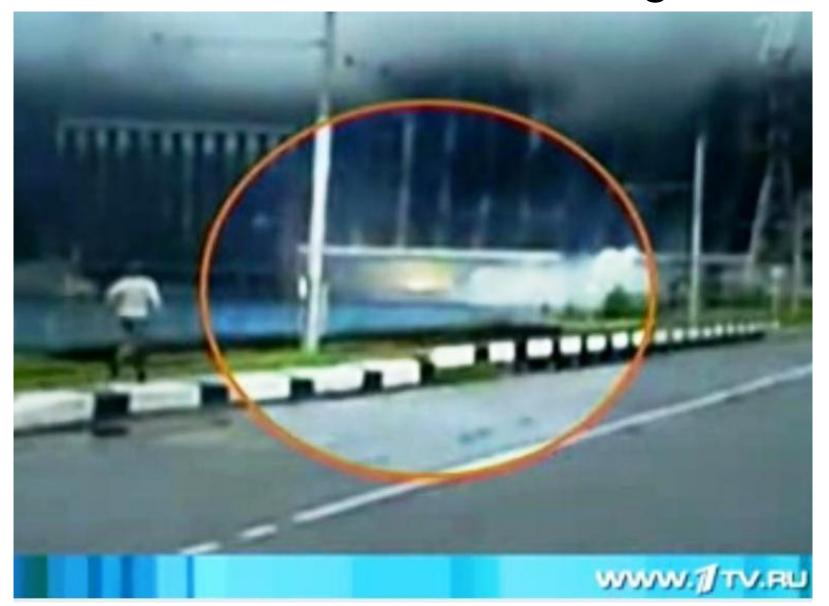
The Accident – 2009 Aug 17

- At 08:13 local time (00:13 GMT) on 17 August 2009, the station suffered a catastrophic "pressure surge" in turbine known as a water hammer. The sudden water pressure surge resulted in the ejection of turbine 2 with all equipment, a total weight some 900 tons, from its seat.

- Turbines 7 and 9 also suffered from severe damage, while the turbine room roof fell on and damaged turbines 3, 4 and 5. Turbine 6, which was in scheduled repair at the time of accident, received only minor damage as it was the only one of the station's 10 turbines that did not receive electrical damage due to shorting of transformers, and it will be restarted as soon as possible.

- Water immediately flooded the engine and turbine rooms and caused a transformer explosion.
- On 23 August 2009, authorities said 69 people were found dead while 6 people are still listed as missing. Efforts to pump flood water from the engine room and complete a search for the missing workmen are expected to take 3 to 8 days.
