# Aircraft Defect Detection Report

Generated on: 2025-07-20 22:25:25

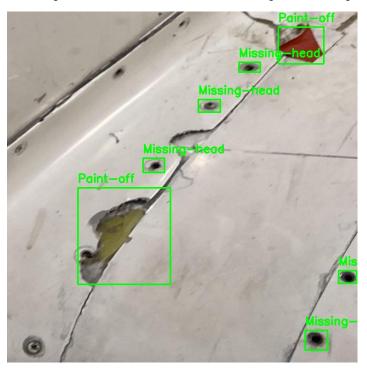
This image shows detected defects outlined with green bounding boxes.

- Detected: Missing-head (Box 1)
- Detected: Missing-head (Box 2)
- Detected: Paint-off (Box 3)
- Detected: Missing-head (Box 4)
- Detected: Paint-off (Box 5)
- Detected: Missing-head (Box 6)
- Detected: Missing-head (Box 7)

- Missing-head: 5
- Paint-off: 2

■ Critical maintenance required! Severe defects like cracks or missing-heads were detected.
