# **Technical Review of the Liulan Reservoir “7·6” Dam Failure Disaster in Hengzhou, Guangxi, China**

## **— Overtopping and Local Breach Development under Extreme Rainfall and Above-Standard Flooding: Processes and Broader Lessons**

Qizhong (George) Guo

Original version: July 8, 2026   Revised: July 25, 2026

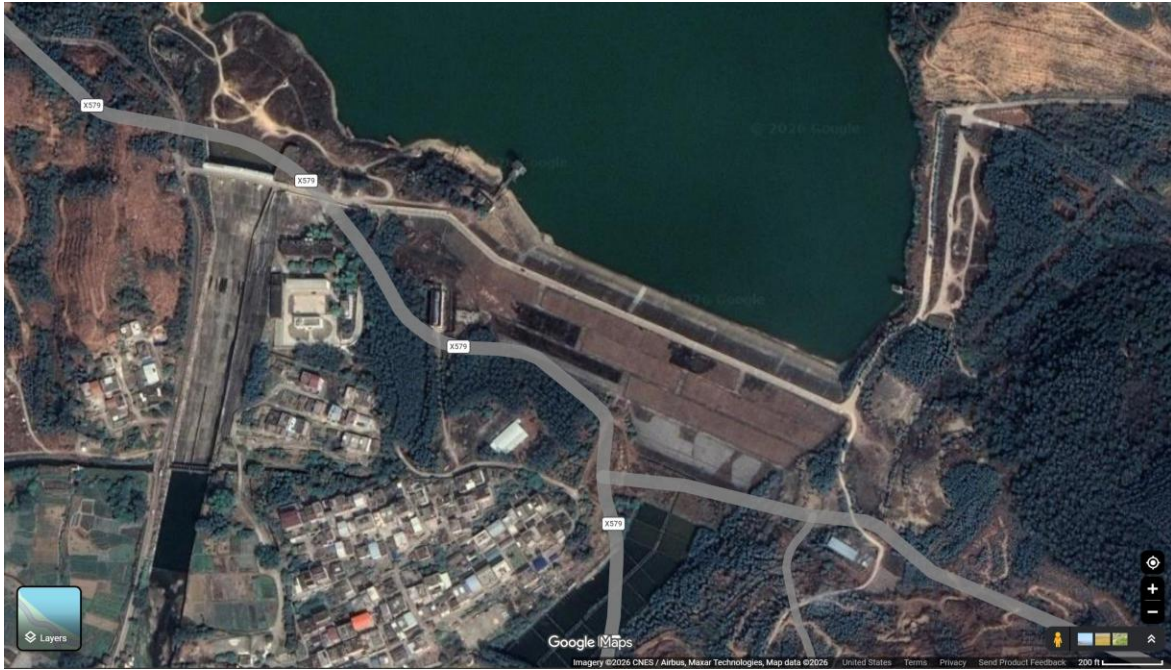
Media reports citing 2009 rehabilitation information and satellite imagery suggested that timber processing, a village access road, repeated vehicle loading, soil densification, or local filling may have altered the control elevation and erodibility of the fuse plug. No blasting charges had been pre-positioned; manual blasting required approval; communications failed; and excavators could not reach the site because roads were damaged. These facts can help explain why manual activation was not achieved in time, but they do not prove that failure of the fuse plug was the sole cause of the main-dam breach. Design drawings, material testing, field elevation surveys, and counterfactual reservoir-routing calculations are needed to estimate how much timely activation would have reduced the peak reservoir level, delayed overtopping, and potentially changed the final outcome.

**Figure 1. Pre-Event Layout of Liulan Reservoir and Satellite Image of the Channel Near the East Abutment. The open bypass-like channel outside the abutment is visible on the right. Public reporting has associated it with a fuse-plug emergency spillway, but its formal function, control elevation, and relationship to the initial breach remain to be confirmed from design records and the investigation. Image source: Google Maps (imagery credits shown in the figure).**

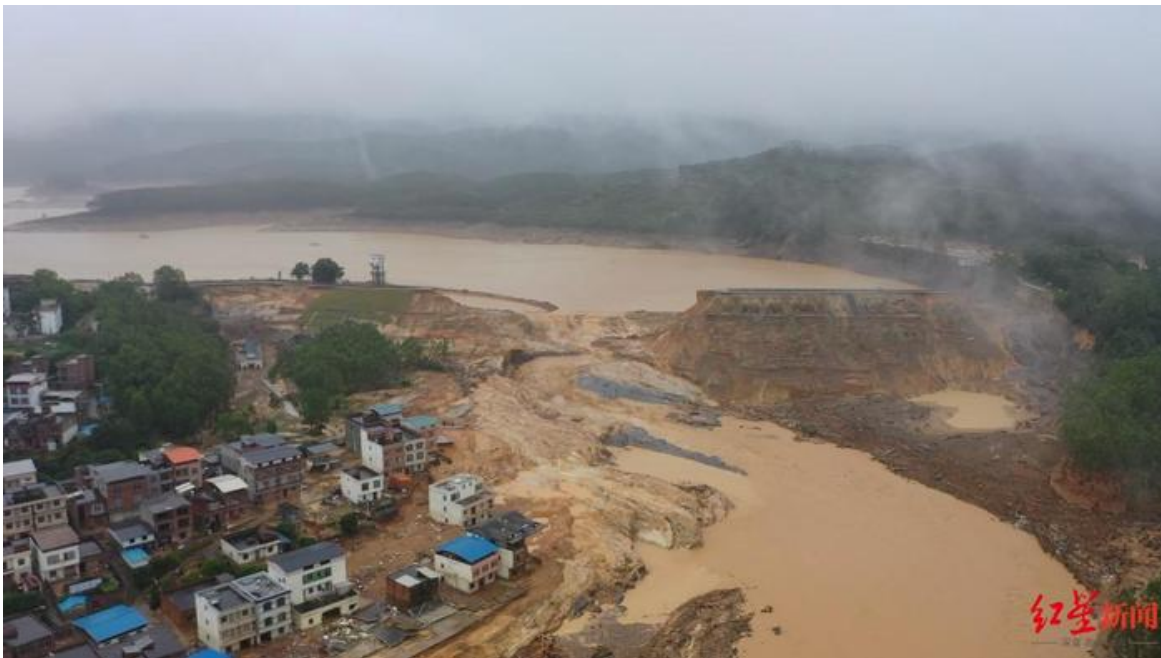
**Figure 2. Aerial View of the Dam Breach and Near-Dam Downstream Area after the Liulan Reservoir Failure. The image shows the large breach, sediment-laden outflow, and affected near-dam downstream area. It documents the overall post-event scene but cannot by itself establish the initial breach location, the precise sequence of overtopping and local breaching, peak discharge, or the specific failure mechanism. Image source: Red Star News, “The Critical 12 Hours before and after the Liulan Reservoir Breach: Those Trapped and Their Rescuers,” July 11, 2026.**
