# **Technical Review of the Liulan Reservoir “7·6” Dam Failure Disaster in Hengzhou, Guangxi, China**

## **— Overtopping and Local Breach Development under Extreme Rainfall and Above-Standard Flooding: Processes and Broader Lessons**

Qizhong (George) Guo

Original version: July 8, 2026    Revised: July 25, 2026

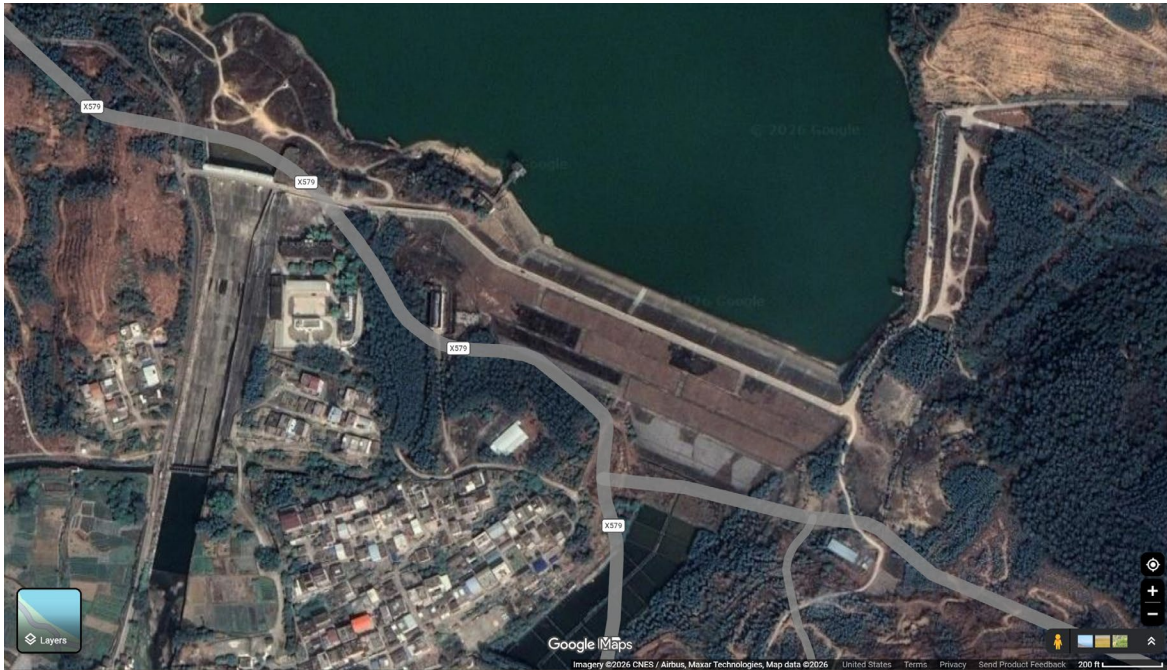
**Figure 1. Pre-Event Layout of Liulan Reservoir and Satellite Image of the Channel Near the East Abutment. The open bypass-like channel outside the abutment is visible on the right. Public reporting has associated it with a fuse-plug emergency spillway, but its formal function, control elevation, and relationship to the initial breach remain to be confirmed from design records and the investigation. Image source: Google Maps (imagery credits shown in the figure).**

As shown by the planform in Figure 1, the reservoir shoreline and dam axis form a degree of planform convergence near the east abutment, where a hillside channel and suspected emergency spillway are also present. This geometry alone does not prove the existence of high-velocity “funnel-like” flow immediately upstream of the dam, because reservoir flow near the dam is normally dominated by storage and relatively low velocities. However, if the east abutment contained a locally low crest or road elevation, a microtopographic depression, an abutment interface, or a downstream flow-guiding channel, overtopping flow could have concentrated there first. Once an initial gully or local collapse formed, a positive feedback could have developed: lower elevation → greater flow concentration → accelerated erosion → breach enlargement. This remains a testable hypothesis and should be evaluated using detailed topographic surveys, continuous imagery, and coupled two- and three-dimensional hydraulic and erosion analysis.

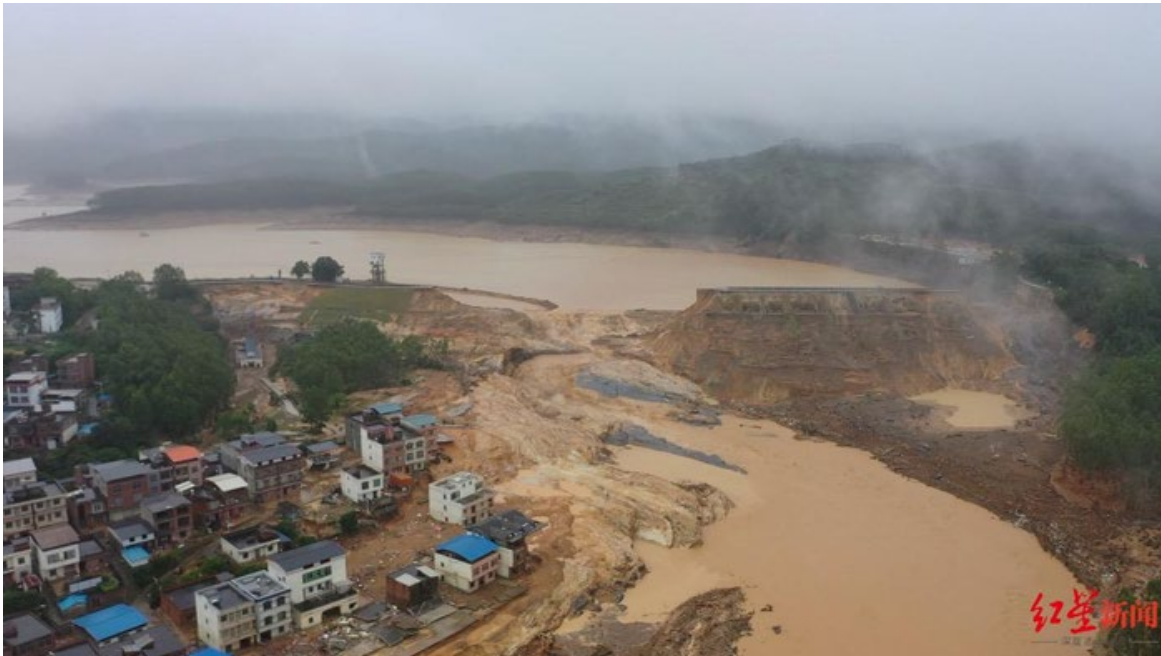
**Figure 2. Aerial View of the Dam Breach and Near-Dam Downstream Area after the Liulan Reservoir Failure. The image shows the large breach, sediment-laden outflow, and affected near-dam downstream area. It documents the overall post-event scene but cannot by itself establish the initial breach location, the precise sequence of overtopping and local breaching, peak discharge, or the specific failure mechanism. Image source: Red Star News, “The Critical 12 Hours before and after the Liulan Reservoir Breach: Those Trapped and Their Rescuers,” July 11, 2026.**
