DICKSON				
Summary Report: Temperature/Humidity Mapping Study for Ryan Coe Test Company				
Project # TM-123456 Rev # 2 Page 15 of 22				
Appendix 1: Sample Warehouse(D1) Results

#### 7.1 Appendix 1: Sample Warehouse(D1) Results

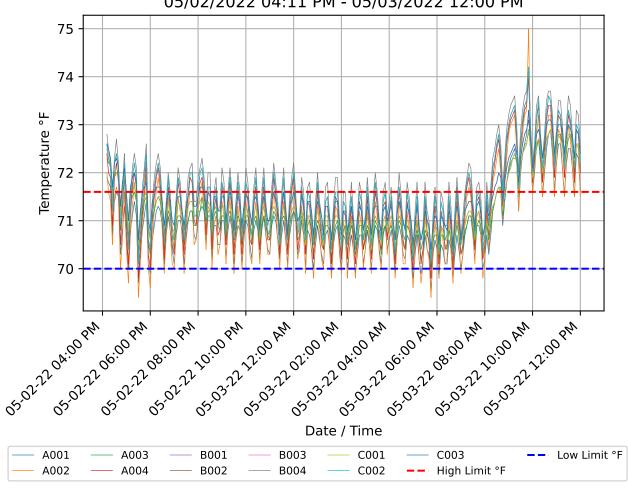
Sample Warehouse(D1)
Temperature °F Distribution
05/02/2022 04:11 PM - 05/03/2022 12:00 PM

rall Summary - :/2022 04:11 PN	Sample Warehouse(D1) I End: 05/03/2022 12:00	PM	
Metric	Location (s)	Temp °F	Metric	Location (s)	% RH
Max Avg. Temp	B004	71.7	May Ava Humidity	A003	39.5
Min Avg. Temp	A001	70.9	Max Avg. Humidity	A003	39.5
Max MKT	B004	71.8	Min Ava Humidity	D002 C002	38.1
Min MKT	A001	70.9	Min Avg. Humidity	B002, C002	30.1
Locations out of range			B004
