## High Plains Property Maintenance

# Irrigation Billing Detail

Monthly service documentation for Woodglenn Squares HOA

INVOICE #57482

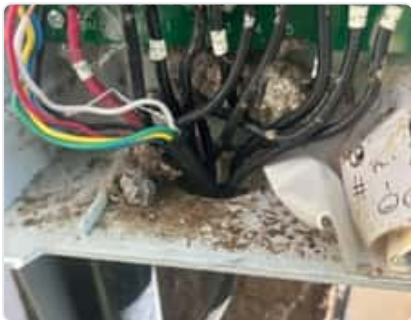
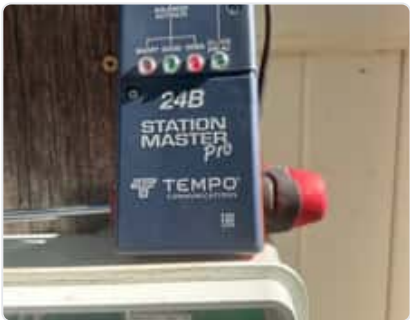
**Billing Sheet #BS-2026-0219 | Invoice #57482**

- A comprehensive wire test was conducted, revealing that zones 2, 3, 5, and 7 are all experiencing an open circuit issue.
- This diagnostic process ensures accurate identification of the problem areas within the irrigation system.
