# Failure mechanisms of wind turbine blades in India: Climatic, regional, and seasonal variability

## Abstract

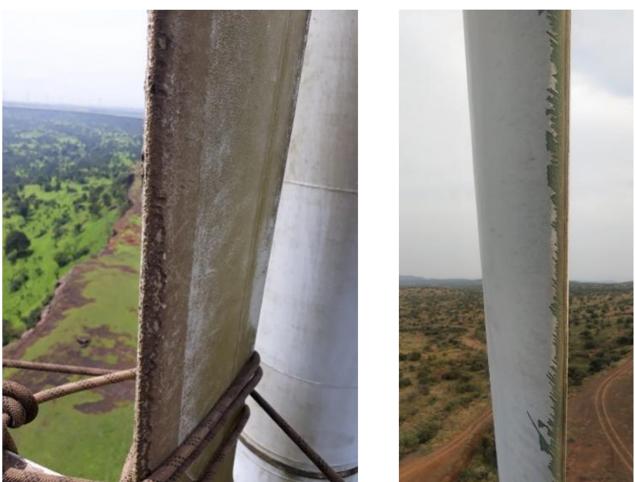
Figure 9 shows photos of heavily eroded wind turbine blades. The erosion of blades can reduce the energy production of wind turbines by 5%–20%, and ultimately, lead to the cracking in laminates.<sup>20</sup>

**FIGURE 9** Eroded wind turbine blades

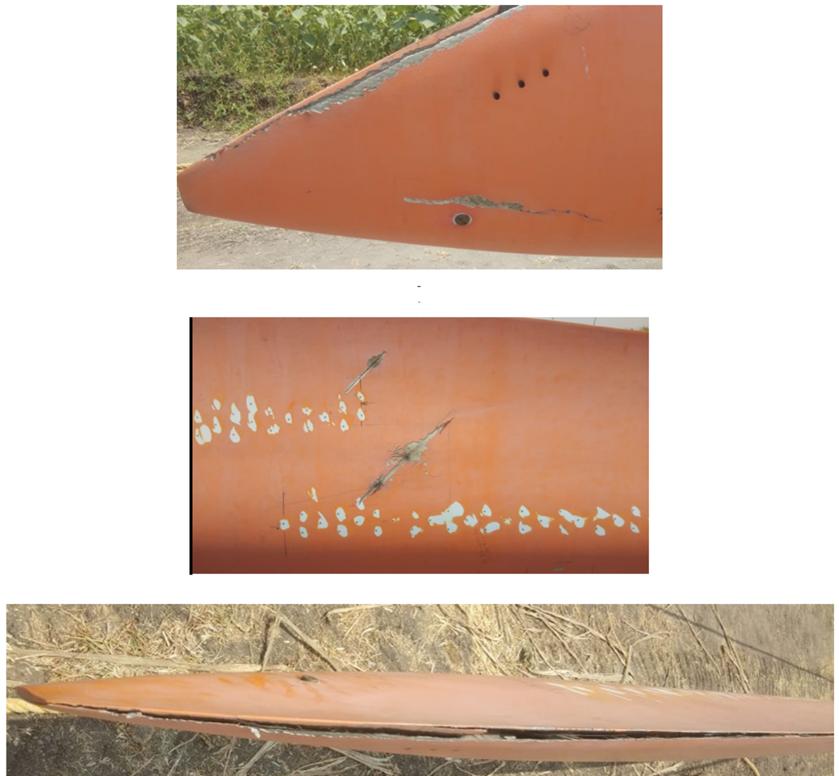
Figure 10 shows wind turbine blade, damaged by lightning strike. It is worth to note that after a blade repair has been carried out, the same kind of repair can be needed again in only 2–5 years, depending on the site conditions.

**FIGURE 10** Wind turbine blade damaged by lightning strike: (A) tip, (B) other side, and (C) splitting blade. Photos are made by Windcare employees

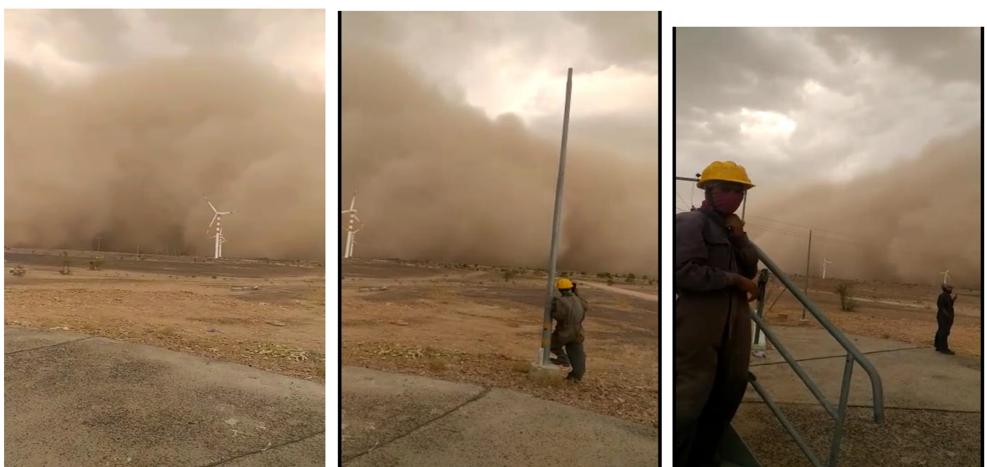
Specifications of wind farm site play an important role in the accumulation and build-up of dust on the blade surface of wind turbines. Whereas, the height of nacelle and rotor RPM in pitch regulated turbine were higher than stall-regulated ones, the effect of dust on the performance of pitch-regulated wind turbine is low. With growing dust on the surface of wind turbine blades, the drag force of the airfoil increases, but the lift force decreases diminishing the power output of the turbine. Also, the dusting on the rotor's blades of horizontal axis stall-regulated wind turbines may lead among others to a long time stops without no production due to heavy accumulated dust and safety demands.

**FIGURE 11** Dust storm by cyclone Vayu in June 2019 in Sanu site near Jaisalmer (Rajasthan, India)
