1. EXECUTIVE SUMMARY

EAPC Architects, Structural and Mechanical Engineers conducted a facility assessment at Richardton Taylor schools in order to estimate the costs of needed repairs and code updates in terms of Architectural updates, Structural fixes, Mechanical systems upgrades, as well as Electrical upgrades to serve the new Mechanical system upgrades. We looked at the 3 buildings on the high school campus as well as the elementary school.

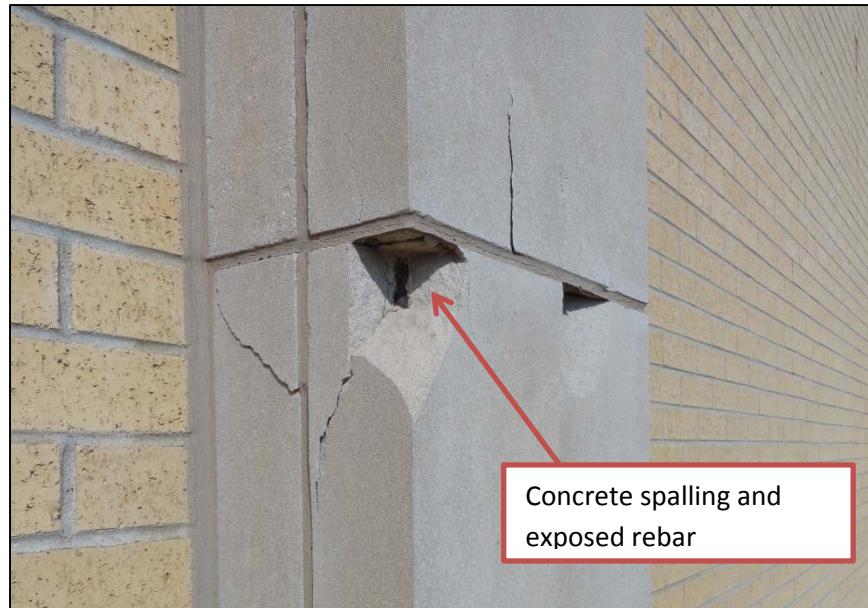
The exterior precast concrete stone accentuations on the gymnasium are deteriorating and spalling in multiple locations (Photo 1).

(Photo: 1, Damaged precast stone)

The gym has exterior precast stone that has been damaged. These openings in the precast stone will allow water to enter and eventually crack and deteriorate the precast faster than normal weathering would do.

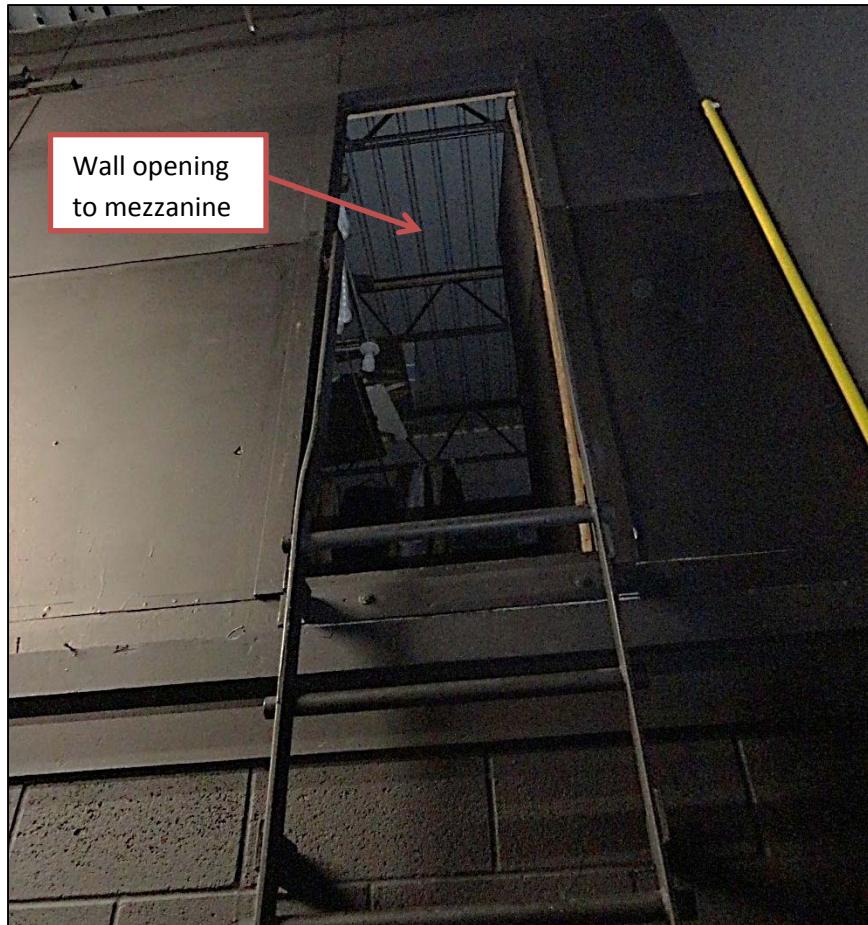
The back of the stage area has a concrete masonry unit and wood framed mezzanine structure. There are multiple 'soft' spots in the wood floor sheathing. Access provided to an elevated mezzanine does not appear to comply with OSHA requirements nor was there a posted load rating of the mezzanine structure (Photo 2).

(Photo 2: Stage mezzanine access)

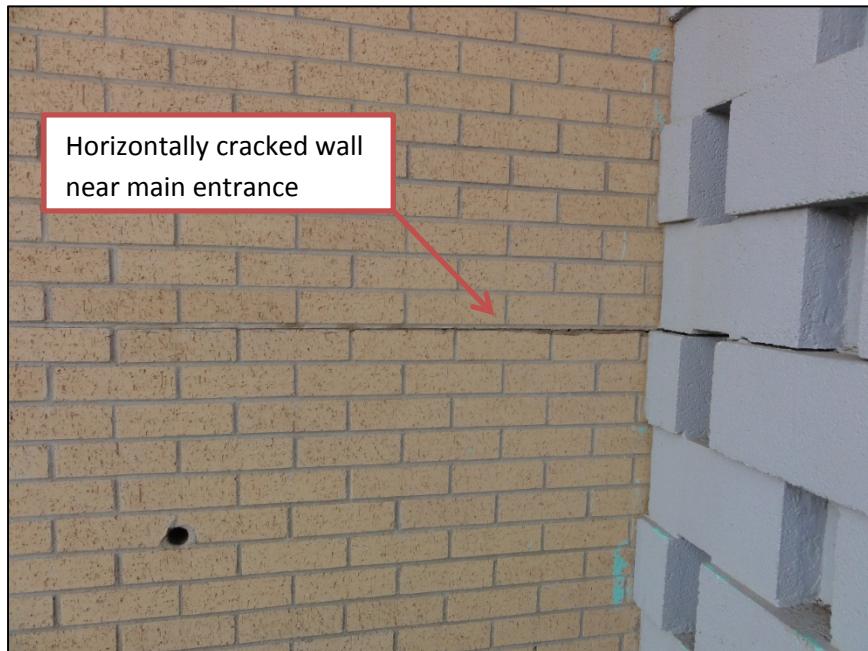
The concrete masonry unit and brick faced walls have experienced settlement of their supporting structure. The result is horizontal cracking in the masonry bed joints (Photo 7).

(Photo 7: Horizontally cracked wall)

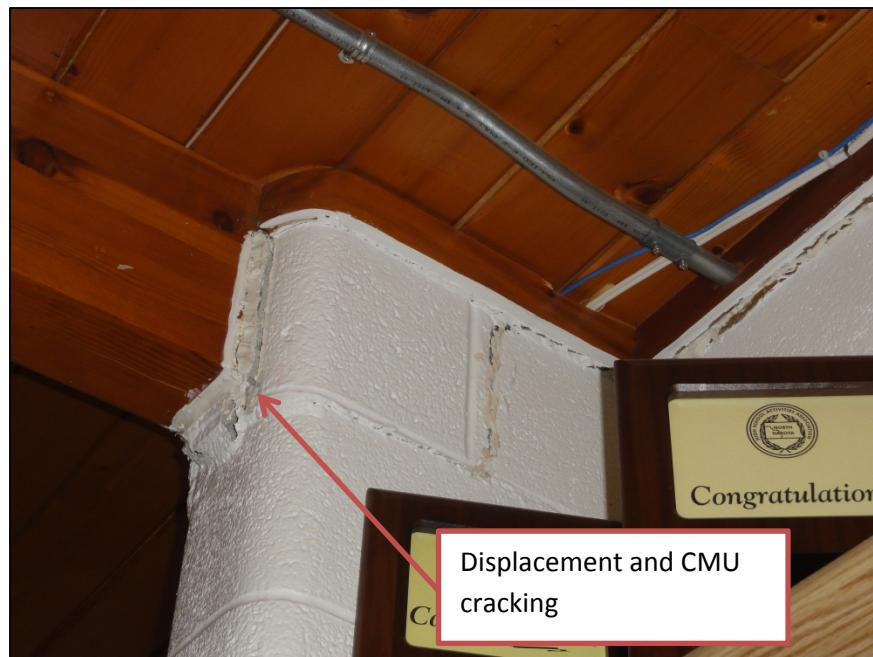
The concrete masonry bearing supports of the wood glulam beams have structurally failed as evident in the photos that follow. Structural failure of the masonry and loss of adequate wood beam bearing poses **immediate life safety concerns**. In multiple locations, the beams and/or bearing seats have displaced from their original locations. It appears that some of the cracks in the concrete masonry have been cosmetically repaired with caulk and paint multiple times. There were also instances where the end of the wood glulam beam has begun to experience torsional twisting and spalling of the concrete masonry units alongside (Photo 8 – 13).

(Photo 8: Cracked and displaced CMU bearing seat and glulam)

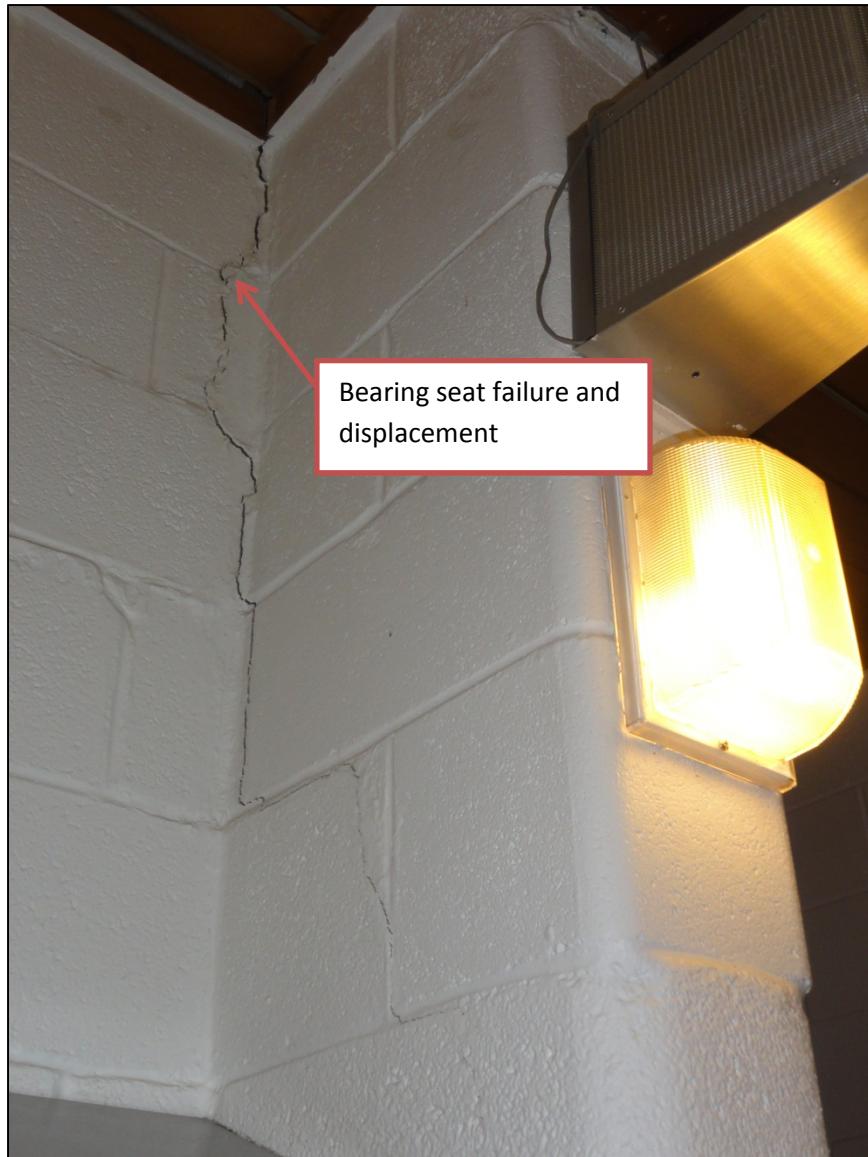
(Photo 11: Cracked and displaced CMU bearing seat)

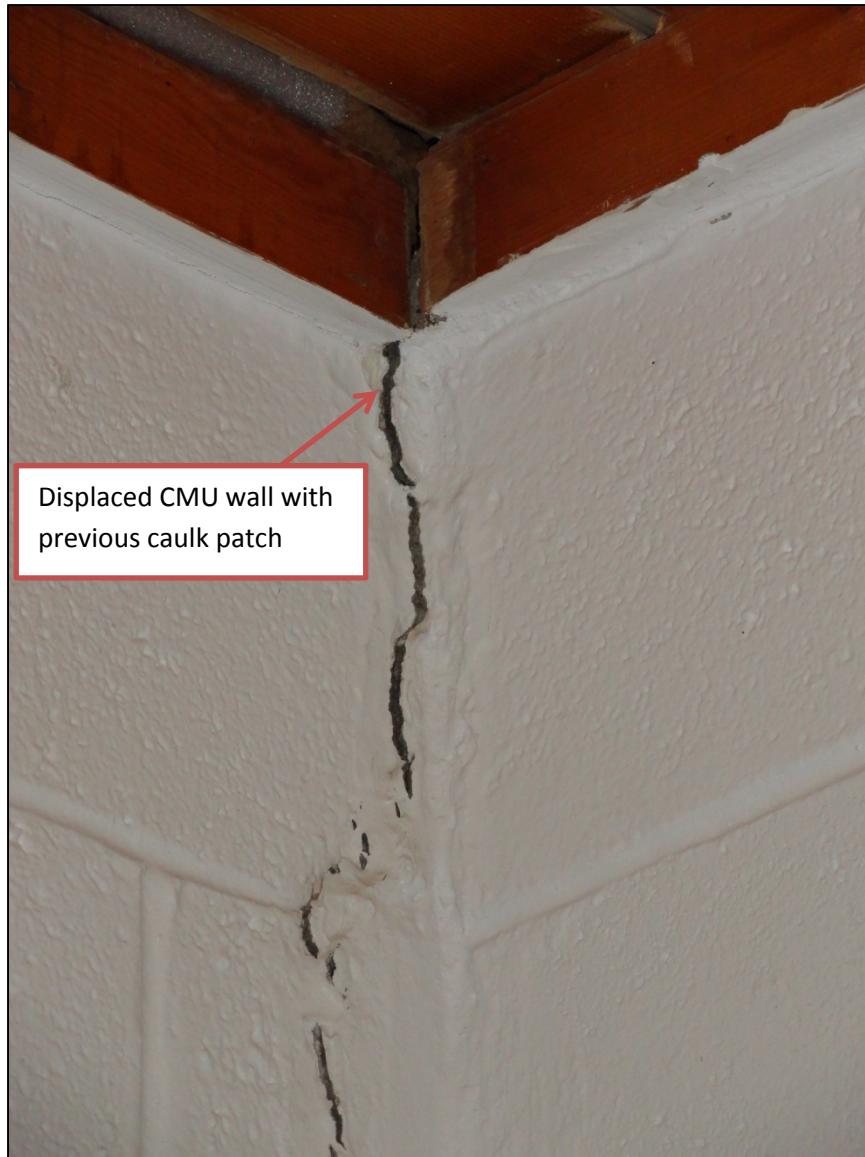
(Photo 13: Cracked and displaced CMU wall)

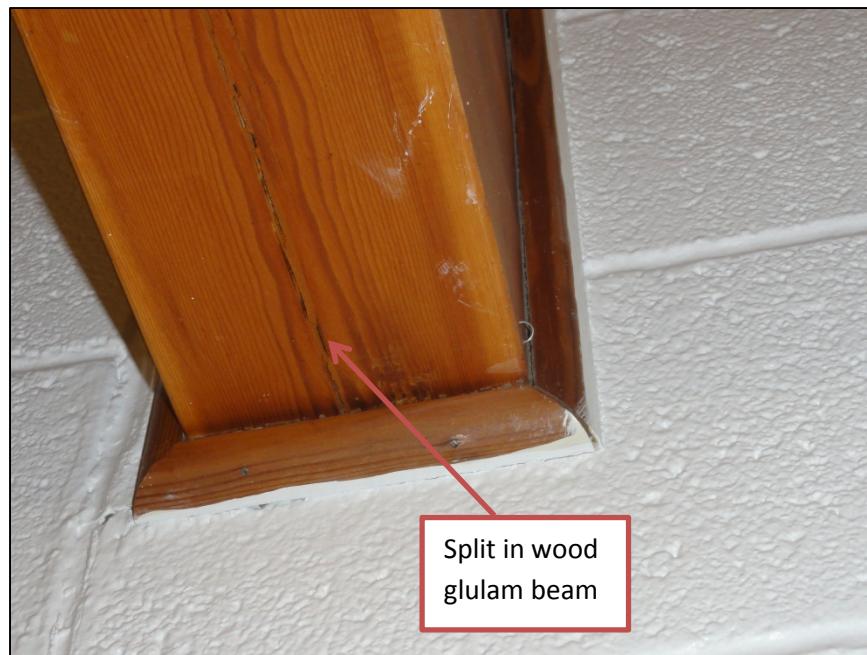
Multiple locations of glulam beam failures above classrooms were observed. There were instances where the beam had split vertically at the bearing location (Photo 14). More structurally concerning are locations where the glulam beams were splitting and separating horizontally between the built-up plies (Photo 15). Failures of this nature greatly reduce the beam's factor of safety and increase the likelihood of complete failure resulting in collapse. Correct repair or retrofit of a glulam beam is difficult and near impractical.

(Photo 14: Split glulam beam)

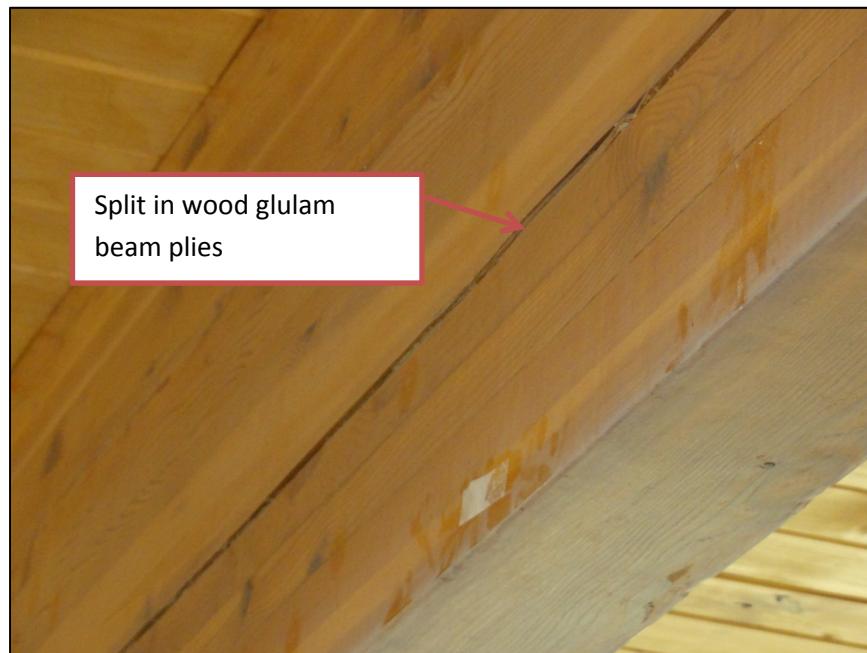
(Photo 15: Splitting/separation between glulam plies)

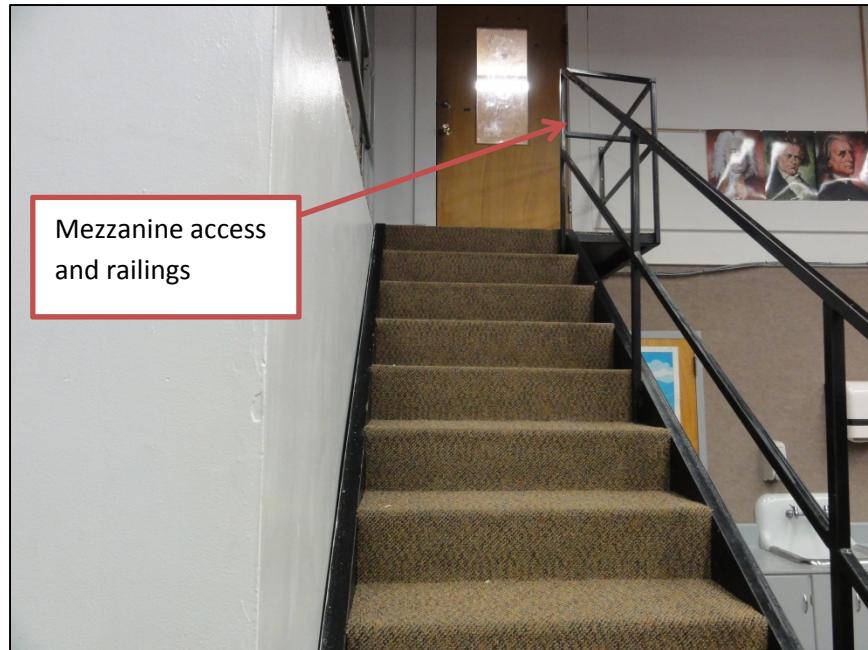
The band room has a concrete masonry unit and wood framed mezzanine structure. Access provided to an elevated mezzanine does not appear to comply with OSHA requirements nor was there a posted load rating for the mezzanine structure (Photo 21).

(Photo 21: Band room mezzanine access)

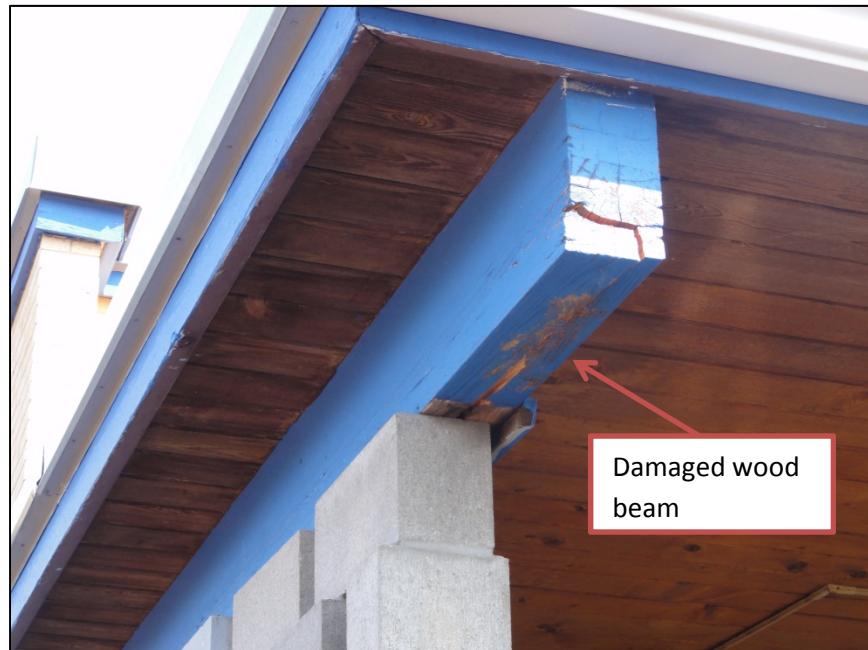
The west building screen wall and overhang support was previously damaged and repaired. The repair was limited to the concrete masonry units. Not addressed was the displacement and destruction to the wood beam spacer (Photo 22).

(Photo 22: West entrance overhang support)

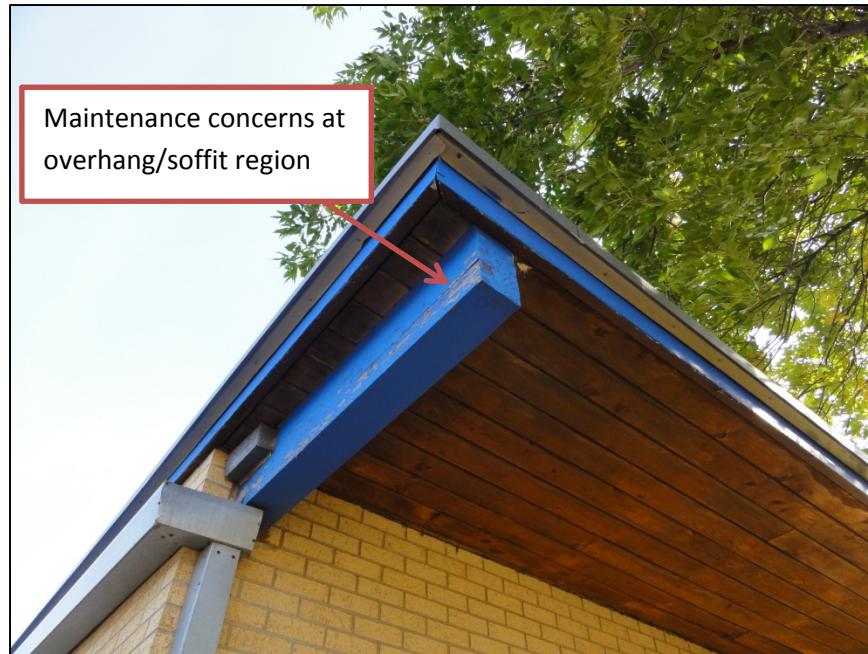
Maintenance and weather protection of exposed structural glulam beams and wood plank decking is paramount to its sustainability. It does not appear that the exterior wooden soffit areas have been well maintained over the years. The lack of routine maintenance results in splitting, sagging, and general deterioration of the wood roof members (Photo 24). Continued, unmaintained exposure will allow for the glulam beam deterioration to continue into the building and adversely affect the glulam beam bearing and beyond creating life safety concerns.

(Photo 24: Typical roof overhang/soffit)

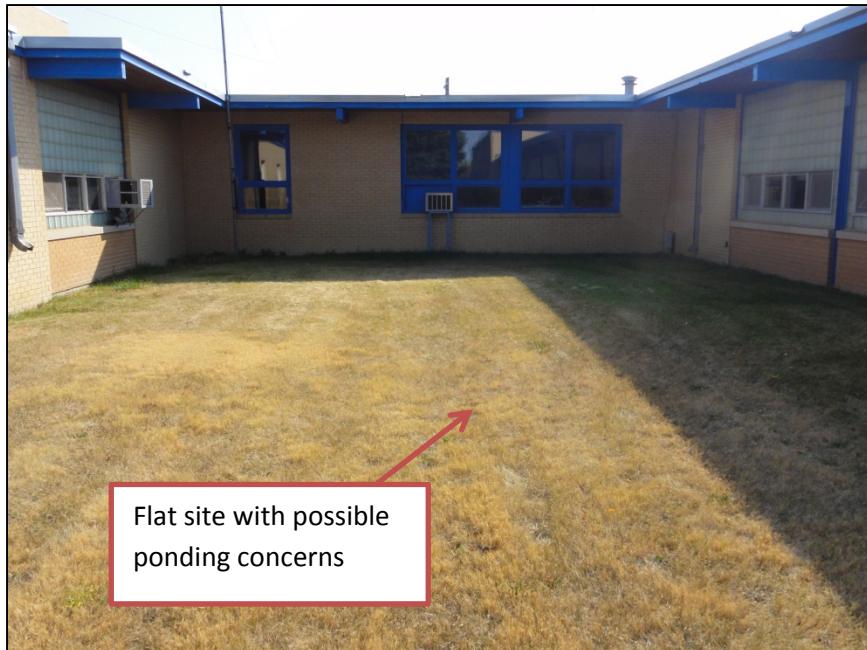
The site surrounding the high school is extremely flat. Storm drain inlets were not observed surrounding the building resulting in overland drainage of storm water (including roof drainage). The grading around the building did not appear to provide positive drainage away from the building (Photo 25). As a result, ponding of storm water near the structure is likely.

(Photo 25: Example of site surrounding school)

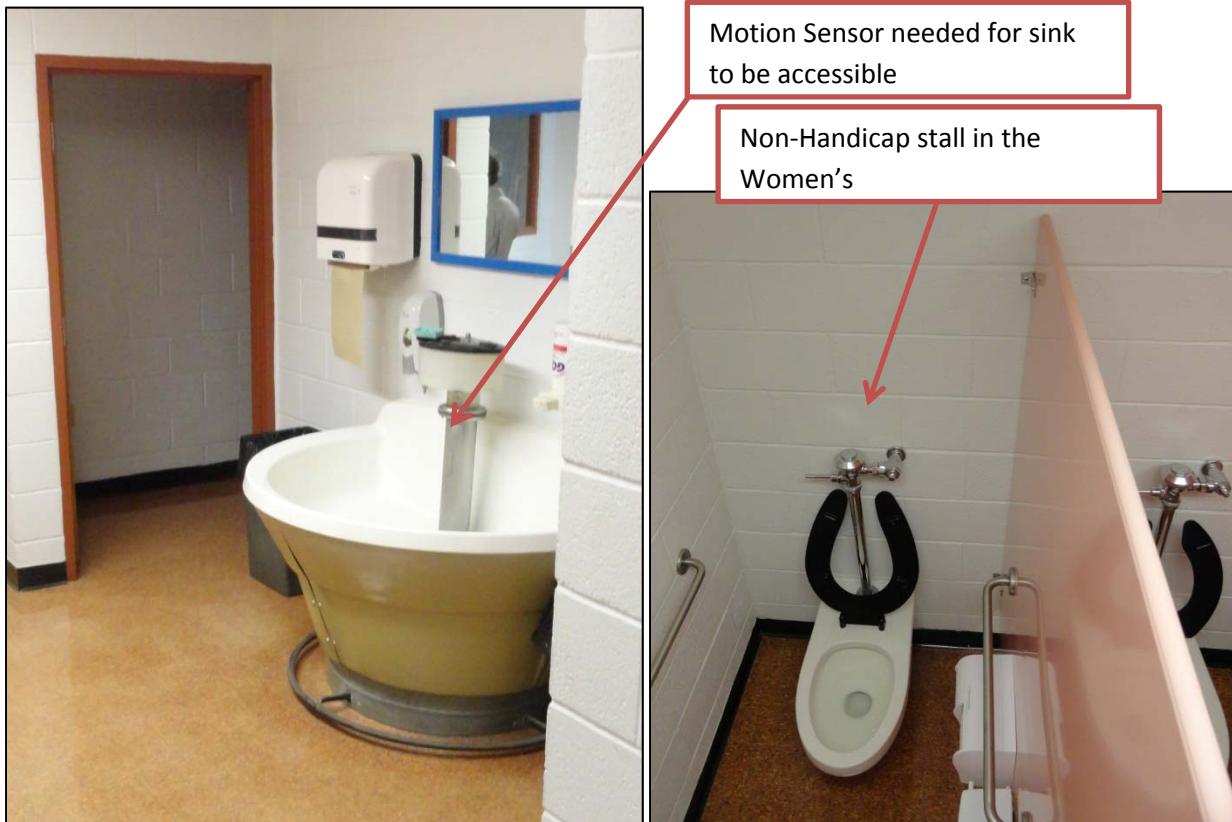
The Industrial trades' building has ADA issues with the restrooms and front entry. There are no ADA compliant sinks or accessible toilet stalls. The front entry does not have 42" from one door leaf to the

edge of the next door leaf as required for accessibility. The rug in the entry is also required to be fastened down to comply with ADA.

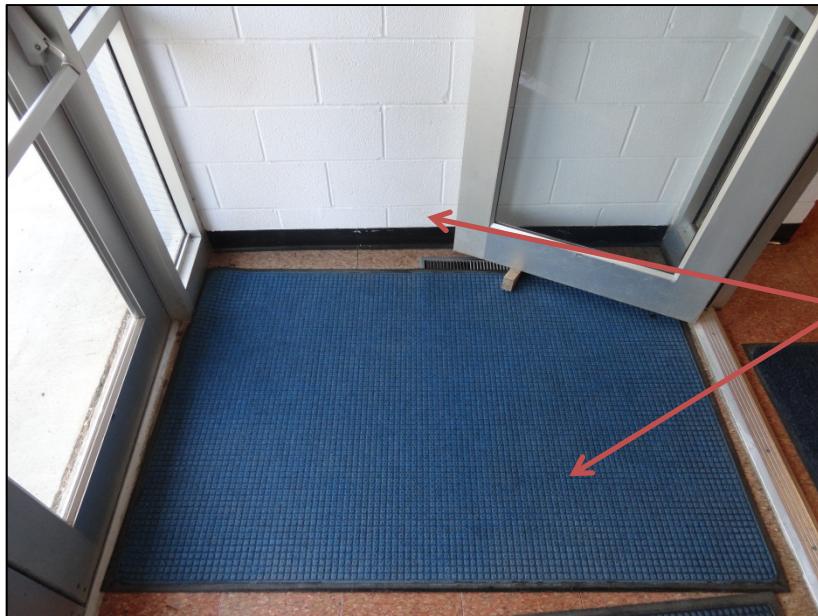
Non-Handicap front entry due to the two sets of doors being too close together and floor mats are not attached to the floor

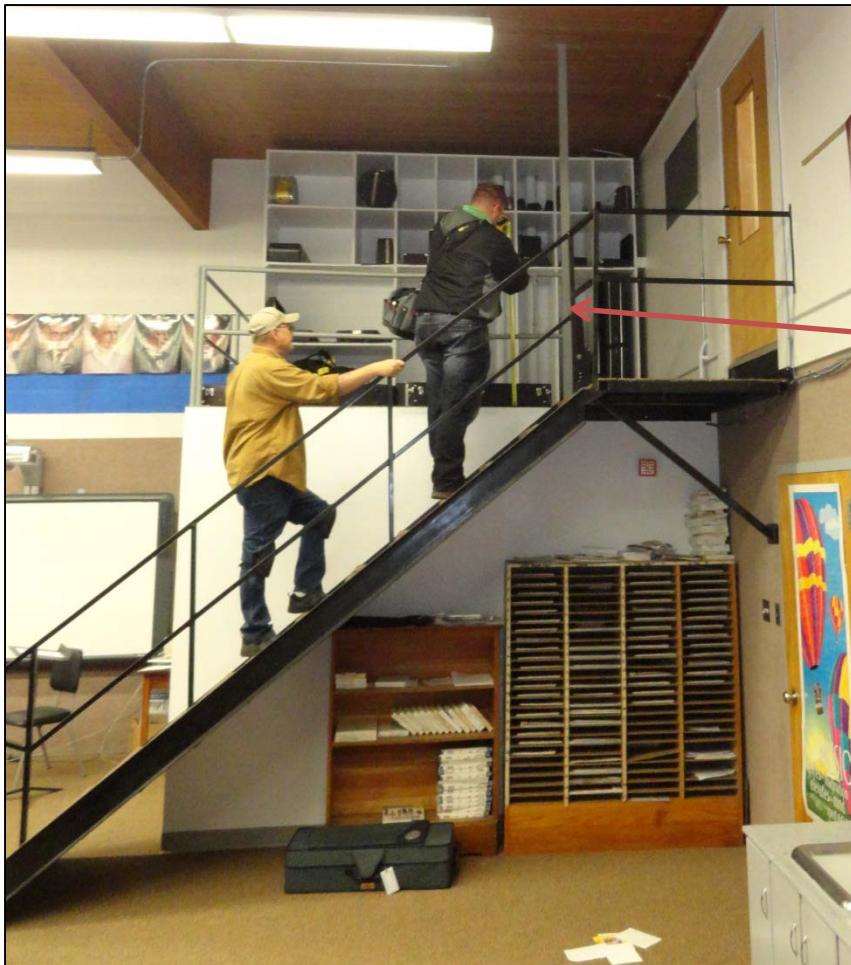
Building Code issues in the High school are the Mezzanine in the Band room and the number of restroom water closets / urinals in the building. The mezzanine does not have the proper handrails or guard rails to protect the safety of the students. Guard rails are required going up the stairs and then at the top of the instrument storage area. The Mezzanine is not handicap accessible. This is allowed as long as the activities happen on the mezzanine can be accommodated somewhere that is accessible. That ends up being a subjective opinion and causes problems when activities continue to occur up there with students.

There is a lack of a code compliant hand rail and guard rails at mezzanine stairs. The mezzanine cannot have an activity that discriminates against a handicap person since there is no handicap access

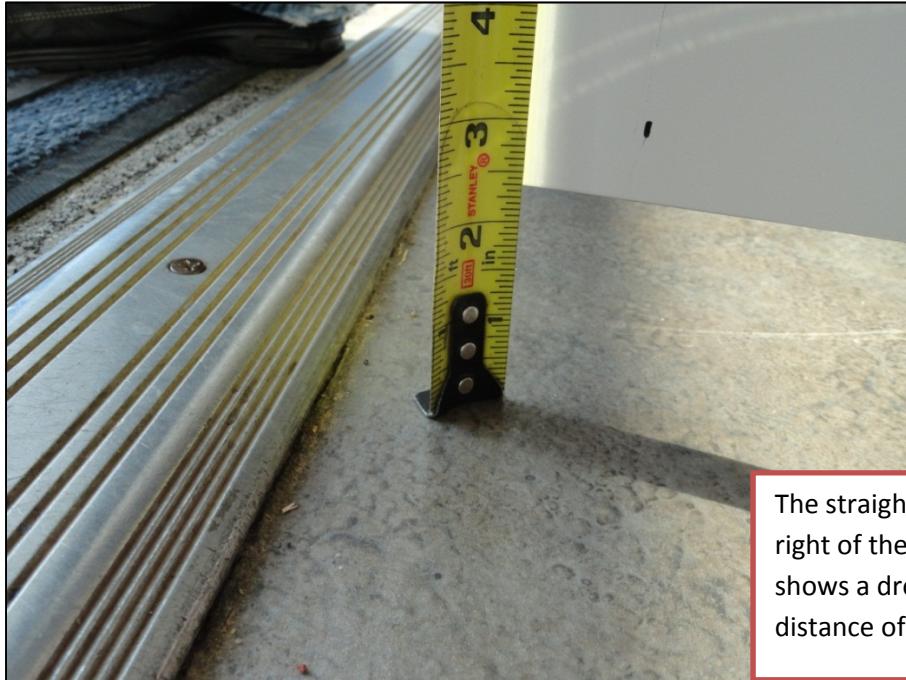
The front hallway by the main office and front doors has settled creating a steep patch that is not fully handicap accessible. The slope of the ramp is greater than the 1:20 slope ADA allows. The actual slope currently is 1:16 which is considered a ramp. Therefore this part of the floor has to have a flat, 60 inch square before the door that is level for a handicap person to be able to open the front door.

The straight edge, at the top right of the picture to the floor shows a drop of over 2-1/4" in a distance of 43 inches.

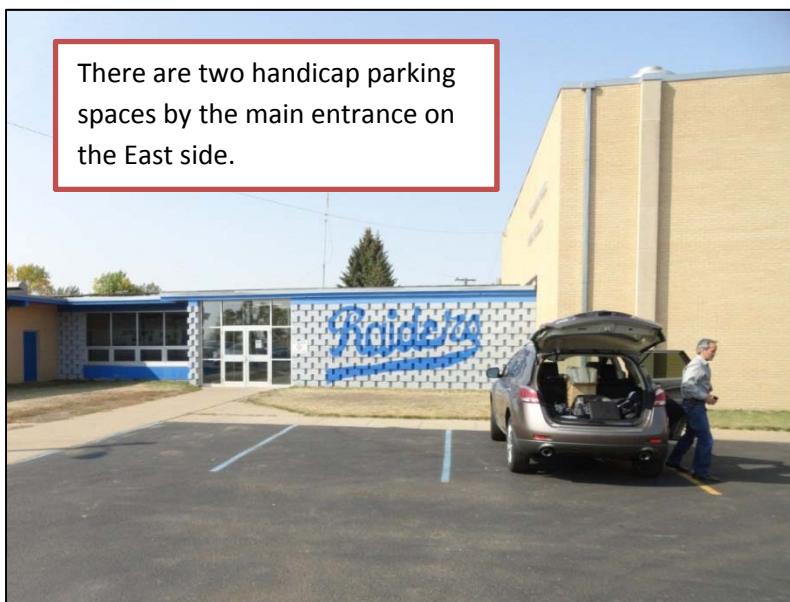
The existing handicap parking spaces are striped blue. There must be at least one van accessible spot which requires an additional 8' striped area for unloading the van. These spots also require a sign stating they are handicap parking spots so they can be properly enforced. The number of required spots needs to be verified by counting all the available parking spots in the lot.

There are two handicap parking spaces by the main entrance on the East side.

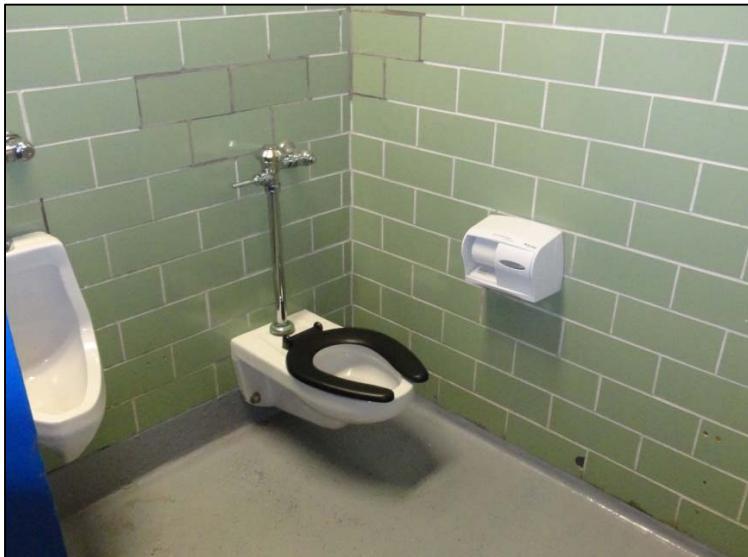
The locker rooms do not have handicap shower stalls with shower seats and hand controls that the disabled can use. There is also a concrete curb into the shower stall which does not allow a wheel chair to roll into the shower area. The toilets are also not fully accessible either because they are not wide enough or do not have the proper grab bars and toilet accessories at the allowed heights.

Locker room toilet facilities lack grab bars and the physical clear space needed for handicap access

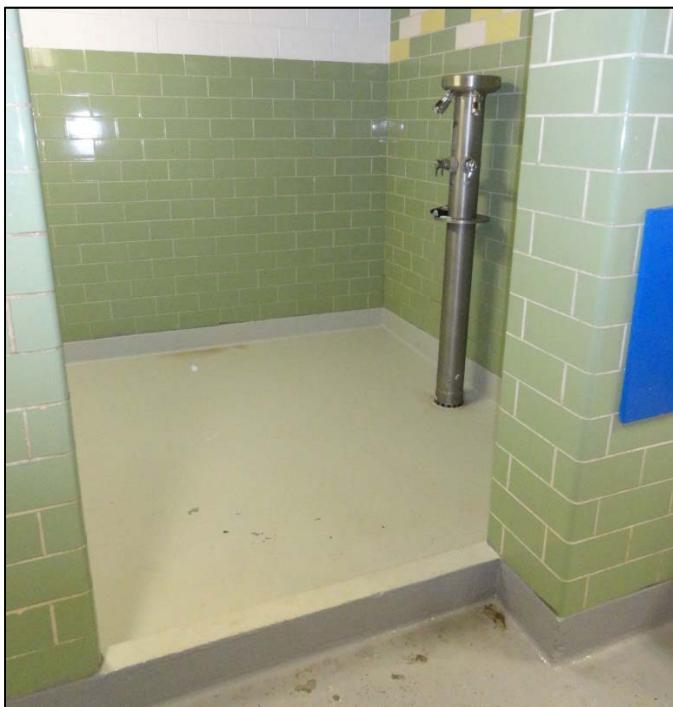
The locker room showers have a large curb which impedes handicap access. No handicap shower with transfer bench and hand-held shower sprayer

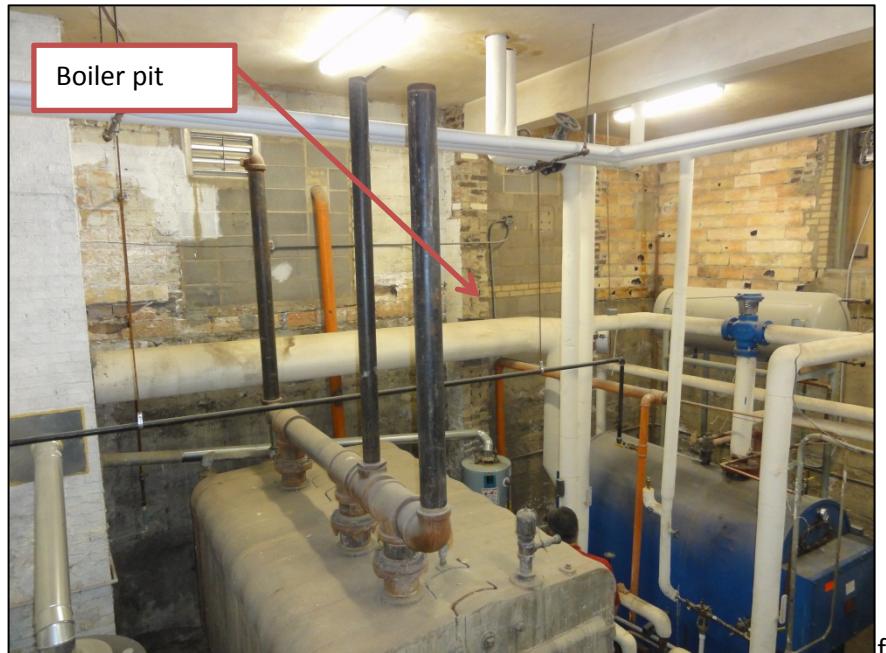
The original pit for the boiler was part of the 1900's era brick school building (Photo 27). There have been multiple openings and patches to the walls over time. The conditions of construction materials are fair although some are considered archaic.

(Photo 27 Boiler pit)

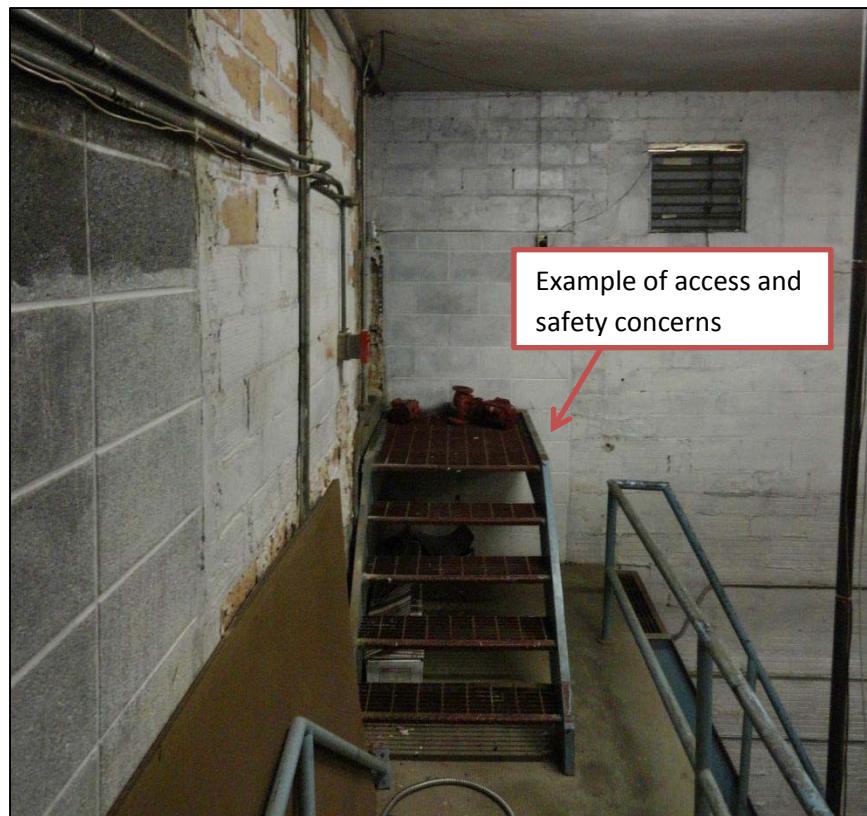
Access to and around the boiler pit is constricted and conflicts with current code standards and OSHA requirements (Photo 28).

(Photo 28: Boiler pit access)

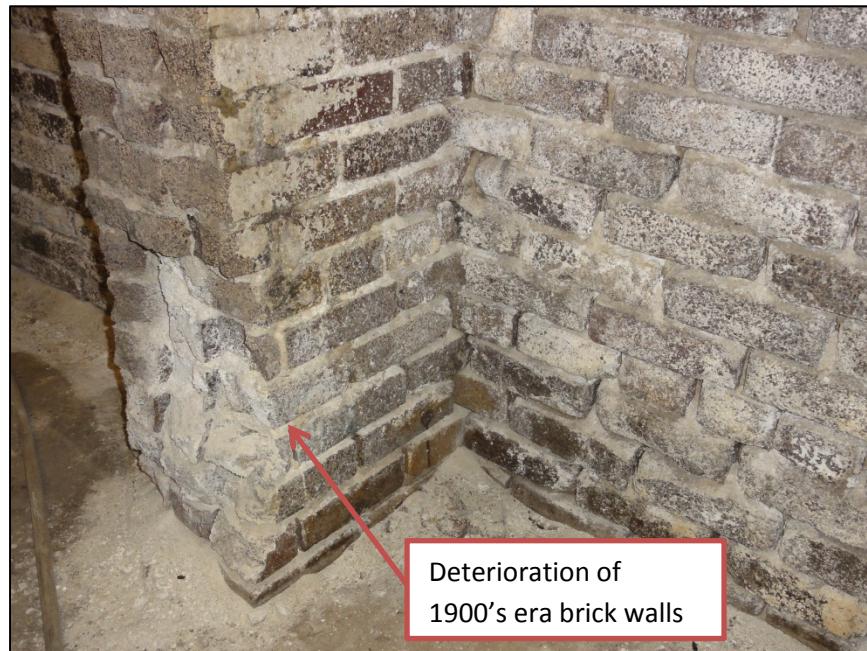
The wall construction of the boil pit is showing signs of its age. General deterioration and damage to the pit structure are spread throughout (Photo 29).

(Photo 29: Boiler pit brick walls)

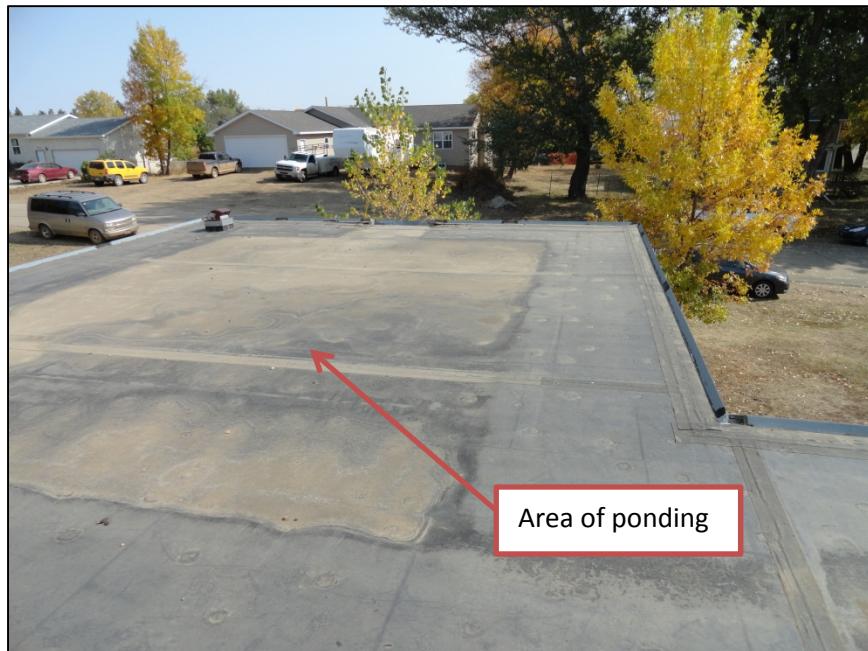
The roof on the 1960's addition consists of a mechanically fastened roof membrane presumably over insulation and metal roof deck. Multiple areas on the roof showed signs of water ponding and drainage concerns (Photo 30). The roof above the gymnasium was not viewable to the time of inspection.

(Photo 30: Roof by East Entry)

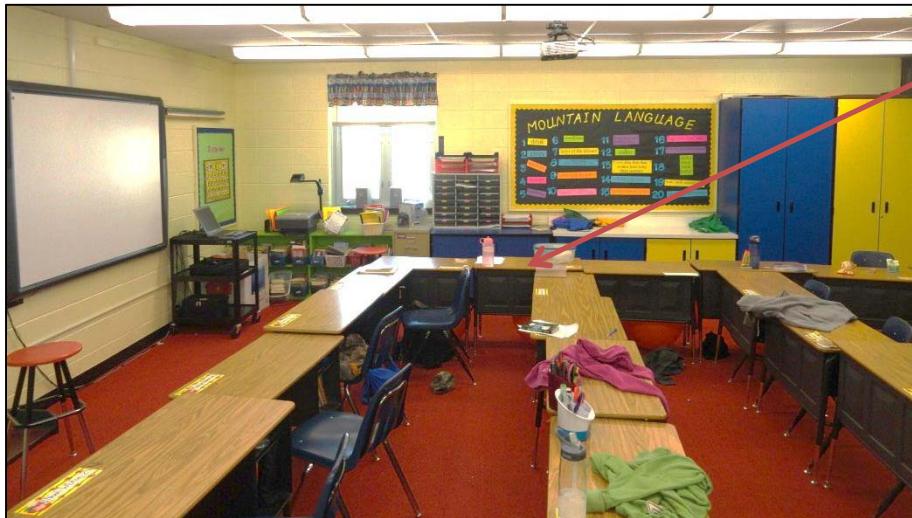
Classroom with not much space for circulation
