Product range of the company

Customer Claim – missing soldering

New station project:

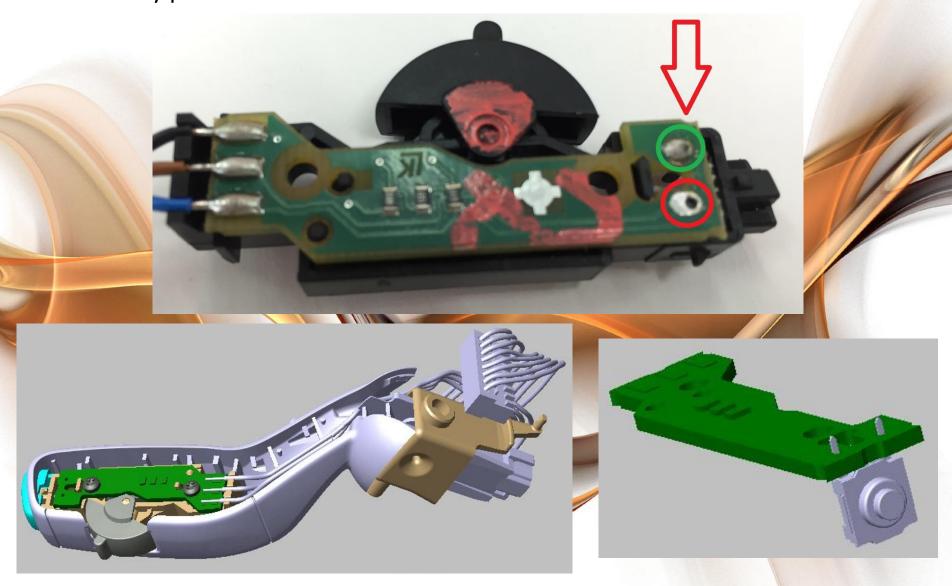
Successfully passed electrical test and send to the customer:

Integrating a visual inspection system is one of the few solutions that can guarantee stability in the production process, due to the specificity of the solder.

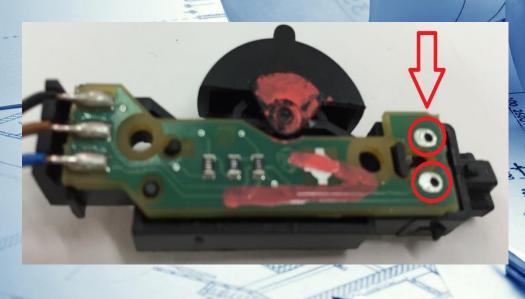
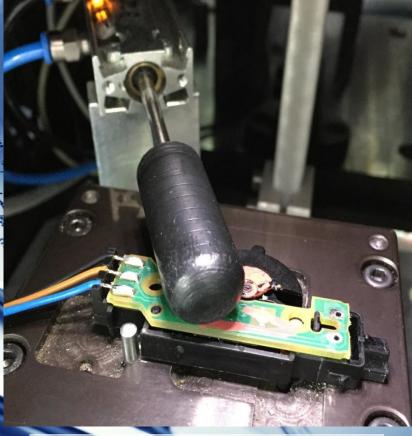
Experiment 1: Part with two missing solders:

Results of simulation experiment 1: Image settings Object locator Until Reference image | Clagged images Run Detailed inspections Visual inspector **Output settings** Edit Results result: Reference objects <0bject 1> All passed Detail failed Not located Outputs 000 Active output O Inactive output Unavailable output Detailed results O Torel counter 13 O T <Pixel counter 2> Frame rate: 19.6 Hz Minimum delay time: 67.6 ms Replace reference image (NoName) 📞 169.254.86.25:2112 🥝 online 💞 synchronized 🐧 Download Immediately Assembly FAIL Sick PLC feedback: SN VT50 Shift

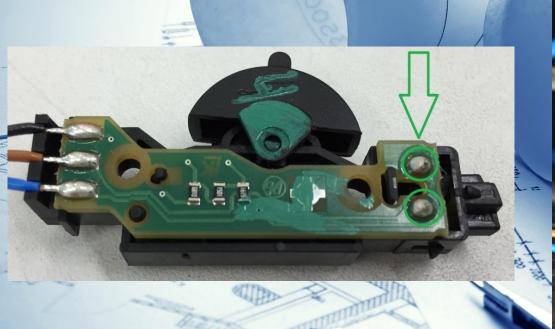
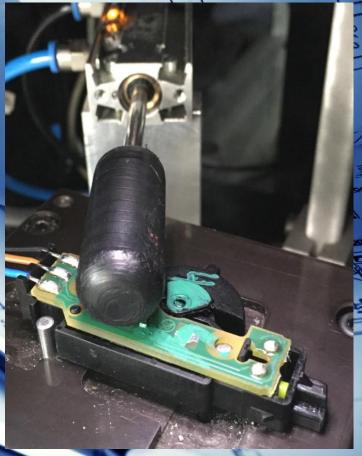
Experiment 2: Part with two OK solders:

Results of simulation experiment 2:
