# ROAD HEALTH & CITIZEN GRIEVANCE REPORT

REF: RHA-20260903-787F87

Automated computer-vision assessment of road surface condition, defect extent and remediation urgency, prepared for municipal grievance submission.

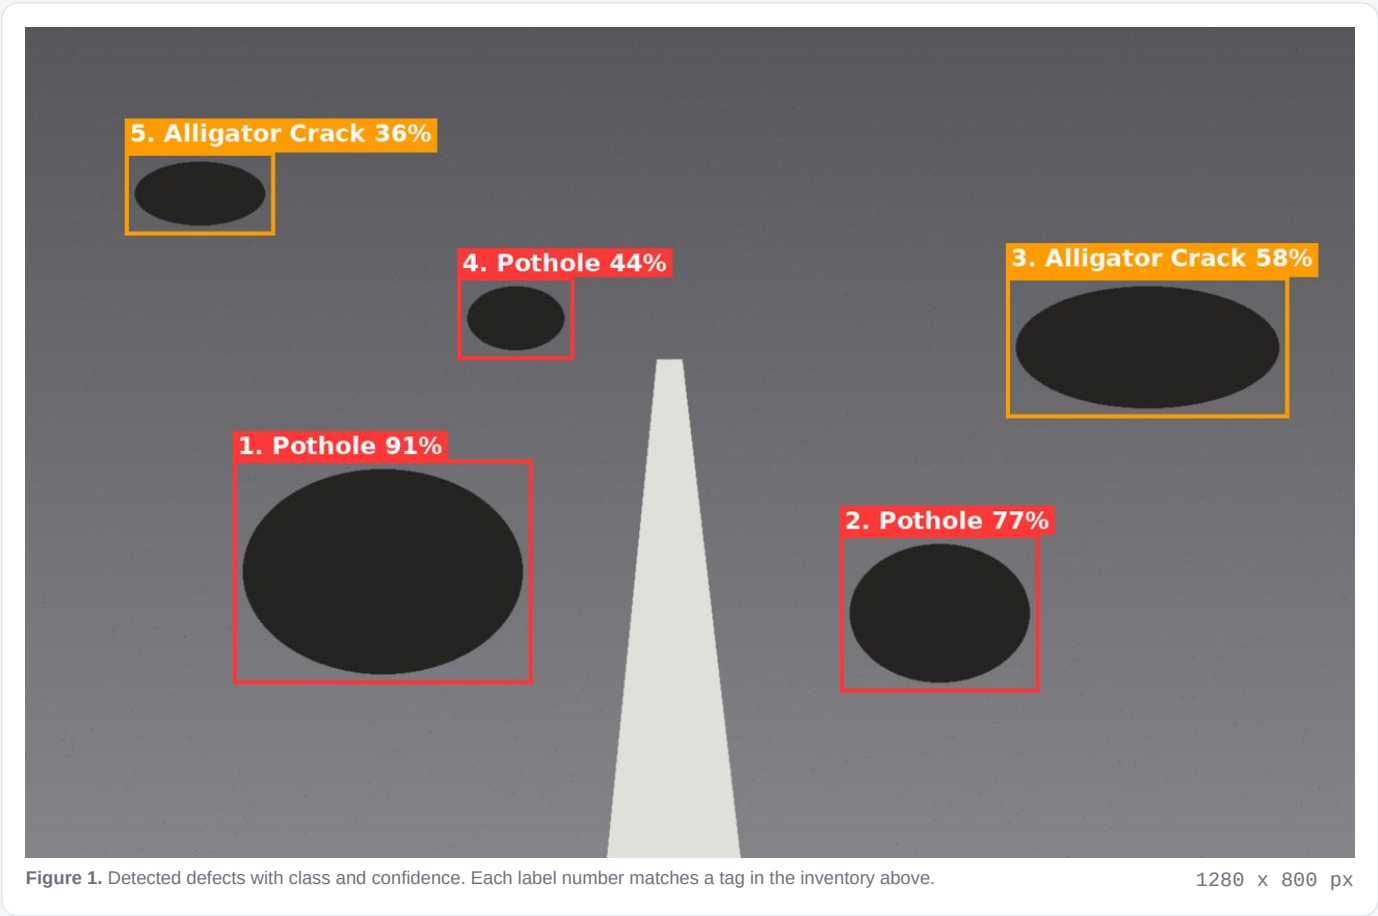
VISUAL EVIDENCE

3 potholes, 2 alligator cracks

Road surface defects were detected in a photograph captured at latitude 17.494800, longitude 78.399600. Automated analysis identified 3 potholes and 2 alligator cracks, covering approximately 14.54% of the photographed road surface. The computed Road Health Score is 85.46 out of 100, indicating a FAIR road condition. The estimated Road Risk Index is 32.4 out of 100, placing this location in the MODERATE risk band; the suggested grievance tier is Priority-3 (remediate within 30 days). The most serious individual defect is rated high severity. The Greater Hyderabad Municipal Corporation (GHMC) is kindly requested to inspect the location and undertake the necessary repair work.

| Priority action | Hot-mix / cold-mix asphalt fill with mechanical compaction |
