# ROAD HEALTH & CITIZEN GRIEVANCE REPORT

Automated computer-vision assessment of road surface condition, defect extent and remediation urgency, prepared for municipal grievance submission.

REF: RHA-20260903-A7F3C1

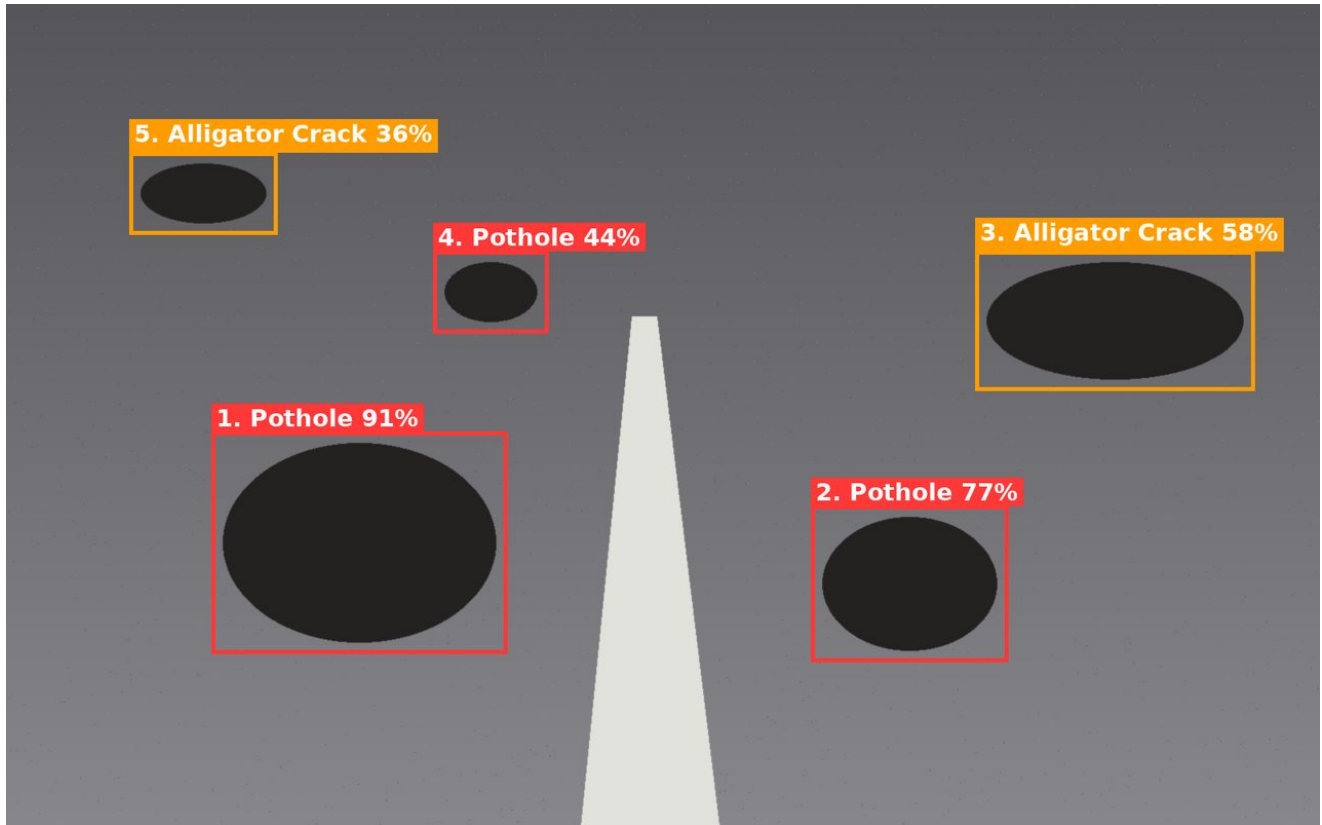
Road surface defects were detected in a photograph captured at latitude 17.494800, longitude 78.399600. Automated analysis identified 3 potholes and 2 alligator cracks, covering approximately 14.54% of the photographed road surface. The computed Road Health Score is 85.46 out of 100, indicating a FAIR road condition. The estimated Road Risk Index is 32.4 out of 100, placing this location in the MODERATE risk band; the suggested grievance tier is Priority-3 (remediate within 30 days). The most serious individual defect is rated high severity. The Greater Hyderabad Municipal Corporation (GHMC) is kindly requested to inspect the location and undertake the necessary repair work.

Figure 1. Detected defects with class and confidence. Each label number matches a tag in the inventory on page 2. 1280 x 800 px.

| Priority action | Hot-mix / cold-mix asphalt fill with mechanical compaction |

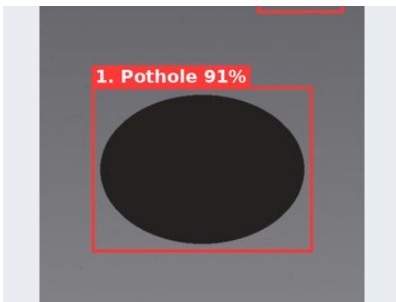
| TAG | CLASSIFICATION | DETECTION<br>CONFIDENCE | | SEVERITY | FRAME<br>AREA | RECOMMENDED REMEDIATION |
|---|---|---|---|---|---|---|
| #1 | Pothole | <div><div></div></div> | 91% | High | 6.08% | Hot-mix / cold-mix asphalt fill with mechanical compaction |

Tag #1 · Pothole  
High · 91% confidence

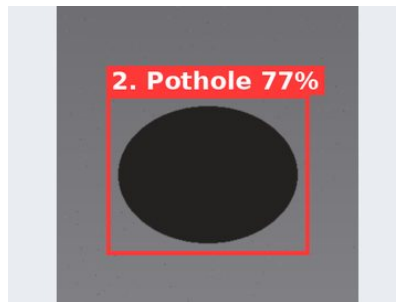
| TAG | CLASSIFICATION | DETECTION<br>CONFIDENCE | | SEVERITY | FRAME<br>AREA | RECOMMENDED REMEDIATION |
|---|---|---|---|---|---|---|
| #2 | Pothole | <div><div></div></div> | 77% | Medium | 2.85% | Edge trimming, tack coat and patch sealing |

Tag #2 · Pothole  
Medium · 77% confidence

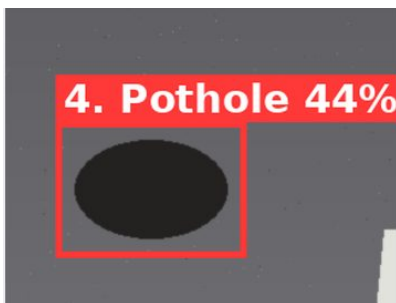
| TAG | CLASSIFICATION | DETECTION<br>CONFIDENCE | | SEVERITY | FRAME<br>AREA | RECOMMENDED REMEDIATION |
|---|---|---|---|---|---|---|
| #4 | Pothole | <div><div></div></div> | 44% | Minor | 0.88% | Localised surface levelling during the next maintenance round |

Tag #4 · Pothole  
Minor · 44% confidence
