# ROAD HEALTH & CITIZEN GRIEVANCE REPORT

Automated computer-vision assessment of road surface condition, defect extent and remediation urgency, prepared for municipal grievance submission.

REF: RHA-20260907-FA6D20

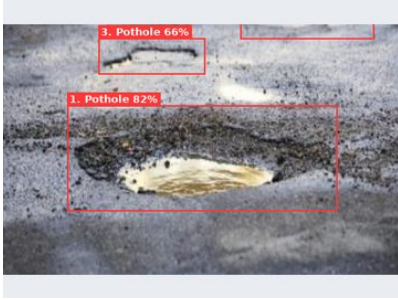
| TAG | CLASSIFICATION | DETECTION<br>CONFIDENCE | | SEVERITY | FRAME<br>AREA | RECOMMENDED REMEDIATION |
|---|---|---|---|---|---|---|
| #1 | Pothole | <div><div></div></div> | 82% | Critical | 10.86% | Barricade, excavate and full-depth patch with hot-mix asphalt |

Tag #1 · Pothole  
Critical · 82% confidence

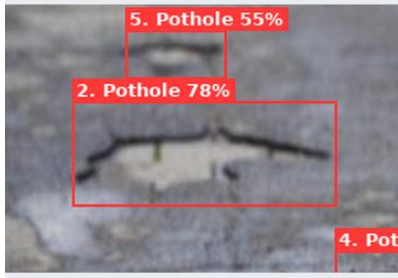
| TAG | CLASSIFICATION | DETECTION<br>CONFIDENCE | | SEVERITY | FRAME<br>AREA | RECOMMENDED REMEDIATION |
|---|---|---|---|---|---|---|
| #2 | Pothole | <div><div></div></div> | 78% | High | 3.46% | Hot-mix / cold-mix asphalt fill with mechanical compaction |

Tag #2 · Pothole  
High · 78% confidence

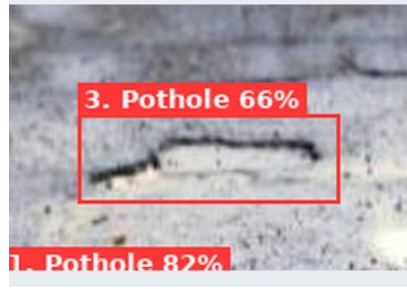
| TAG | CLASSIFICATION | DETECTION<br>CONFIDENCE | | SEVERITY | FRAME<br>AREA | RECOMMENDED REMEDIATION |
|---|---|---|---|---|---|---|
| #3 | Pothole | <div><div></div></div> | 66% | Medium | 1.46% | Edge trimming, tack coat and patch sealing |

Tag #3 · Pothole  
Medium · 66% confidence

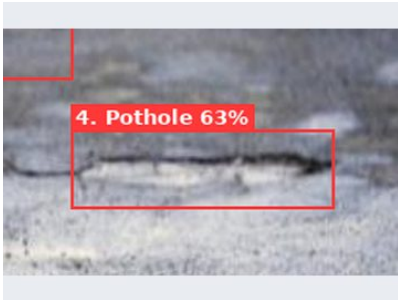
| TAG | CLASSIFICATION | DETECTION<br>CONFIDENCE | | SEVERITY | FRAME<br>AREA | RECOMMENDED REMEDIATION |
|---|---|---|---|---|---|---|
| #4 | Pothole | <div><div></div></div> | 63% | Medium | 2.04% | Edge trimming, tack coat and patch sealing |

Tag #4 · Pothole  
Medium · 63% confidence

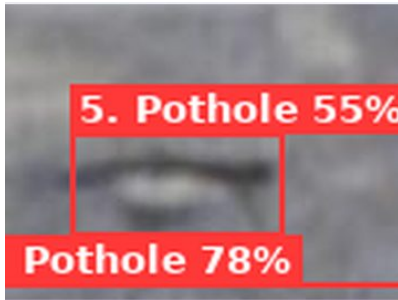
| TAG | CLASSIFICATION | DETECTION<br>CONFIDENCE | | SEVERITY | FRAME<br>AREA | RECOMMENDED REMEDIATION |
|---|---|---|---|---|---|---|
| #5 | Pothole | <div><div></div></div> | 55% | Minor | 0.62% | Localised surface levelling during the next maintenance round |

Tag #5 · Pothole  
Minor · 55% confidence

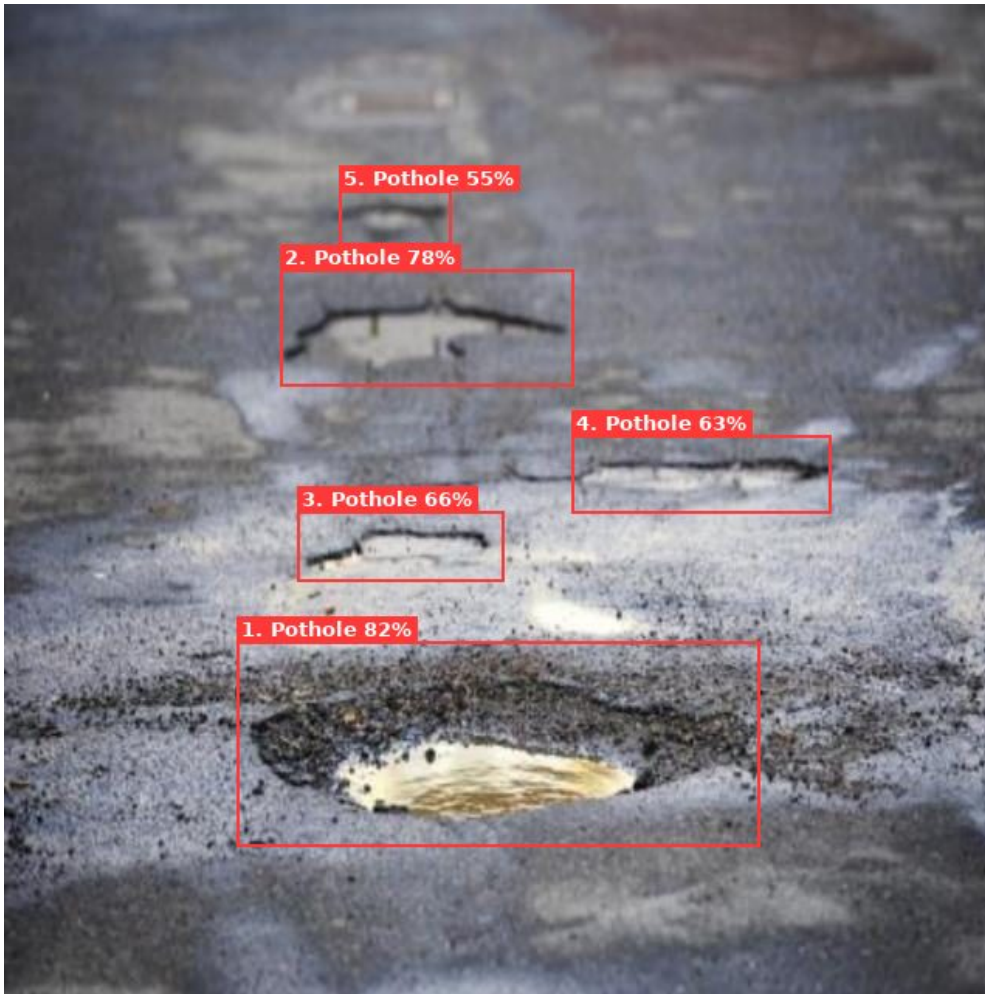
**Figure 1.** Detected defects with class and confidence. Each label number matches a tag in the defect inventory. 640 x 640 px.
