KHYBER PAKHTUNKHWA CITIES IMPROVEMENT PROJECT LOCAL GOVERNMENT ELECTIONS & RURAL DEVELOPMENT DEPARTMENT

Project: <u>CW2 – Lot 2 – KPCIP Abbottabad</u>

Subject: Observations Reported by CIU Engineer – 12-02-2024

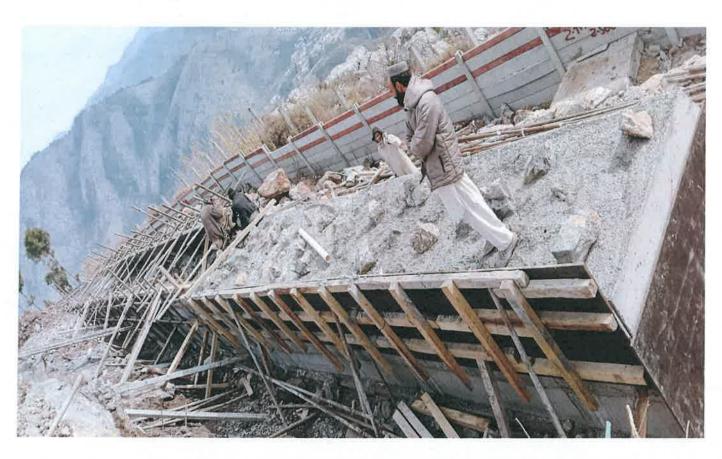
- 1. The CIU team reached on site at 12:50 PM and found that work on site was in progress in the absence of PMCSC personnels.
- 2. There was no curing on recent plum concrete (right side retaining wall).

Plum Concrete (Right Side Retaining Wall) Uncured

PMCSC is advised to ensure the presence of site inspectors on site during working hours, supervise the work in progress and closely monitor the site-specific practices as described in the project specification.
