Ref: KPCIP/CIU-ATD/CE/00911

Project: CW2 - Lot 2 - KPCIP Water Treatment Plant, Abbottabad

Subject: Observations: Urgent Resolution Required for Rusty Steel Rebars and Quality Control at WTP
Construction Site

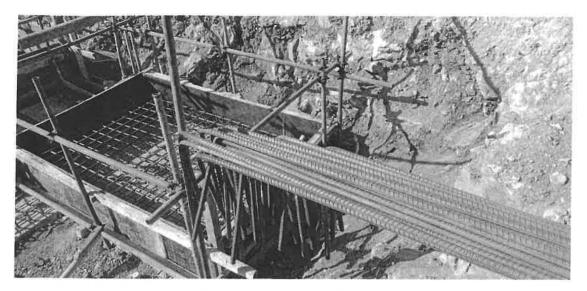
As evident from the attached photograph, the steel supplied and fabricated on site of WTP as well as stored in warehouse is heavily rusted, which is contravening the desirable standards of quality and workmanship.

Picture 1 - Rusted Steel Rebars

PMCSC is hereby instructed to submit the stance of "The Engineer" as to why such heavily rusted steel is

being used in WTP.

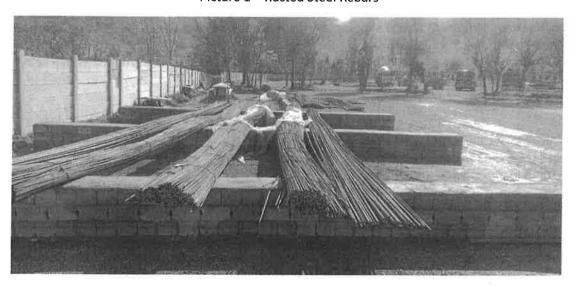
Picture 2 – Steel Rebars are Placed Over Concrete Blocks

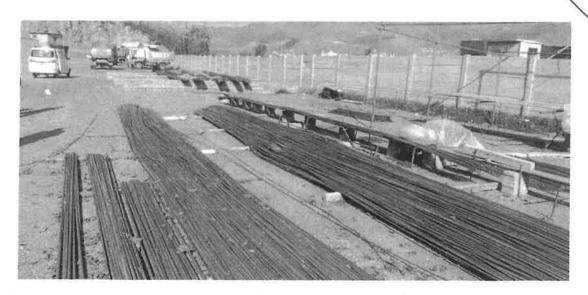
${\bf Picture~3-Steel~Rebars~are~Bordering~with~Ground~which~is~a~Major~Source~of~Moisture~Absorption}\\$
