Failure investigation of a hydraulic hose for service in liquid carbon dioxide at high pressure

K.M. Orzessek

Report Number	:	GS.10.53319	
Title	:	Failure investigation of a hydraulic hose for service in liquid carbon dioxide at high pressure	
Author(s)	:	K.M. Orzessek	PTE/EMMI
Approved by	:	F.J.M. Busch	PTE/EMMI
Content Owner	:	F.J.M. Busch	PTE/EMMI
Issue Date	:	December 2010	
Activity Code	:	ZZPT/006092/0101	
Sponsor	:	Shell Global Solutions (UK)	
Keywords	:	Hydraulic hose, carbon dioxide service, failure analysis, nitrile rubber	
Electronic file	:	GS.10.53319.pdf	
Issuing Company	:	Shell Global Solutions International BV, Amsterdam P.O. Box 38000, 1030 BN Amsterdam, The Netherlands. Tel: +31 20 630 9111

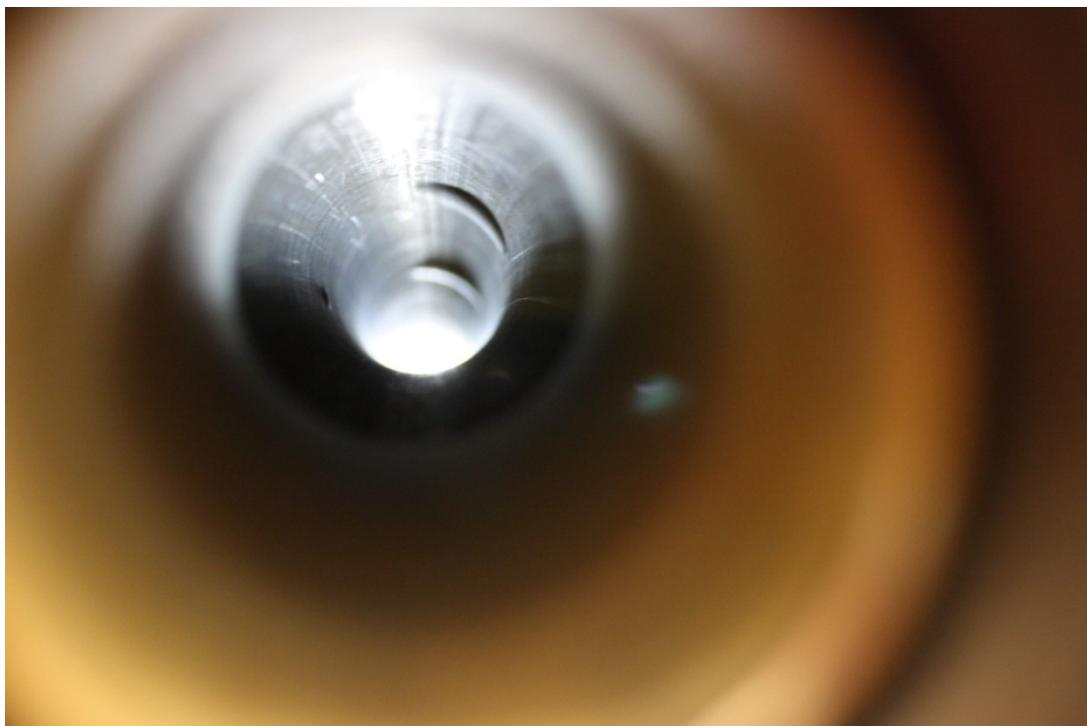
Defects were observed in the internal liner of the 2 inch flexible hose during endoscopical inspection by GSUK-PTD/HMHM (Figure 1) and on the external surface (blister Figure 2). The hose was cut at the location of the internal defects and send to Amsterdam for failure analysis.

Looking at the morphology of the separation failure in the liner it is likely that at this area the liner had been blown down. The reason for the blow down was the permeation of liquid CO<sub>2</sub> through the liner wall and the accumulation of that liquid which created an annulus between liner and reinforcement, most probably initiated at an adhesion defect at that location between liner and fabric. When pressure was released the temperature increased and the CO<sub>2</sub> liquid transformed to gas, resulting in expansion in the annulus and the development of the blister observed during the initial endoscopic inspection.

**Figure 1** Defects (blisters) observed at the internal side of the hose

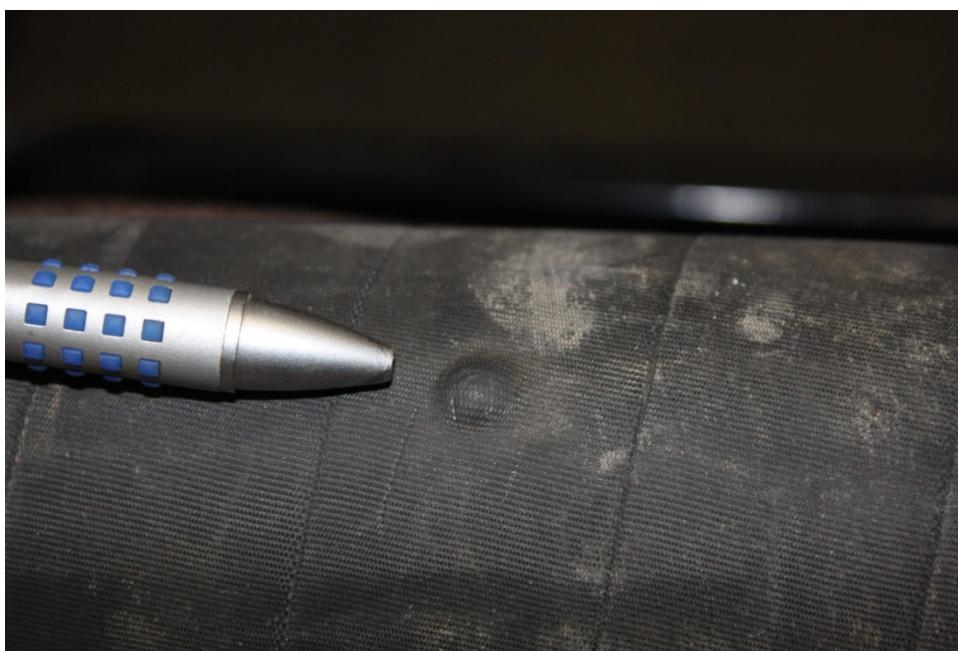
Gas (or liquid) permeation and accumulation of gas in an already present cavity was most probably also the cause for the blister observed in the cover. The fact that this blister faded away over time indicates that gas permeation and expansion is an important reason for the visibility of such kind of failures. As soon as the gas volume is reduced again by permeation the blister is not visible anymore but the cavity between the cover/reinforcement is still present and may form a weak spot in the cover.

**Figure 2** Defect observed at the external side of the hose

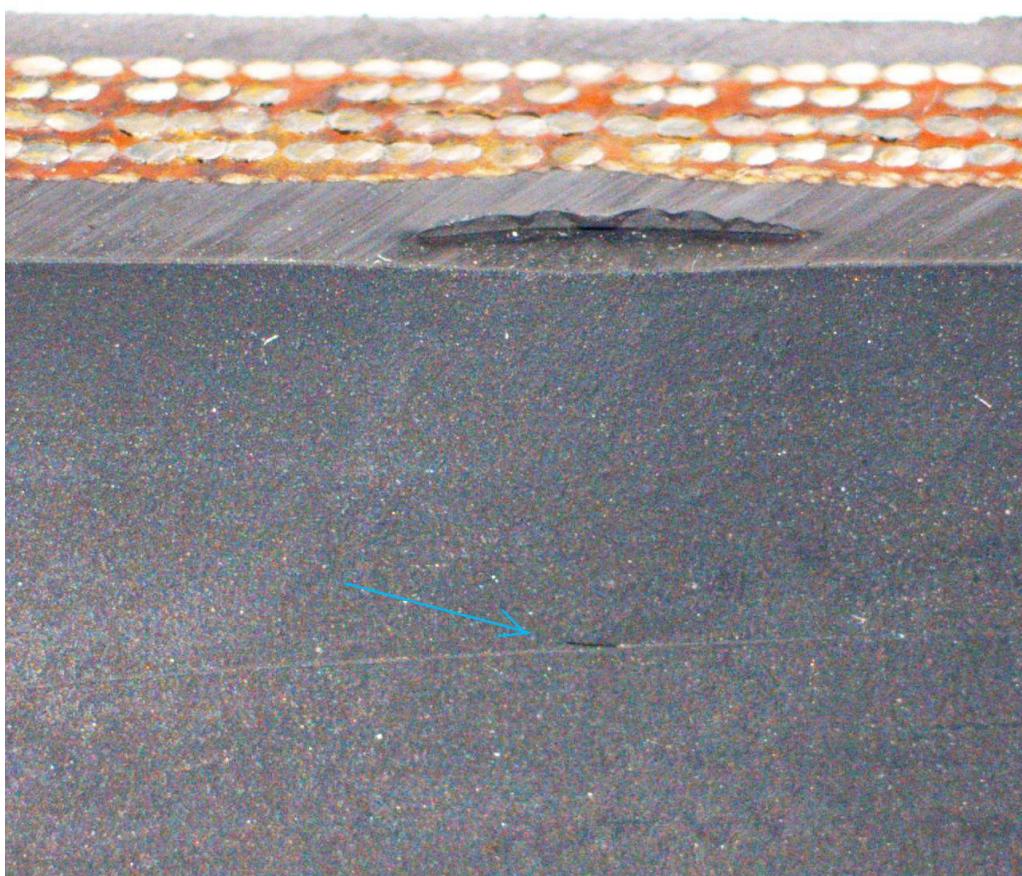
In the vicinity of the blister (distance about 400 mm) a 7 mm long slit is observed in the middle of the liner (Figure 6) that seems to have an internal connection to another tiny incision (1 mm) on the internal surface of the line (arrow).

One exception is the tiny slit observed in the liner in the vicinity of the cover blister. This slit could be caused by rapid gas expansion.

**Figure 6**  
*Defect in the liner, observed in the vicinity of the blister; the larger slit is obviously connected to a tiny incision on the internal surface of the liner*
