Failure investigation of GRVE caustic discharge line P-14049

Shell Nederland Chemie - Moerdijk

Amsterdam, October 2007

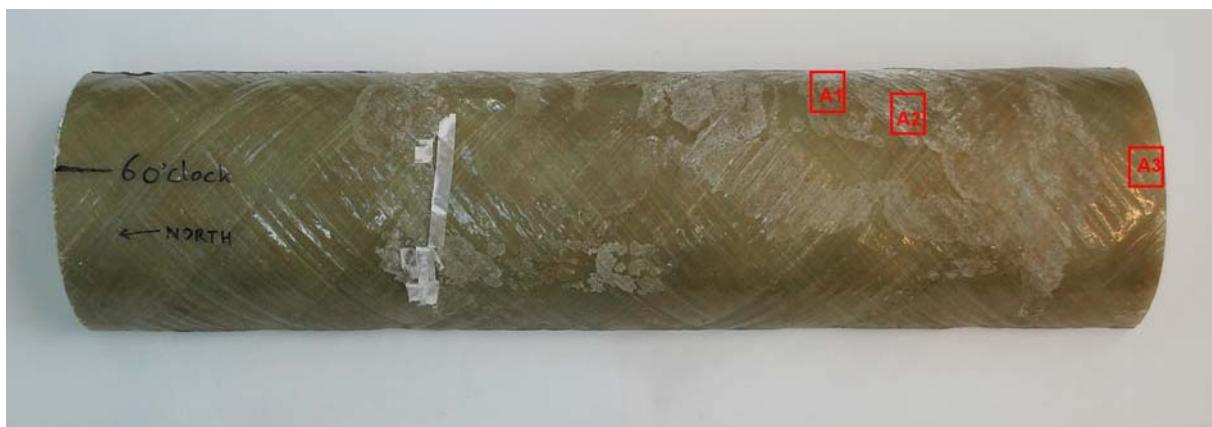
Figure 1 shows pipe section A, showing several light coloured areas, which can be easily wiped-off, and probably caused by spilled caustic. At Locations A1, A2, and A3, specimens have been taken for microscopic inspection. At Locations A1 and A2, areas of surface whitening are clearly visible. Position A3 was selected at a “clean” surface location.

Figure 1 Pipe Sample A, "6-o-clock" position, Location north of T860

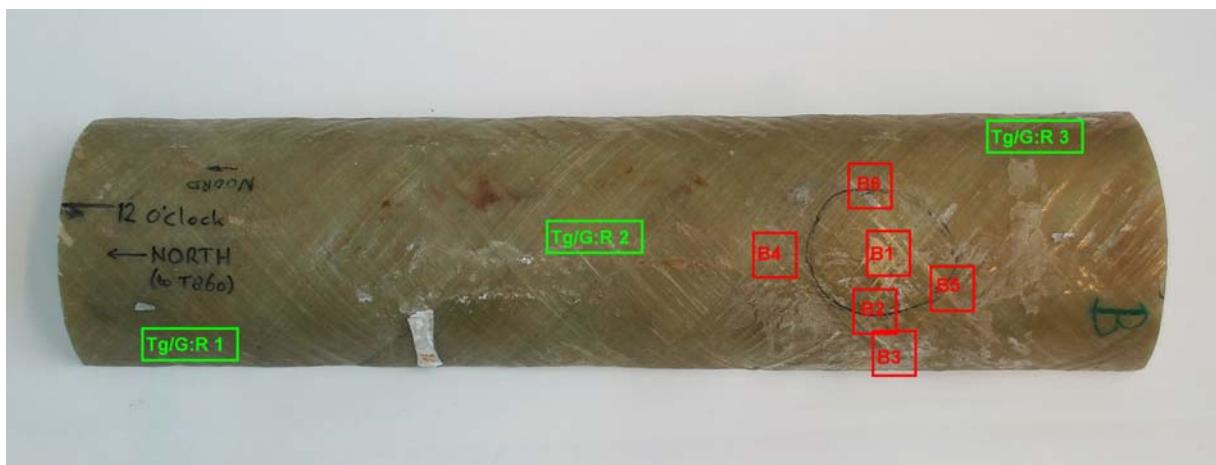
Figure 9 shows pipe section B. At Locations B1 to B6, specimens have been taken for microscopic inspection. At the Locations R1, R2, and R3 samples have been taken to determine the glass transition temperature (T_g) and the glass-fibre content (by mass), for the GRVE pipe material. At Location B1, where the leakage has occurred, a relative large “blister” (white area) is observed most probably caused by impact, see Figure 10.

Figure 9 Pipe sample B, "12-o-clock" (leak / blister) position, north of T860

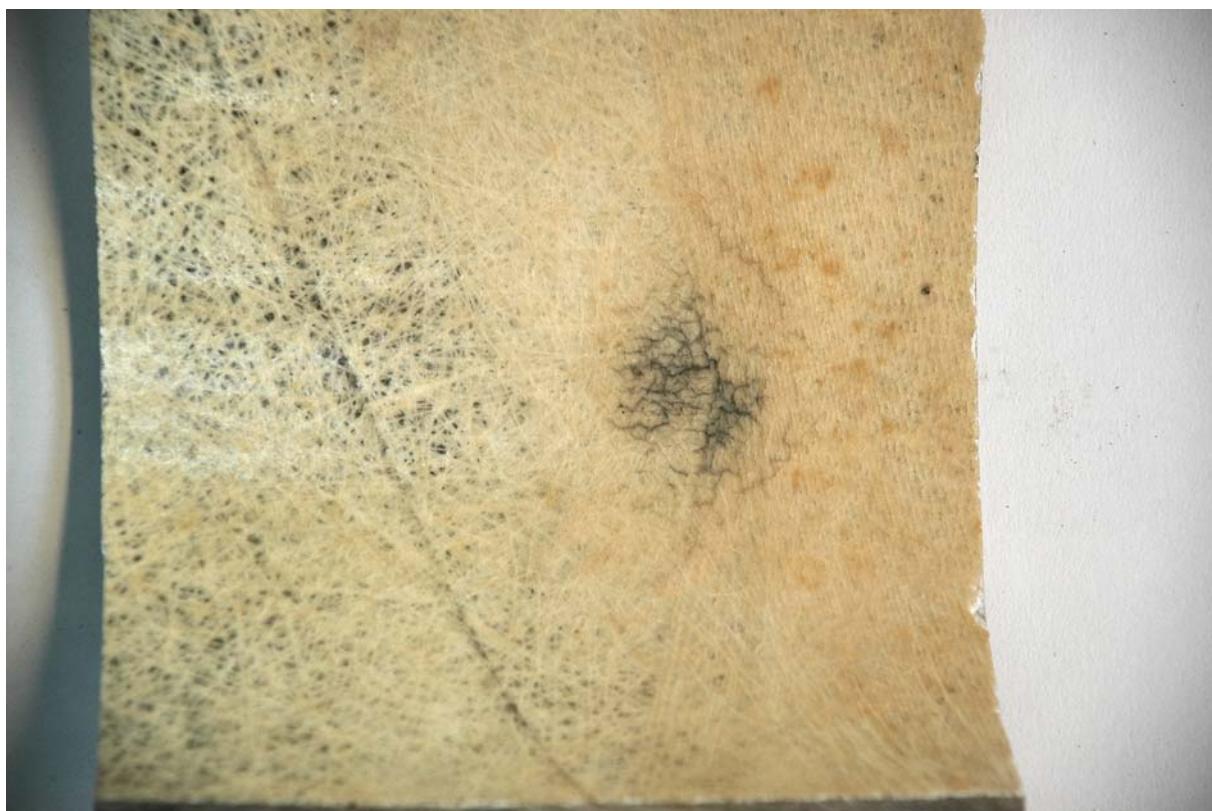
Figure 24 Pipe repair joint, location between tank T860 and road number 9
(after first 90° bend)

Figure 24 shows a section of the laminated repair joint, showing detail of the external, and internal (liner) surface. At Locations E1, E2, and E3, specimens have been taken for microscopic inspection. The internal pipe surface (liner) shows a dark coloured “crazing type” pattern, similar as observed for the pipe section A and B.

(a) External surface of repair joint; showing locations of samples taken

(b) Internal surface of repair joint, showing local "crazing type" pattern
