Investigation of GRP Caustic discharge pipe

Shell Nederland Chemie – Moerdijk

GS.05.50579

P.J.M. van Loon

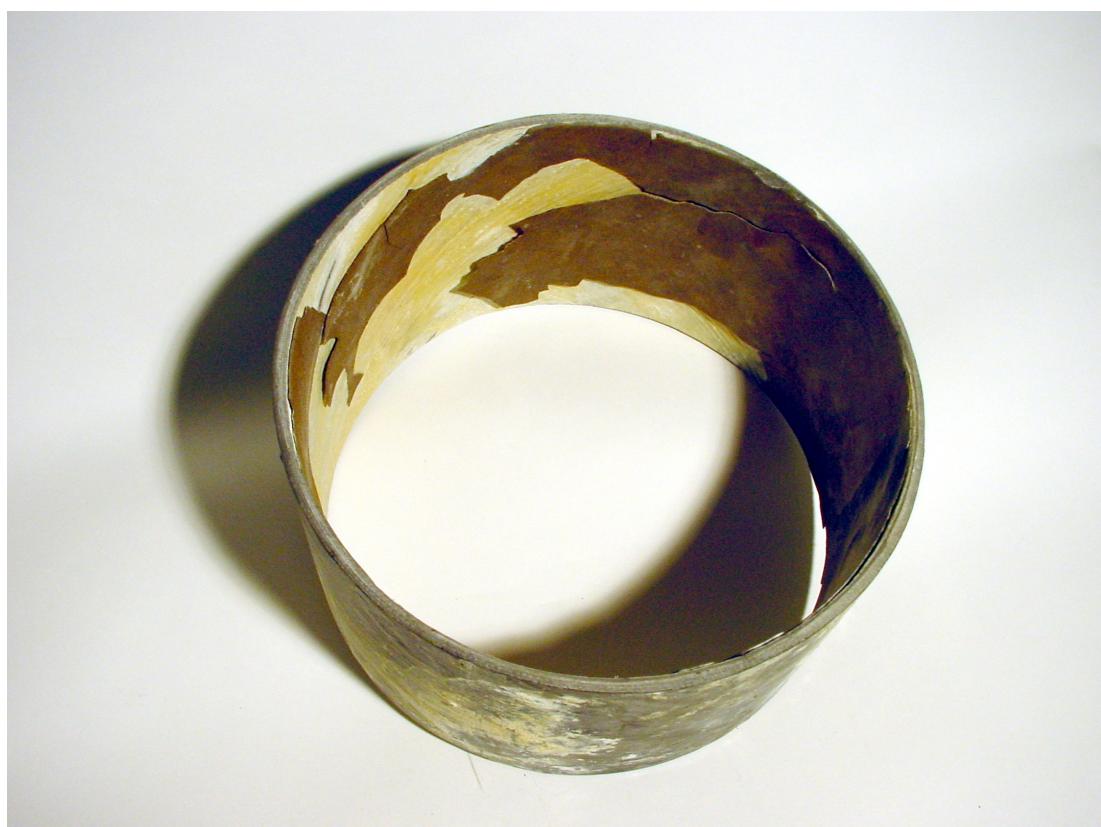
The GRE pipe sample, showing significant damage of the internal liner, is shown in Figure 1.

Figure 1 Degraded internal surface of GRE pipe sample, showing "loose" liner

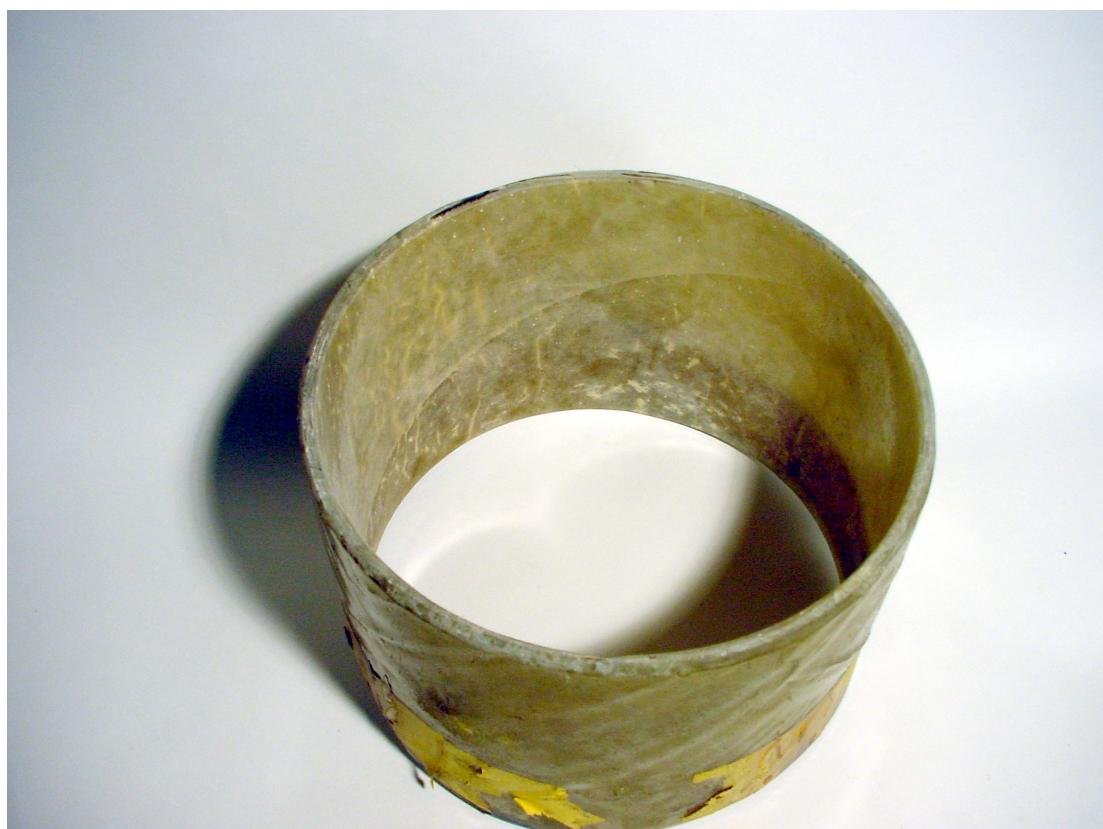
The GRVE pipe sample, showing the intact pipe, including liner, is shown in Figure 6.

Figure 6 Intact GRVE pipe sample
