Lifetime qualification of mechanical
clamp repairs

D. Ritchie and F.A.H. Janssen

Amsterdam, December 2006

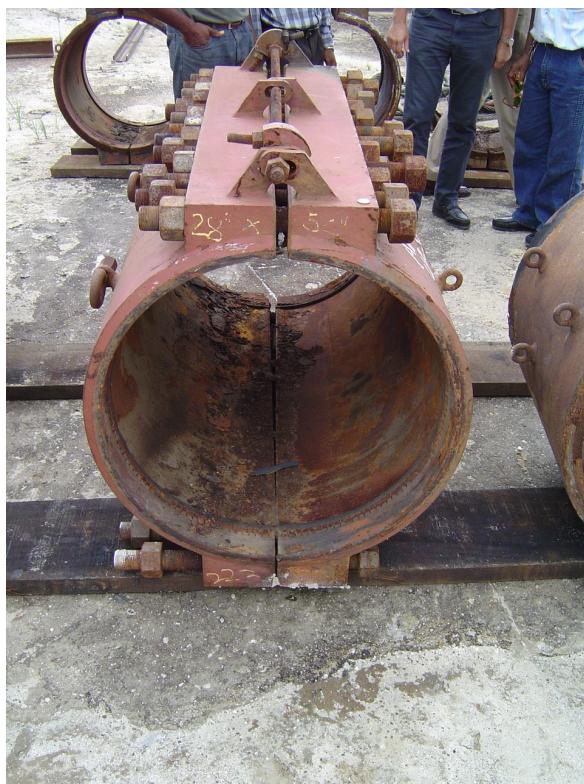
The visual inspection of the clamps showed that there was some general corrosion but in general the clamps appeared to be fit for purpose. Pictures of the retrieved clamps are given in Appendix 2. Only the girder band material was cause for concern i.e. it had corroded to a great extend.

Plidco however indicated that the girder bands are more an installation aid and do not have an actual function after installation, as such their degradation is assumed not to effect the integrity of the clamp.

Figure 2-1 Detail of Steel radial girder band (corroded) and radial seal

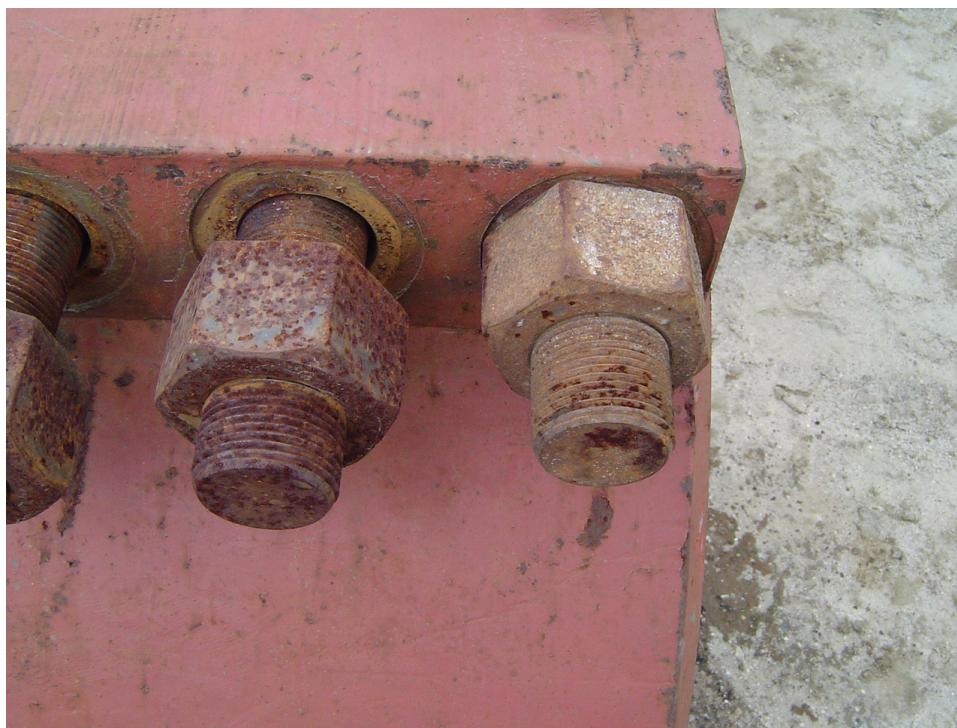
Figure 2-2 Detail of bolts and nuts

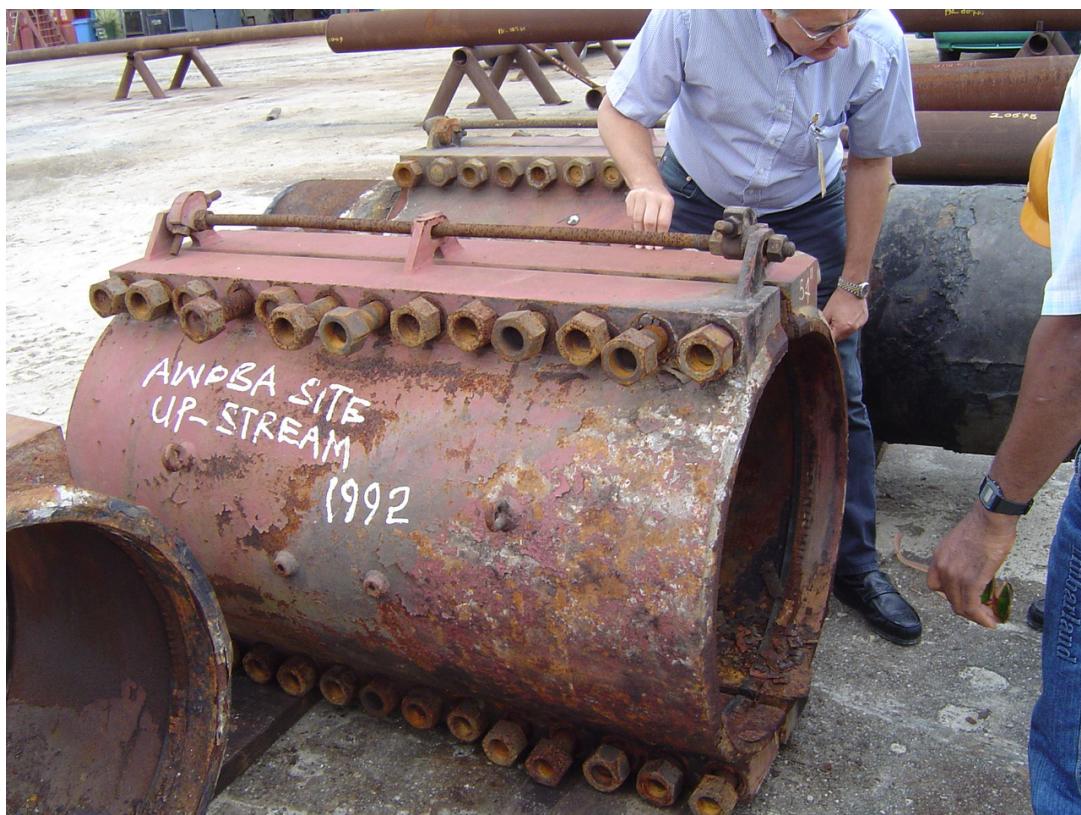
Figure 2-5

Awoba Site Upstream 1992, it is assumed that 1992 refers to the year of installation.

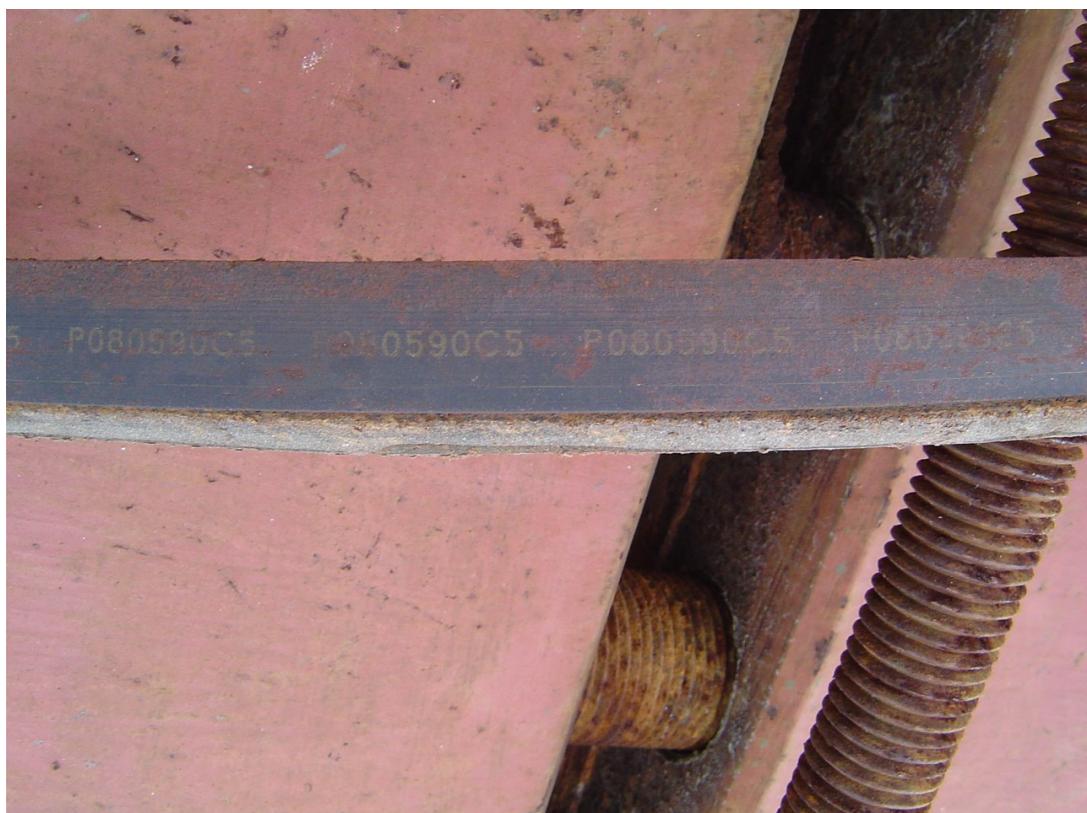
Figure 2-6 Removal of radial seal

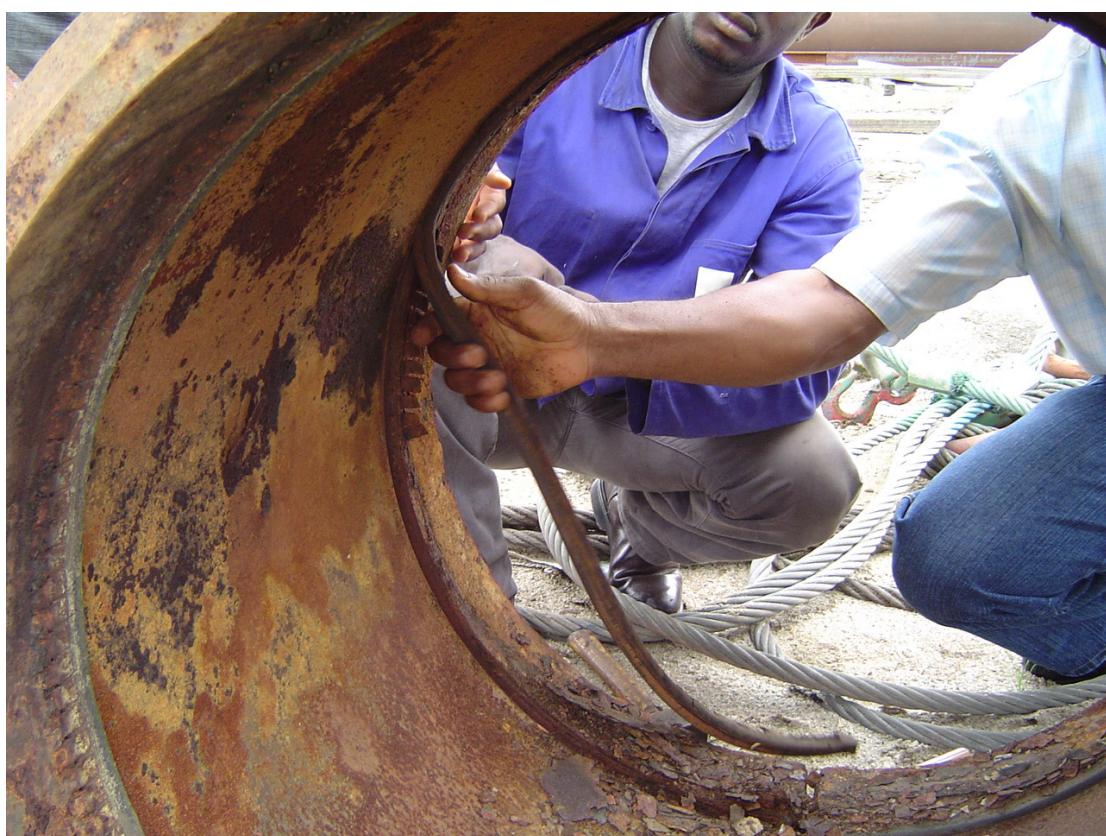
Figure 2-10

Degraded sealing material applied to prevent moisture/water ingress towards radial girder bands and seals

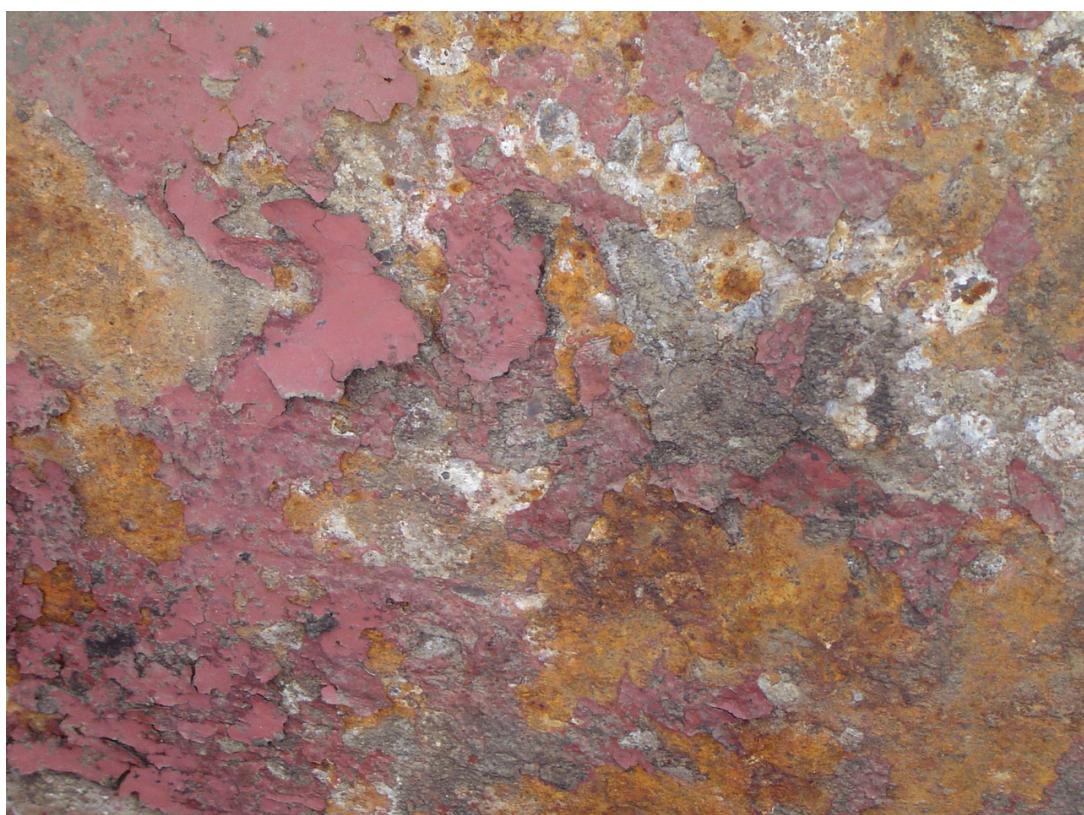
Figure 2-12 Detail of degraded clamp coating of new Calabar Site Clamp 1999

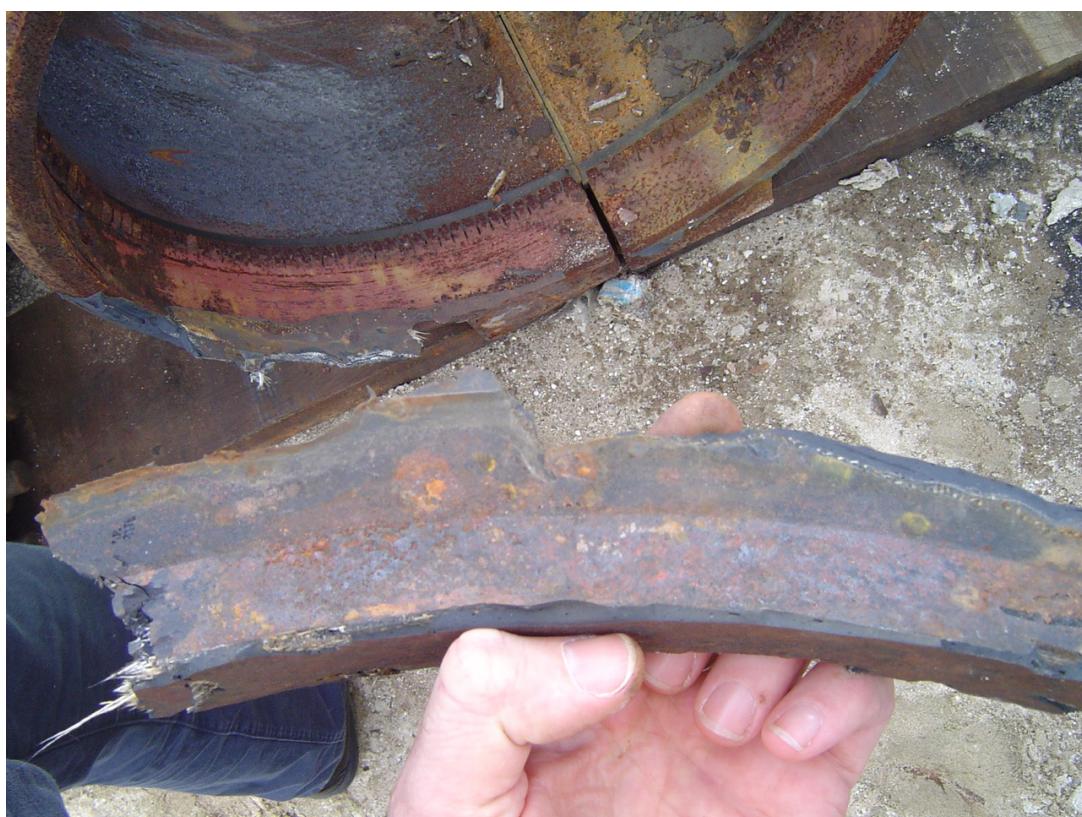
Figure 2-16

Fragment of sealing material used to prevent moisture and water ingress towards girder bands and seals.

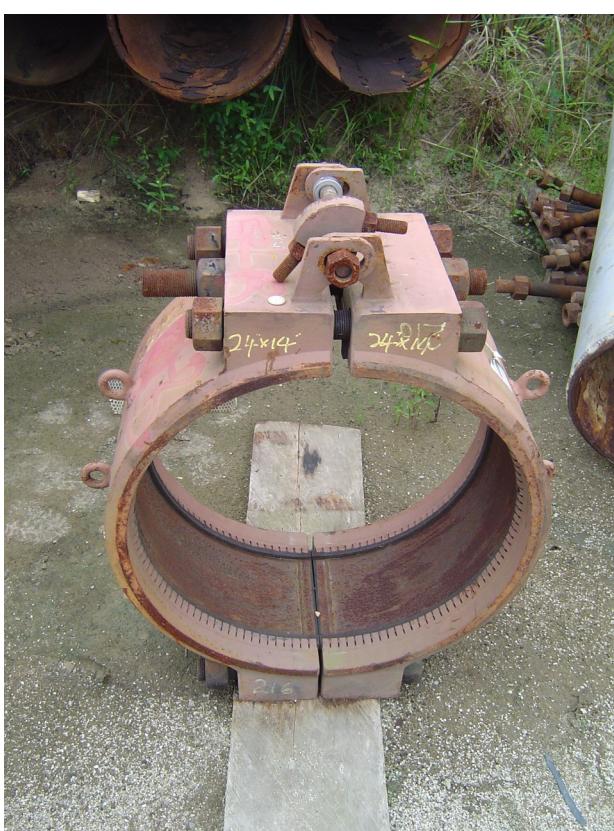
Figure 2-17 Unused Weld + Ends Coupling in outdoor storage.
