Republic of the Philippines **Tourism Infrastructure & Enterprise Zone Authority**

MEMORANDUM

ERODED SEAWALL

06 MAY 2021

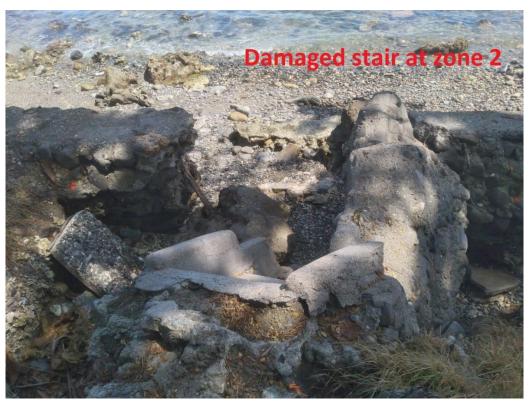
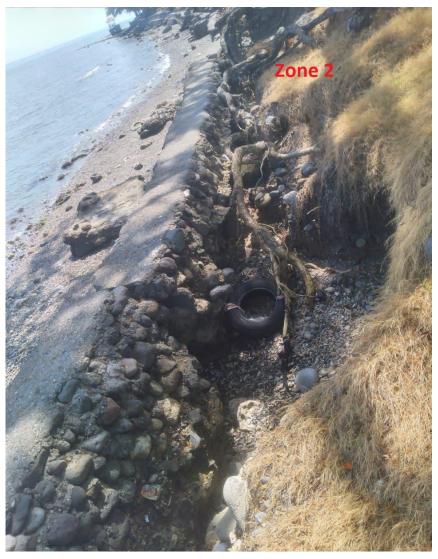
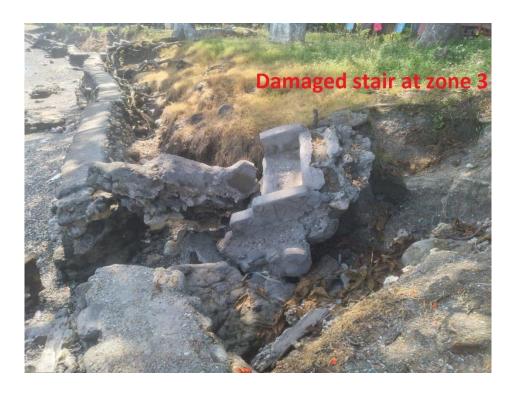
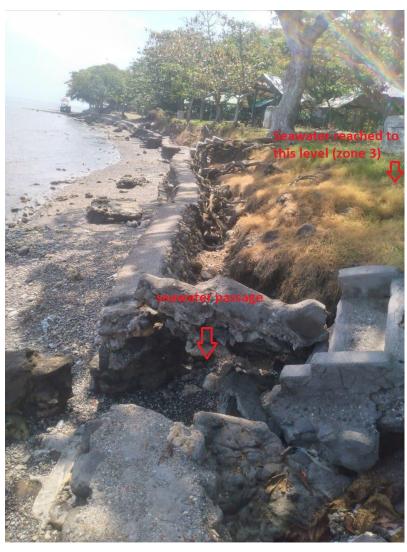
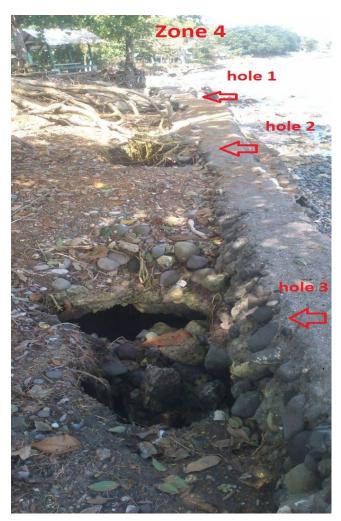
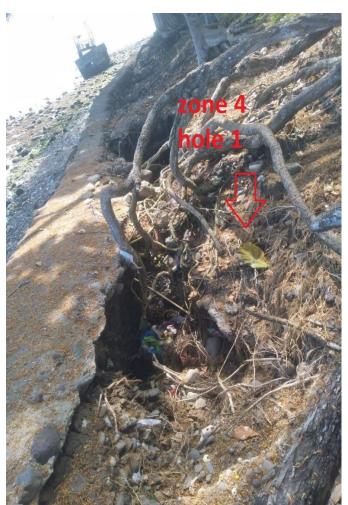
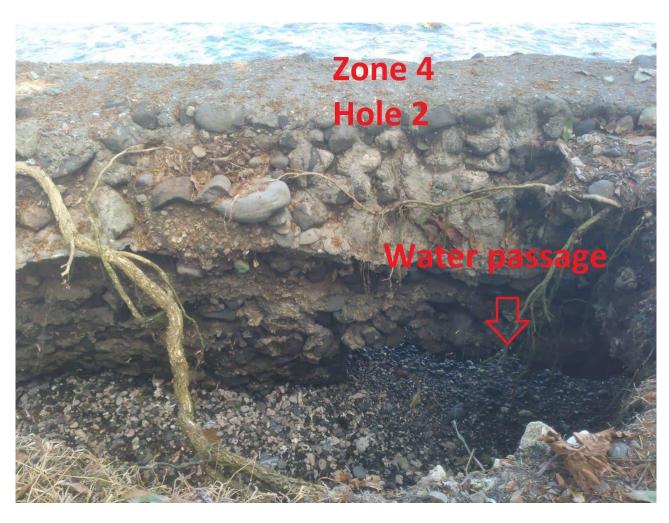
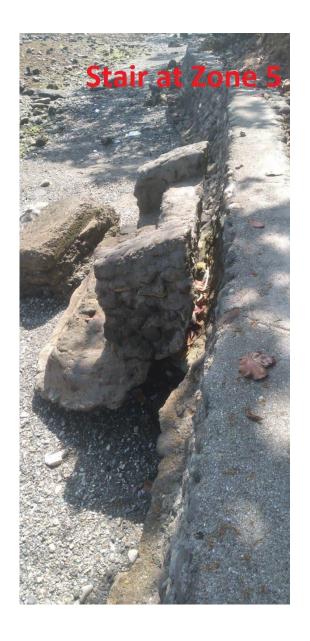
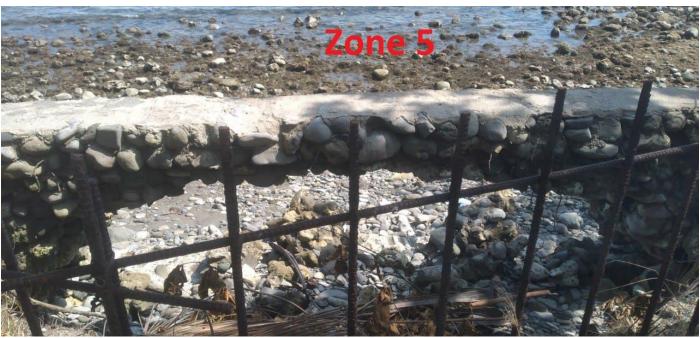
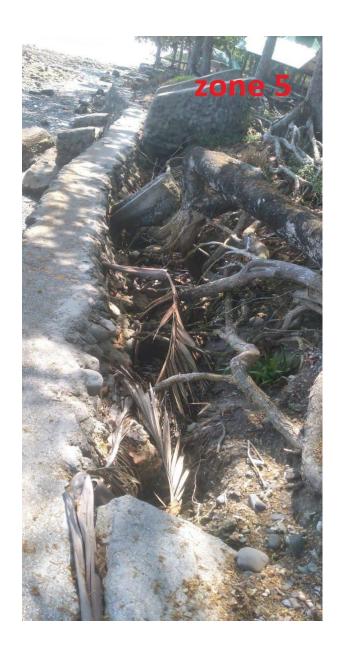
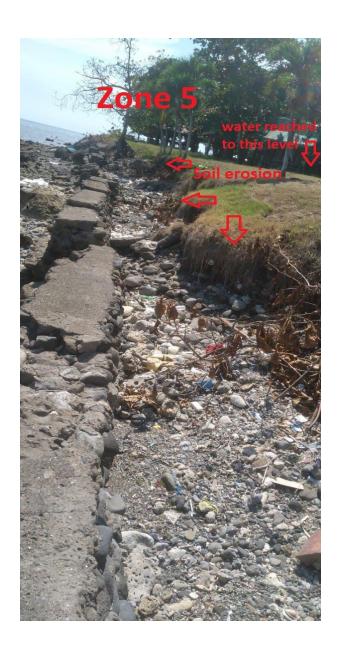
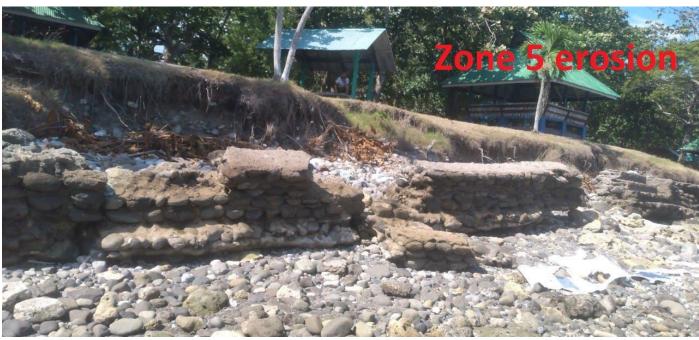
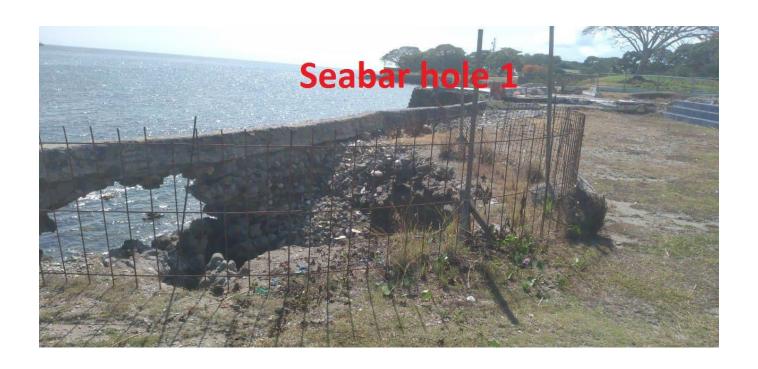
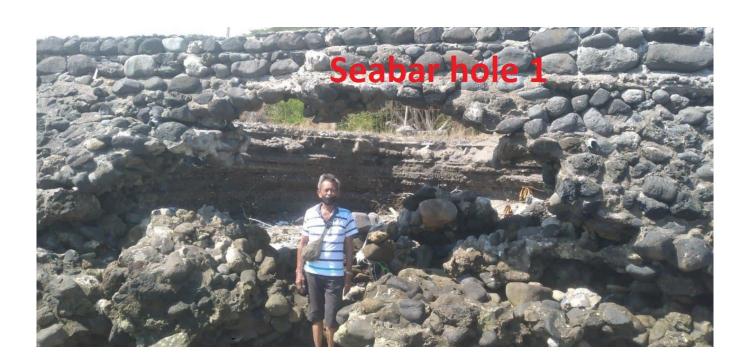
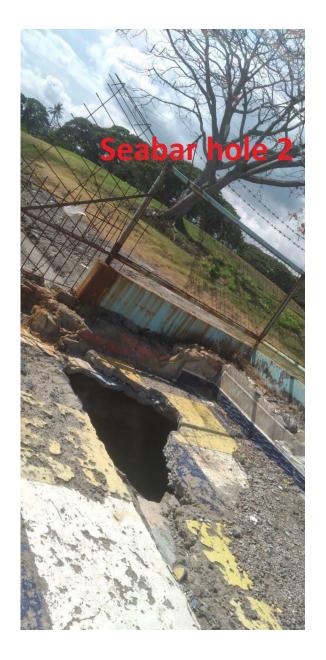
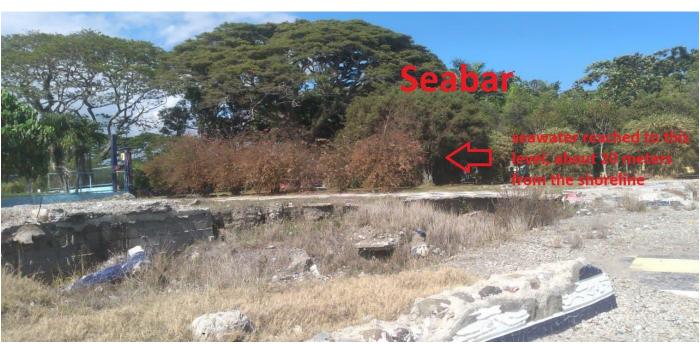
Seawall from zone 2 to zone 5, seabar and at whole 12 are already ruined due to often surge. Seawater reached as far as about twenty (20) meters from shoreline. The water exceeded the seawall which cause for the erosion of soil beside the seawall.

Attached herewith are pictures of the seawall taken last 29 April 2021 after a week of high tide and strong wave.

We would like to reiterate request to fast track processing of the repair or construction of seawall at our Zamboanga Beach Park. The current status of the seawall is really alarming.
