Record Details

Transformer No	TX-0002
Pole No	EN-102
Region	Kandy
Type	Bulk
Capacity (KVA)	1000
Location	Market Square
Inspection Number	20005
Inspection Date	202595

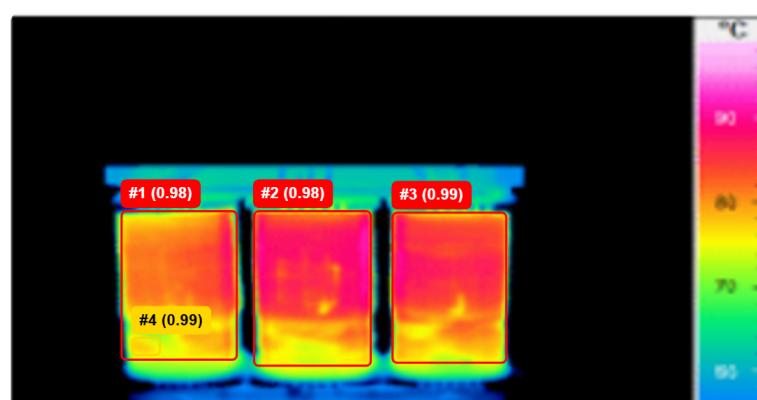
Type	Category	Location (x,y,w,h)	Severity / Confidence	Source	Details
Point Overload (Faulty)	point_overload	73, 132, 78, 100	Faulty / 0.98	AI detected	
Point Overload (Faulty)	point_overload	161, 132, 79, 104	Faulty / 0.98	AI detected	
Point Overload (Faulty)	point_overload	253, 133, 77, 101	Faulty / 0.99	AI detected	
Point Overload (Potentially Faulty)	point_overload	80, 216, 20, 13	Potentially Faulty / 0.99	AI detected

Inspector	Suren G.B.
Status	Needs Maintenance
Voltage	251
Current	133
Recommended Action	Perform oil filtration, inspect LV bushing for surface tracking, and tighten secondary terminal lugs.
Additional Remarks	Slight humming noise detected under peak load. Oil color slightly dark; moisture presence suspected. No visible oil leaks.

Name	M. Jayawardena
Status	OK
Voltage	230
Current	118
Remarks	Noise level normalized. Insulation resistance improved after cleaning. Transformer operating within safe limits.
