## SITE INSPECTION REPORT

**KingEdward Village 2**  
**4028 Knight Street**  
**Vancouver, V5N 5Y8**  
**c/o Rancho Property Management**  
**8<sup>th</sup> Floor – 1125 Howe Street**  
**Vancouver, BC, V6Z 2K8**

Source of Damages Caused:	Water Damage	Common area hallway from the 16th floor - leaking copper pipe that was on the hot water re circ line burst
Date & time call received:	03/30/2024	
Purpose:	Mitigate Damages	
Date and Time of Site Visit:	03/31/2024 – 04/12/2024, 04/17/24-04/19/24

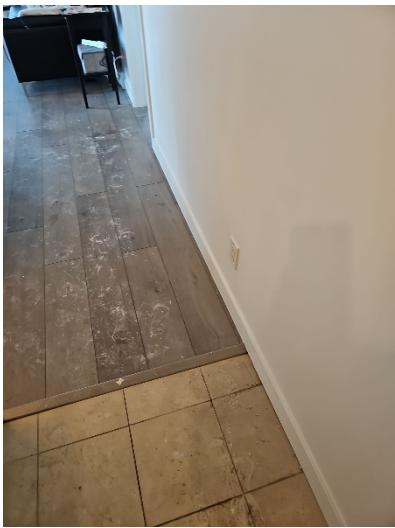
Unit 1602 – Hallway- floors damaged

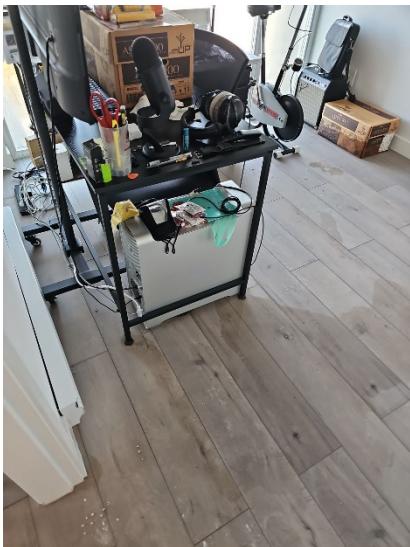
Unit 1602- Floors- damaged

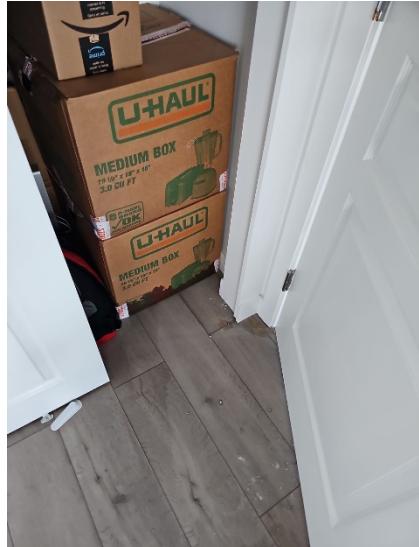
Unit 1602- storage closed floors damaged

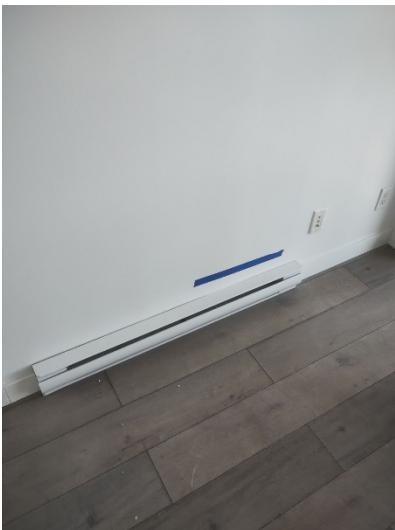
Unit 1602- Living room wall- marked to be opened

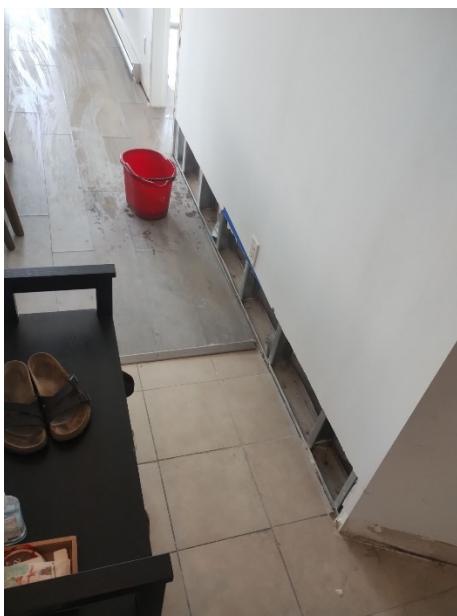
Unit 1602- Hallway wall-opened

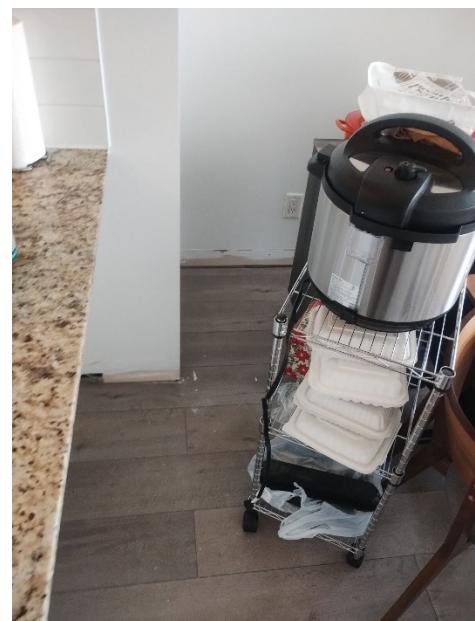
Unit 1602- Living room wall-made ventilation holes

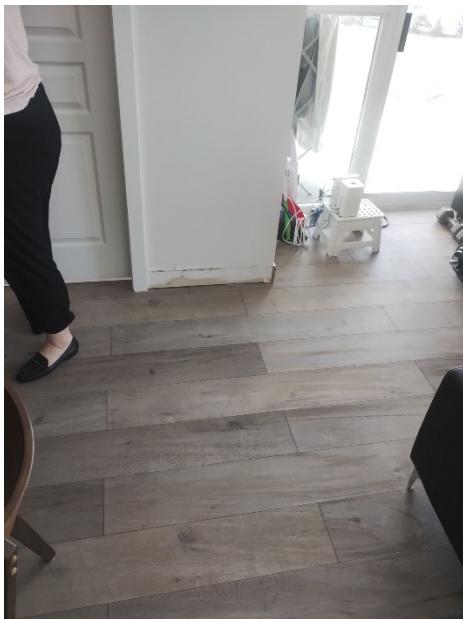
Unit 1602- living room- baseboards removed

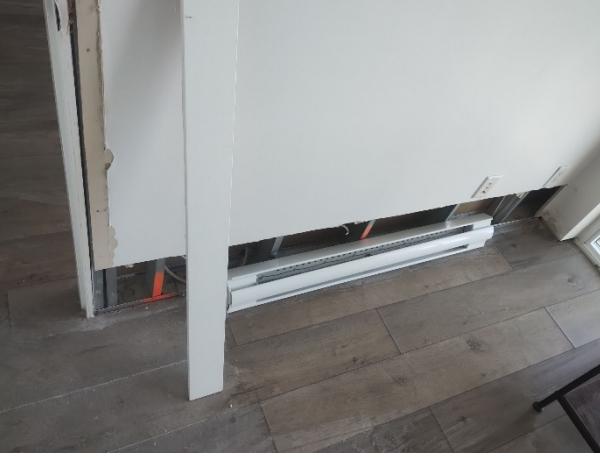
Unit 1602-living room wall opened

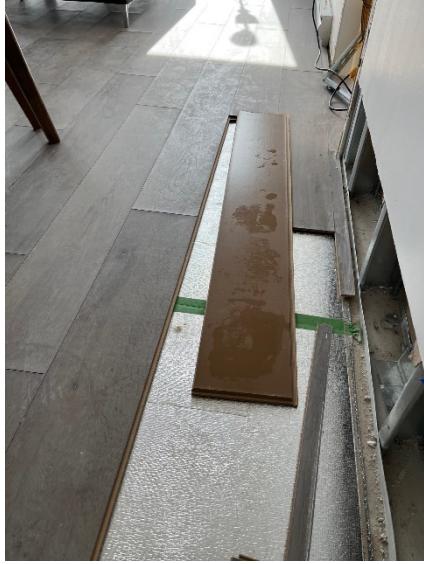
Unit 1602- Laminate floors with water damage

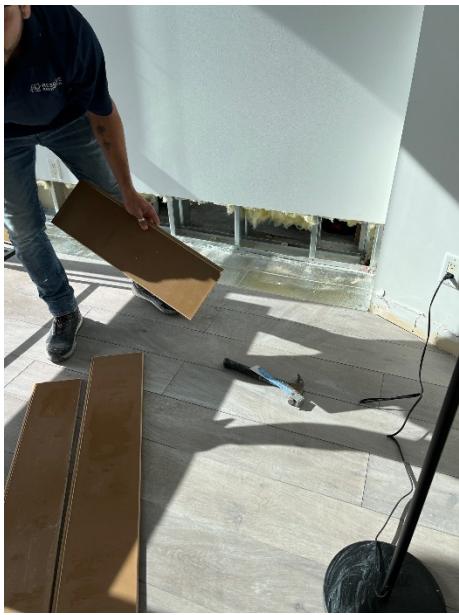
Unit 1602- Laminate floors damaged

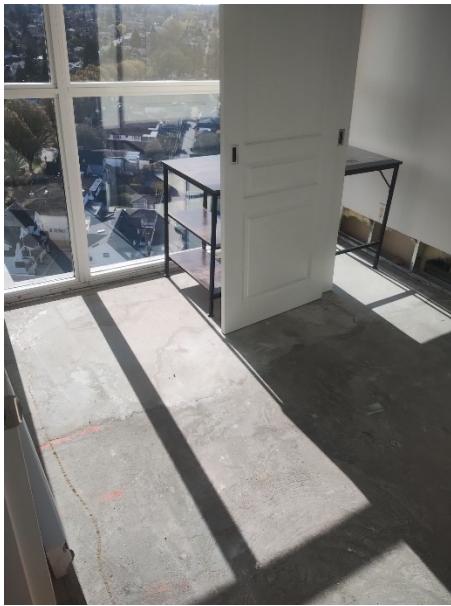
**Unit 1602- Spare bedroom- floors removed**

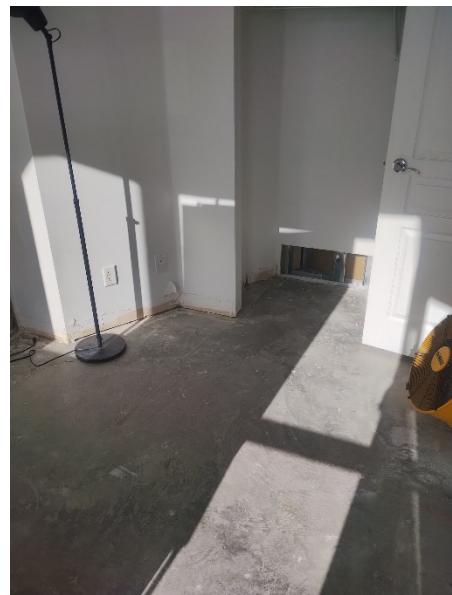
**Unit 1602- Spare bedroom- different view**

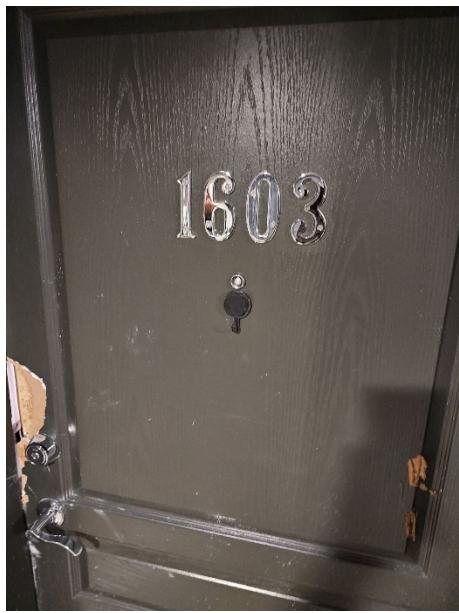
**Unit 1603- Door damaged**

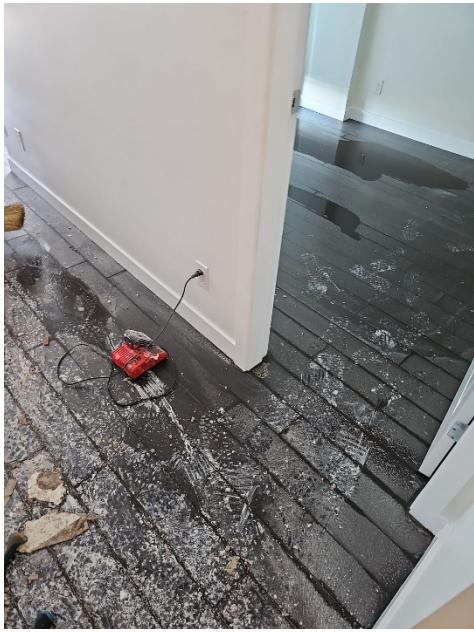
**Unit 1603- Hallway/Living- floors wet**

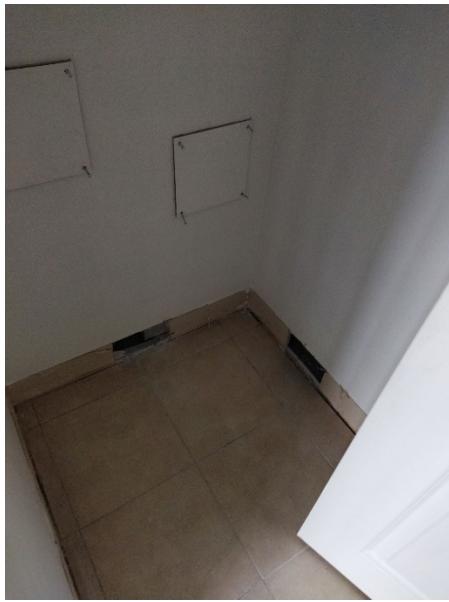
**Unit 1603-Main closet a- ventilation holes made**

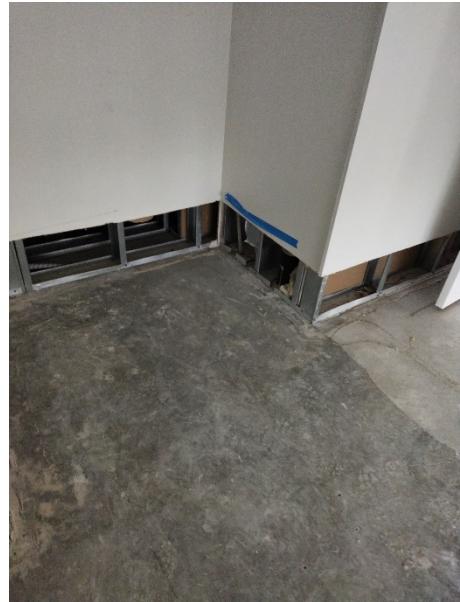
**Unit 1603-Living room- walls opened**

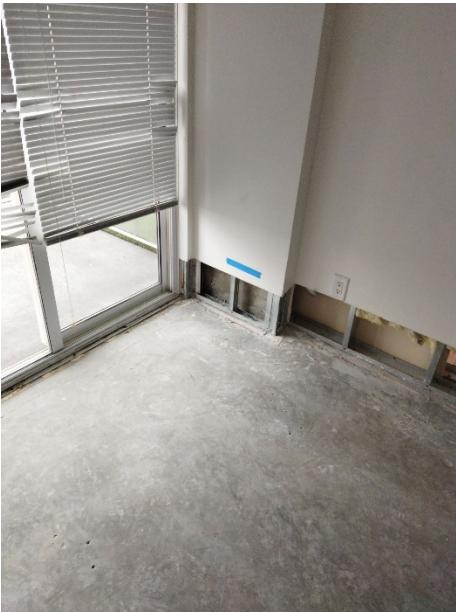
**Unit 1603-living room walls and floors removed**

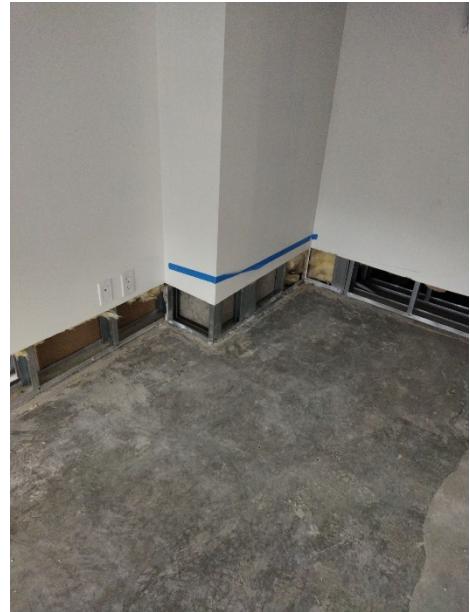
**Unit 1603- Bedroom- floors and drywall removed**

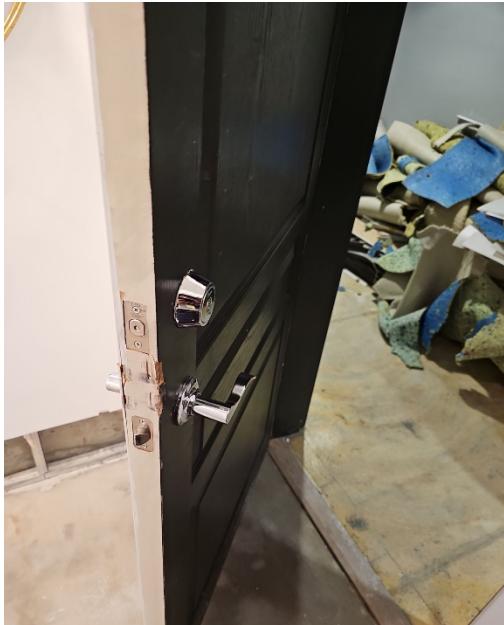
**Unit 1604- Main door damaged**

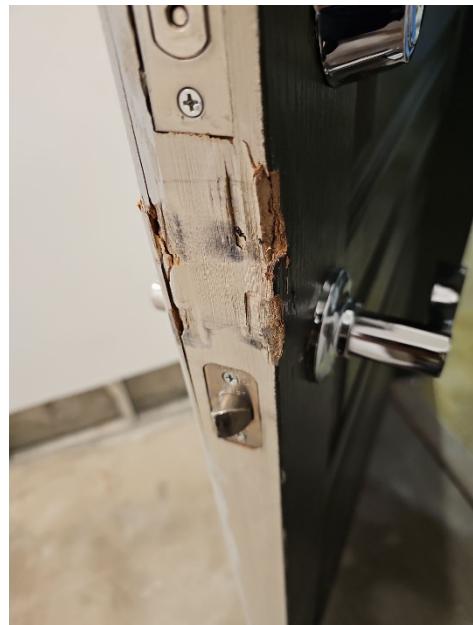
**Unit 1604-close up of main door damage**

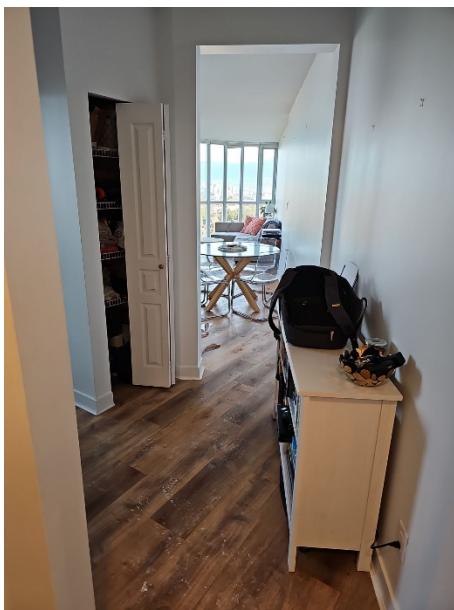
**Unit 1604- Main hallway- floor damaged**

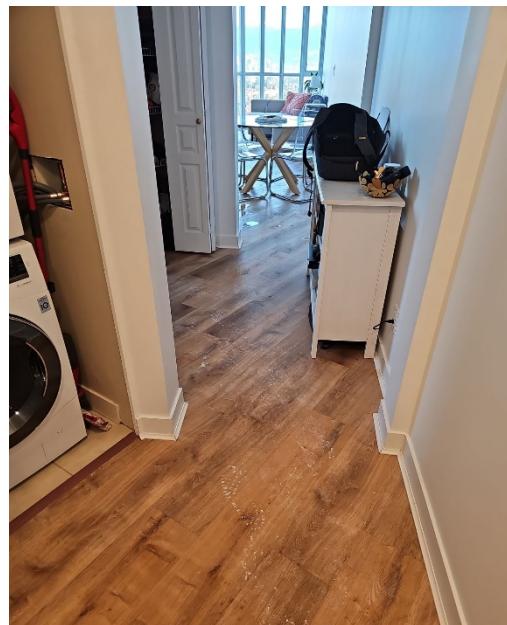
**Unit 1604- Hallway- Floors damaged**

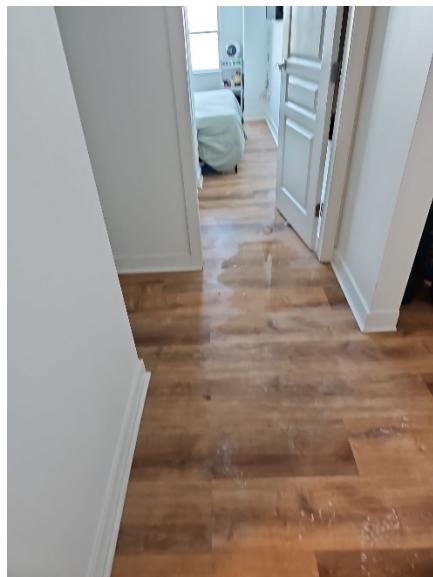
**Unit 1604- Hallway- leading to bedrooms**

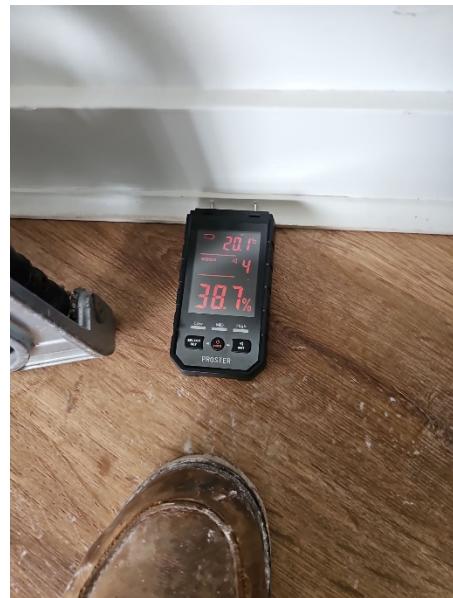
**Unit 1604-High moisture readings**

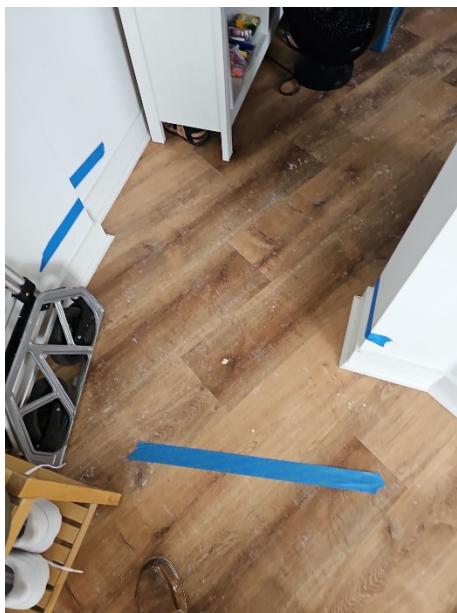
**Unit 1604- Areas marked for removal**

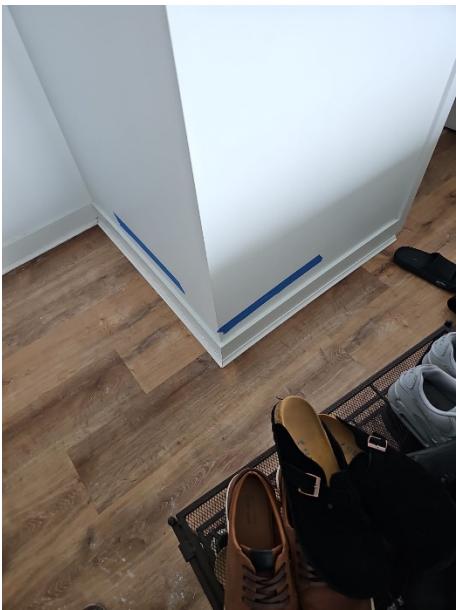
**Unit 1604-Hallway -Wall marked**

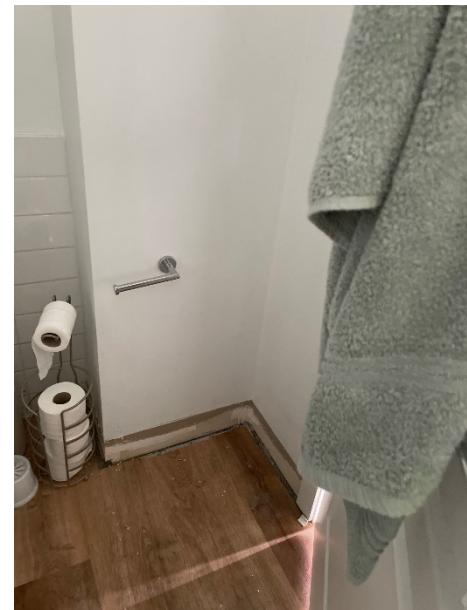
**Unit 1604- Bath room- baseboards removed**

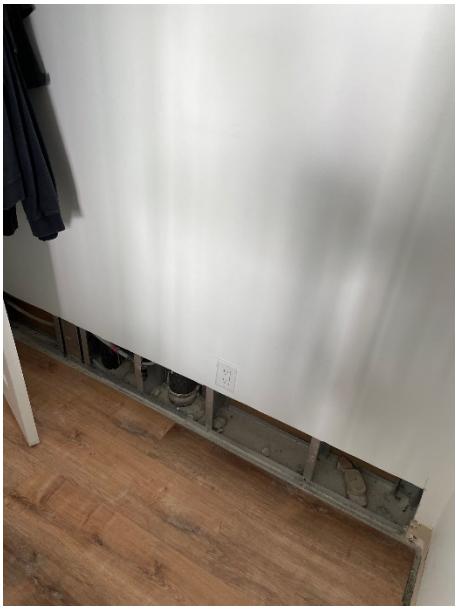
**Unit 1604- Master bedroom-Wall section opened**

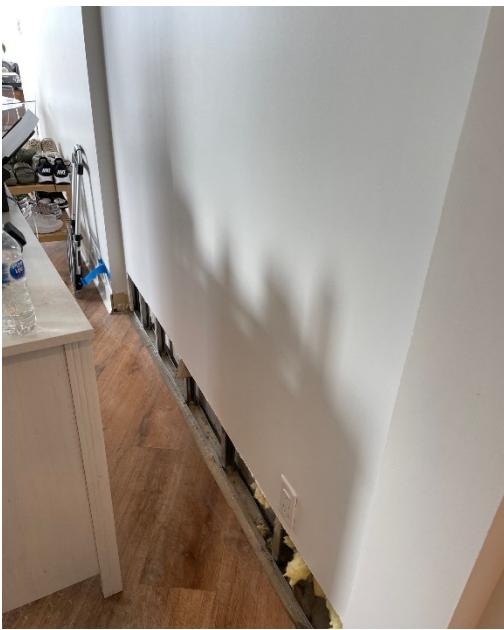
**Unit 1604- Hallway - Wall section opened**

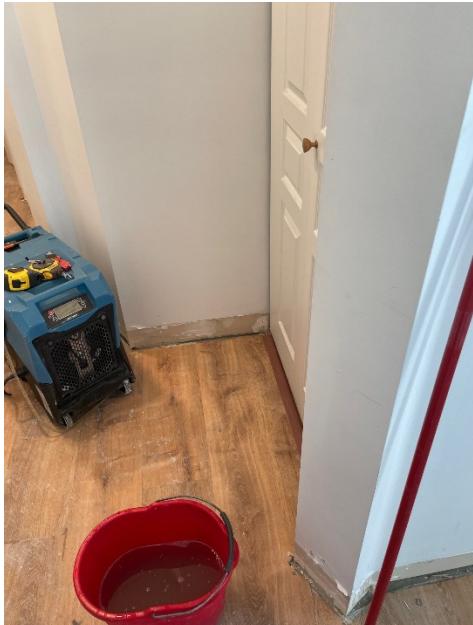
**Unit 1604-Hallway - Equipment setup**

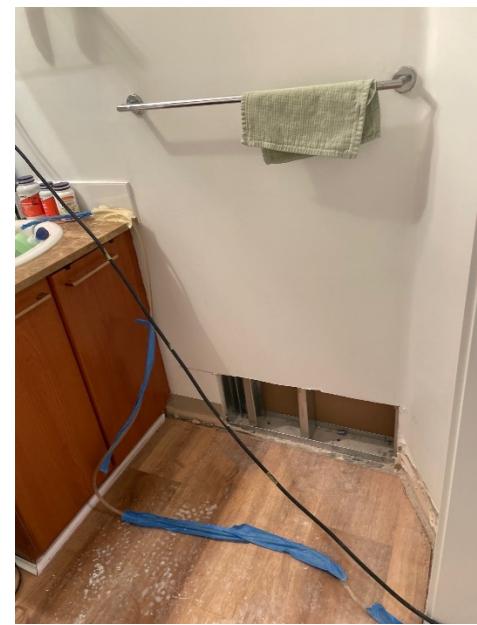
**Unit 1604- Second washroom- Wall opened**

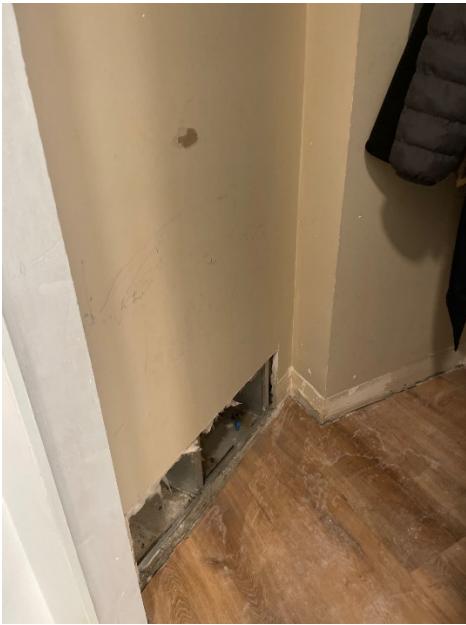
**Unit 1604- Main closet- walls opened**

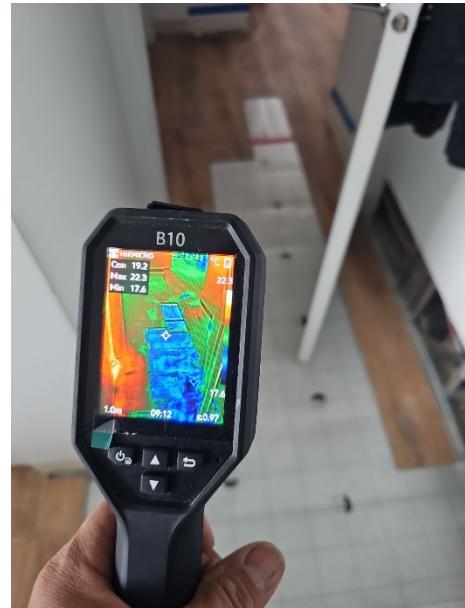
**Unit 1604- Hallway-moisture reading**

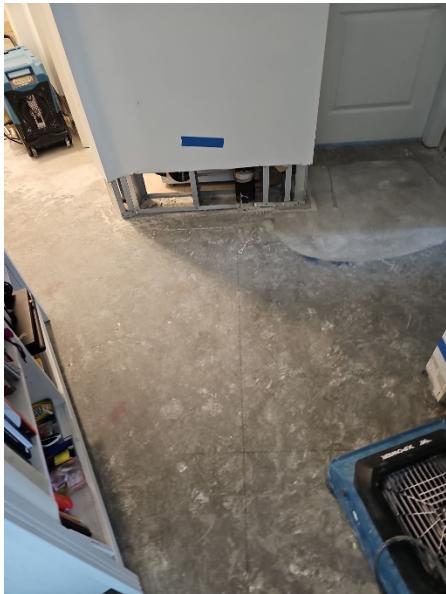
**Unit 1604- Hallway- Floors removed**

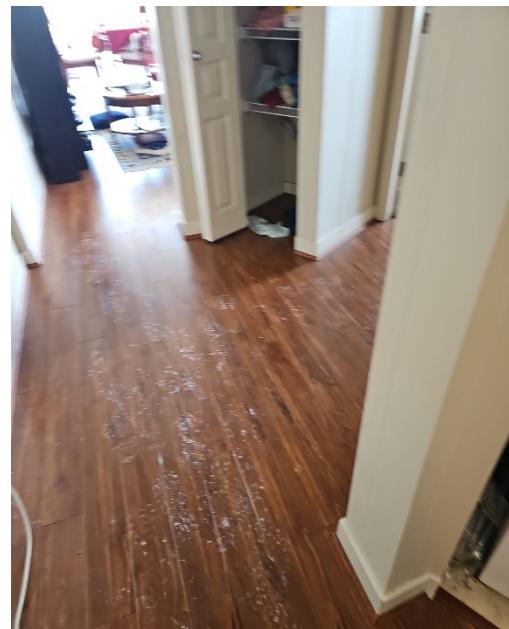
**Unit 1605- Hallway- Close up showing floors damaged**

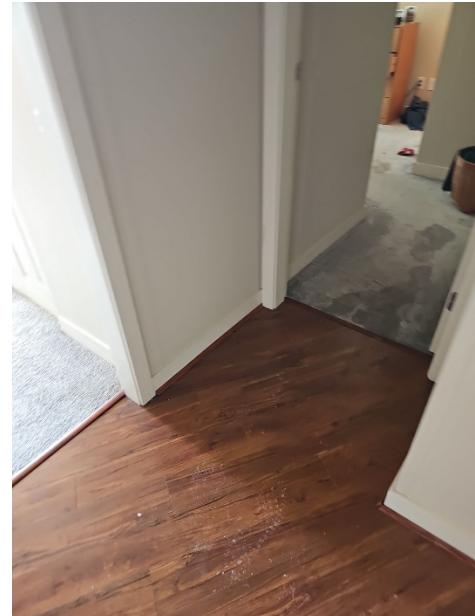
**Unit 1605- Main closet- Floors damaged**

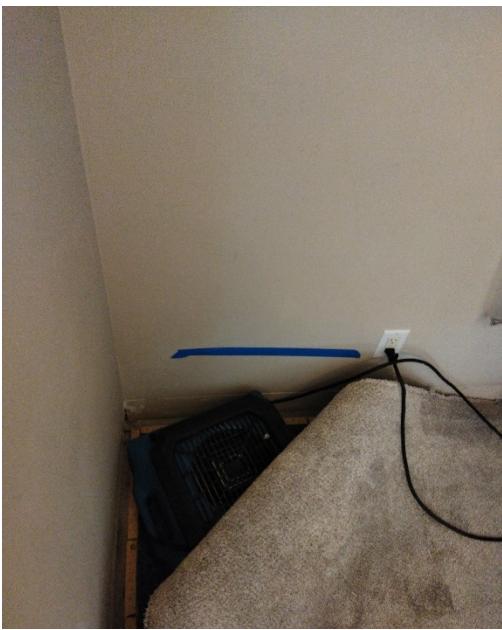
**Unit 1605- Engineering floors removed**

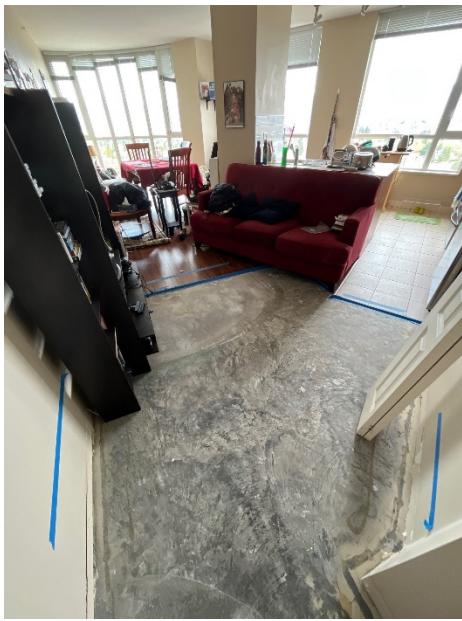
**Unit 1605- Floors damaged**

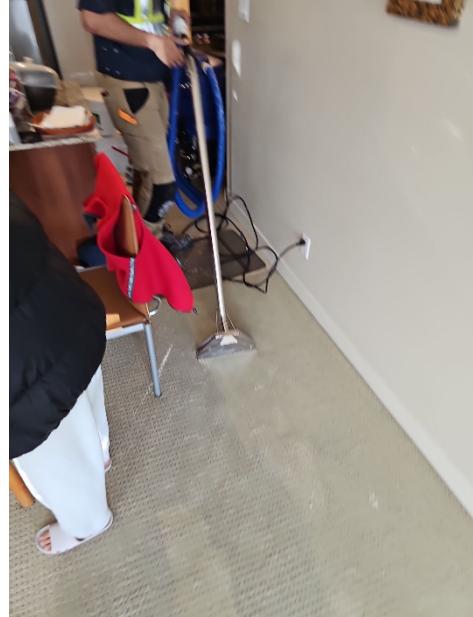
**Unit 1606- Living room- carpet-damaged and extracting**

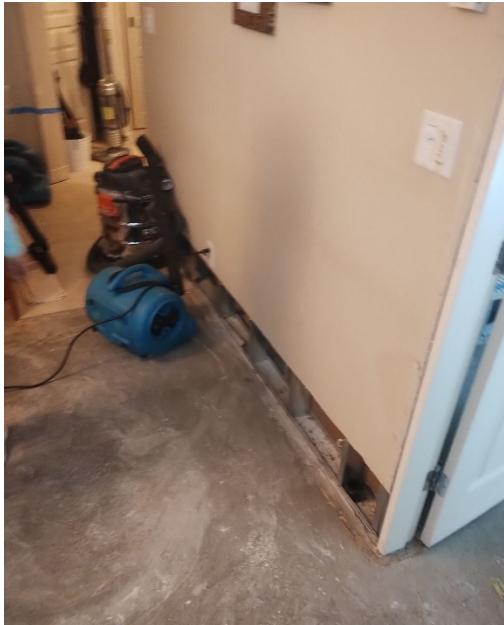
**Unit 1607- Living room- carpet damaged leading to bedroom**

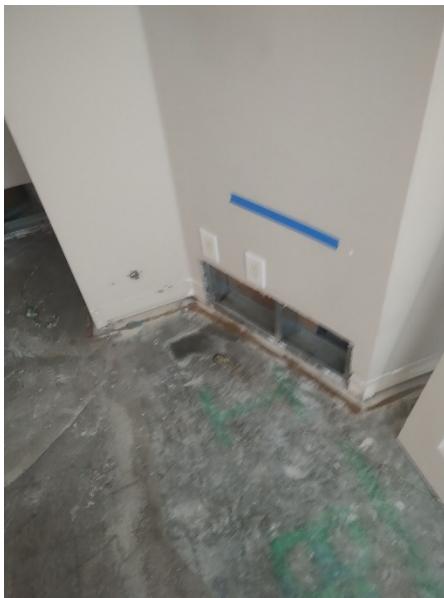
**Unit 1607-Living room- EQ being setup**

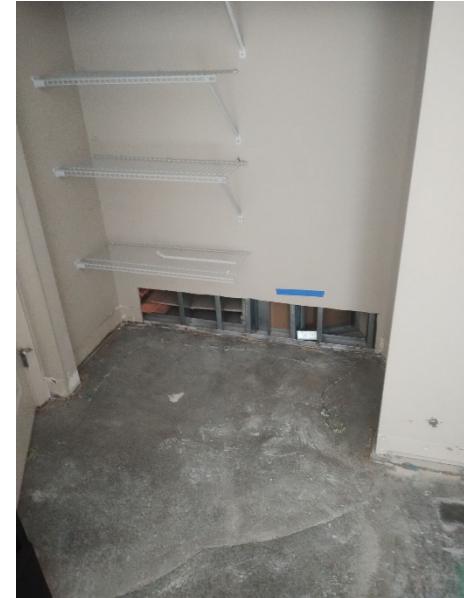
**Unit 1607- Spare bedroom- Carpet removed**

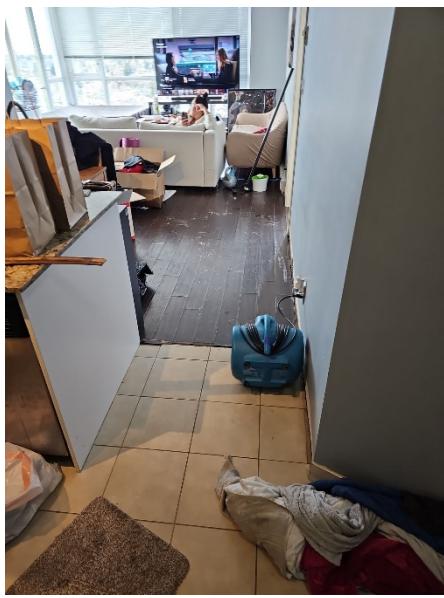
**Unit 1607-Livuing room carpet removed**

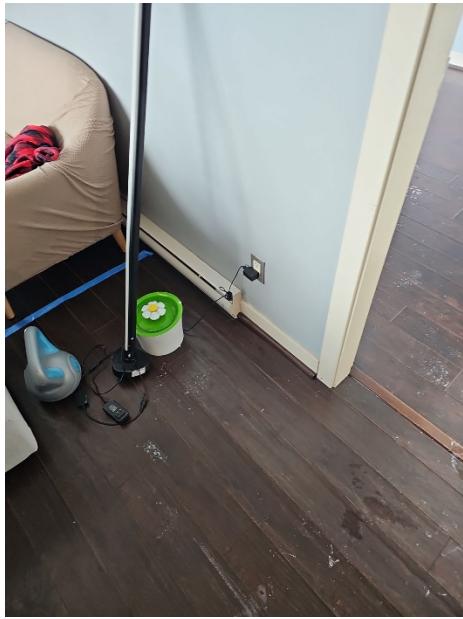
**Unit 1502- Living room- floors damaged**

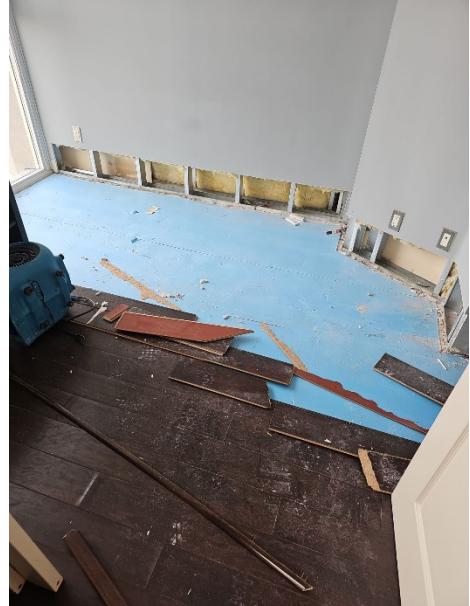
**Unit 1502- Moisture readings high in spare bedroom**

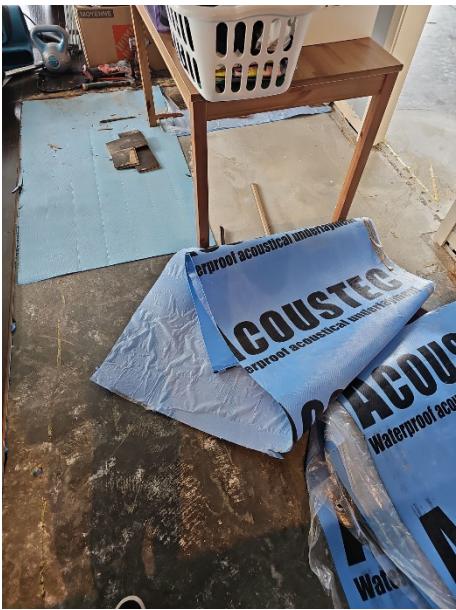
**Unit 1502-Spare bedroom- floors being removed**

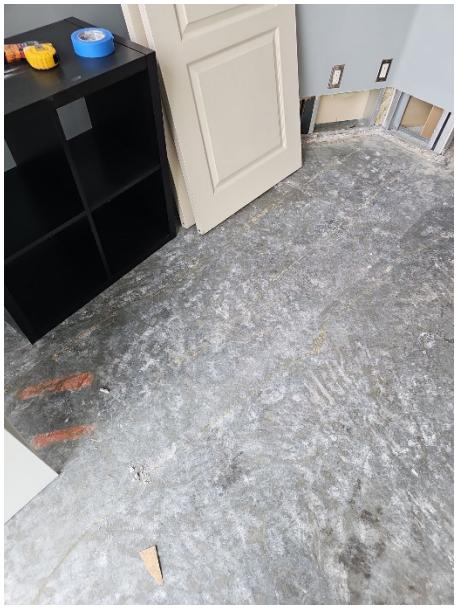
**Unit 1502- Living room- floors removed**

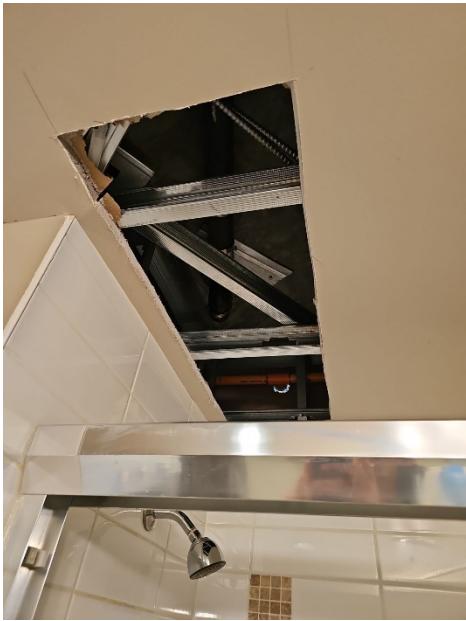
**Unit 1502- Washroom Ceiling readings**

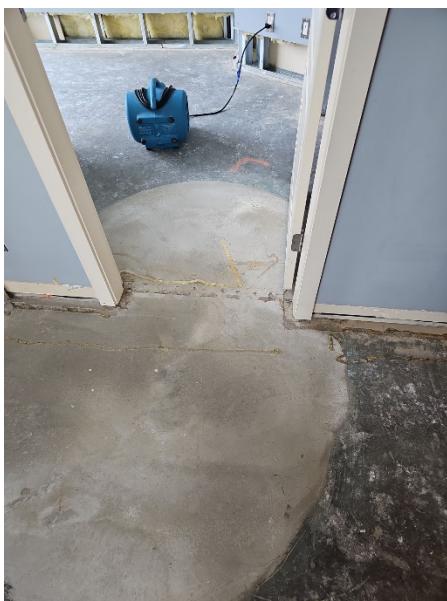
**Unit 1502- Hallway- floors removed**

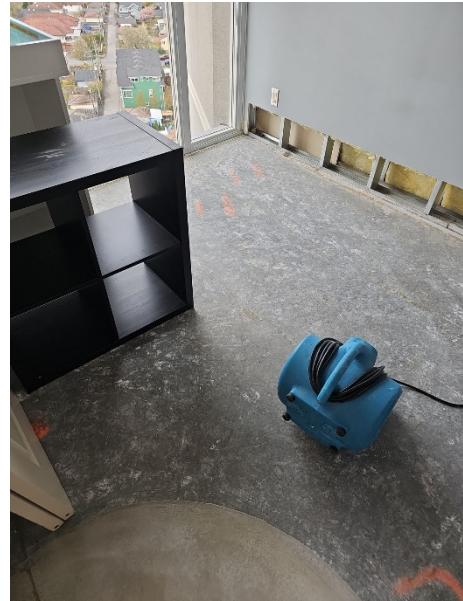
**Unit 1502- EQ setup to dry area**

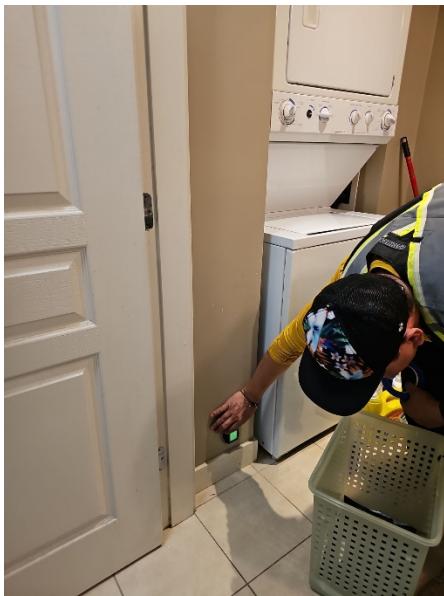
**Unit 1502 Sprae bedroom- EQ setup**

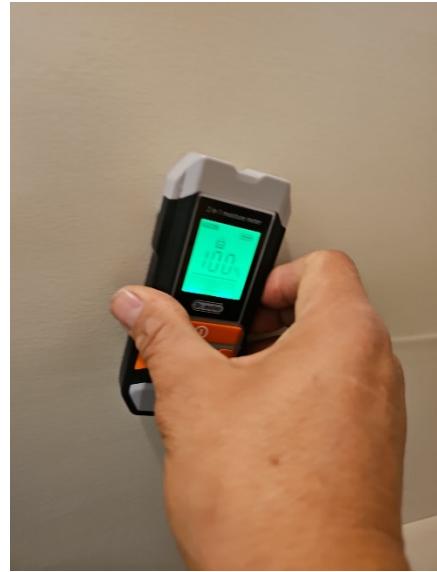
**Unit 1503- Washroom- Reading washroom area**

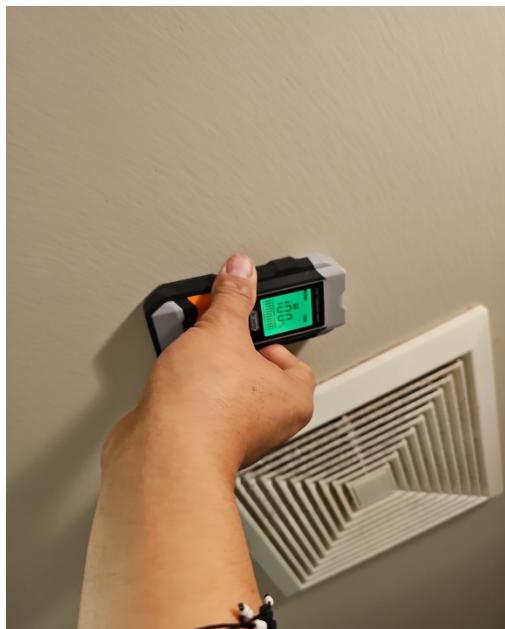
**Unit 1503- Washroom- high readings**

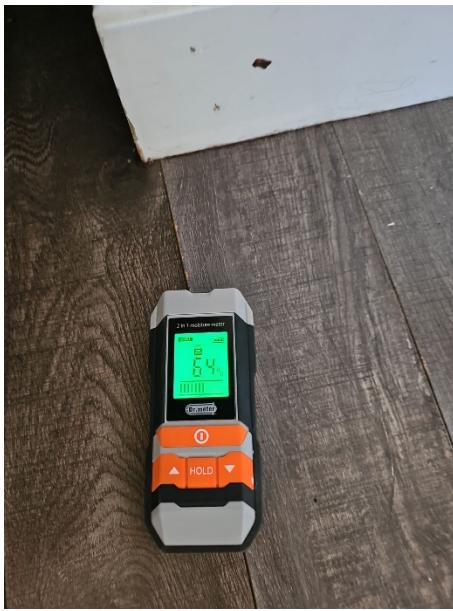
**Unit 1503- Living room- Wall marked to be removed**

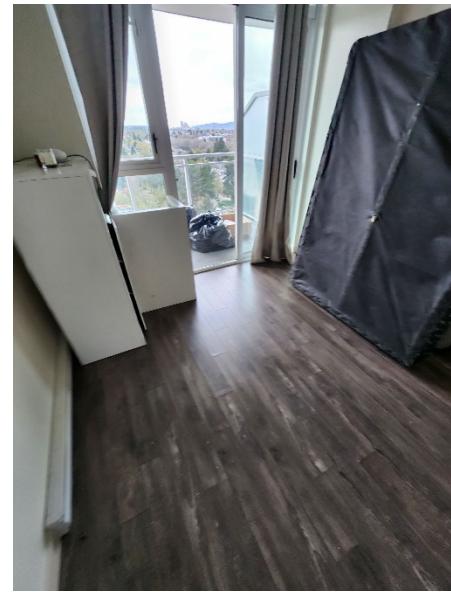
**Unit 1503- Floors marked to be removed**

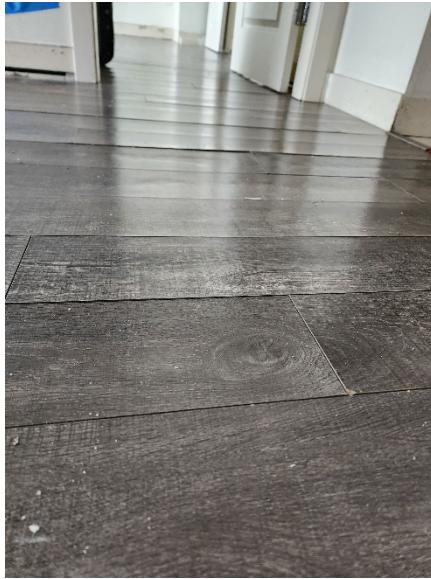
**Unit 1503- Bedroom- Floors damaged**

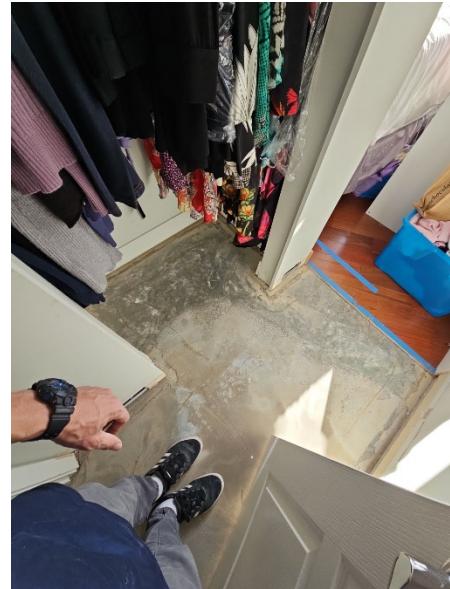
**Unit 1504-Hallway floors removed**

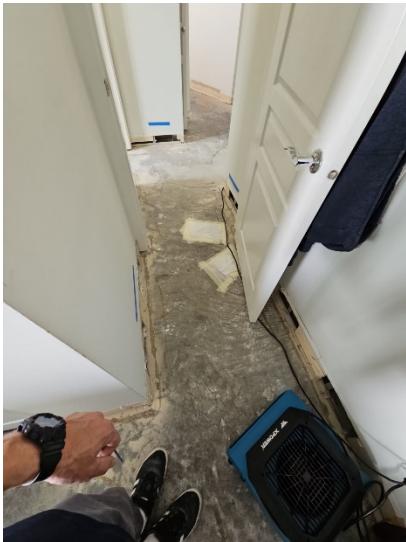
**Unit 1504- Spare bedroom- floors removed**

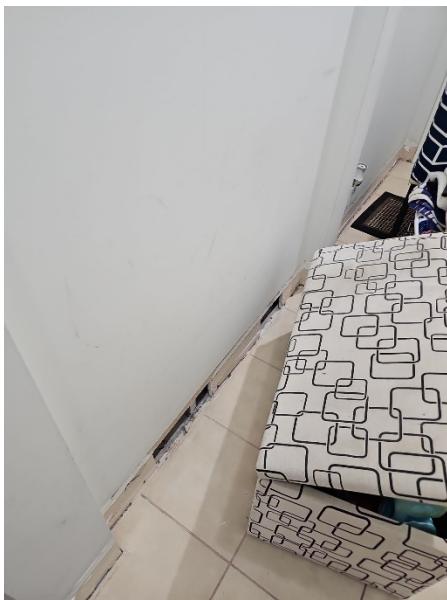
**Unit 1504- Hallway -ventilation holes**

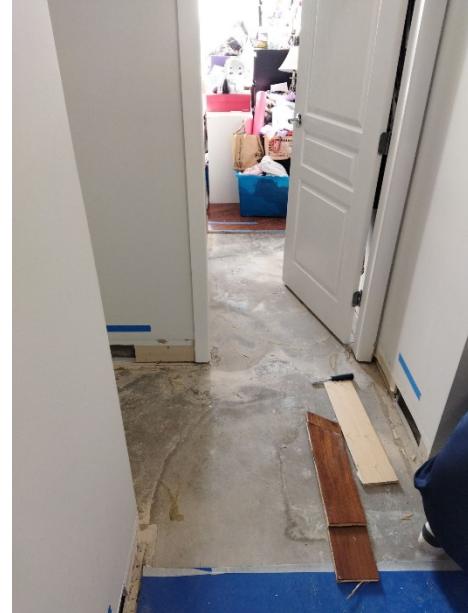
**Unit 1504-Engineering floors removed**

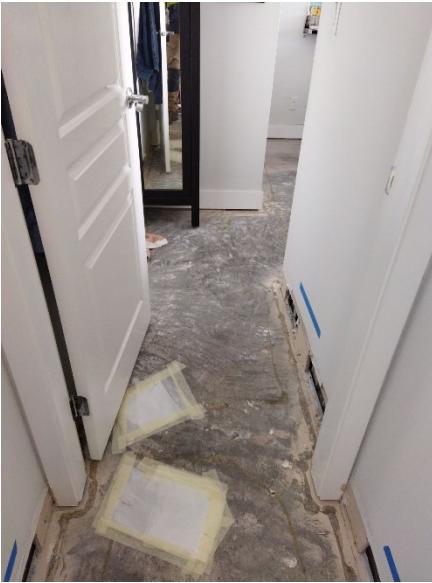
**Unit 1504-Hallwy leading to room engineering floors removed**

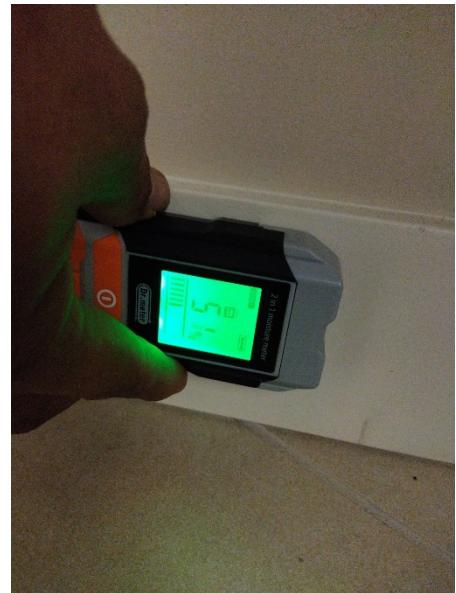
## **Unit 1505-Main closet-readings**

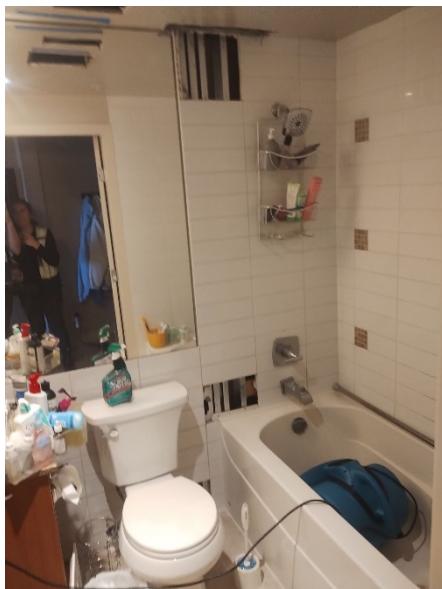
**Unit 1505- Master washroom-EQ setup**

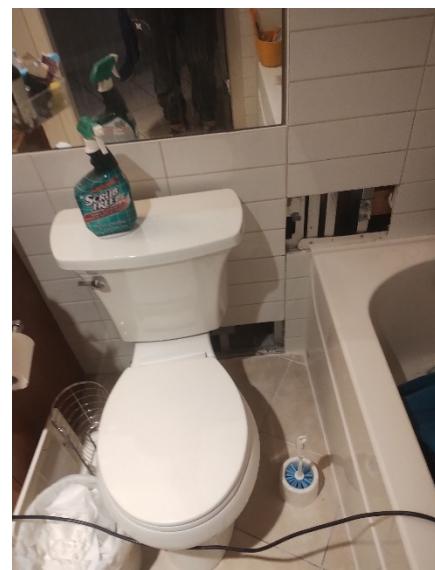
**Unit 1505- Spare washroom- top section drywall and tiles removed**

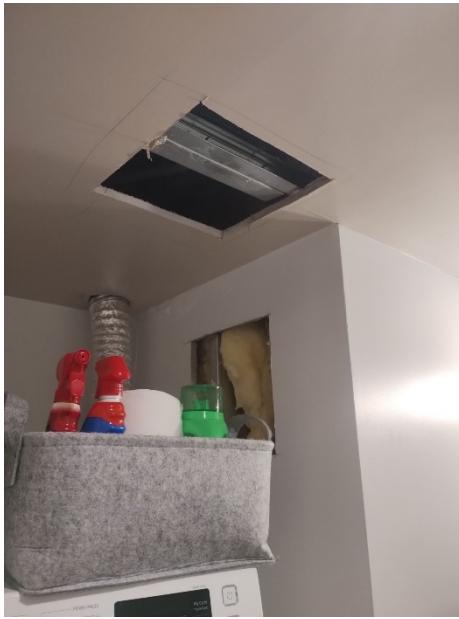
**Unit 1507- Washroom-readings of ceiling marked for removal**

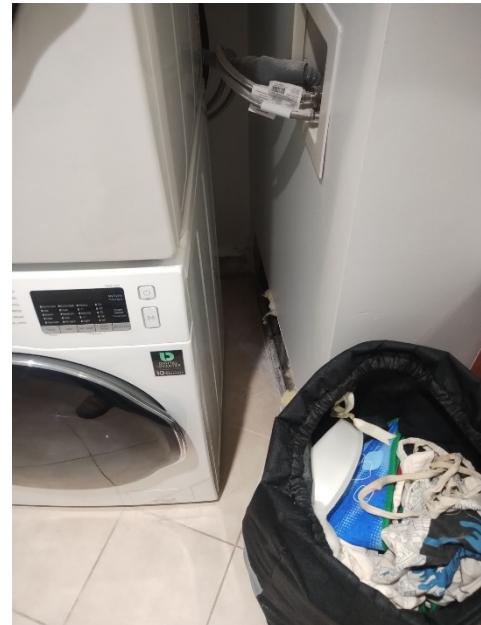
**Unit 1507- Washroom- Ceiling area removed**

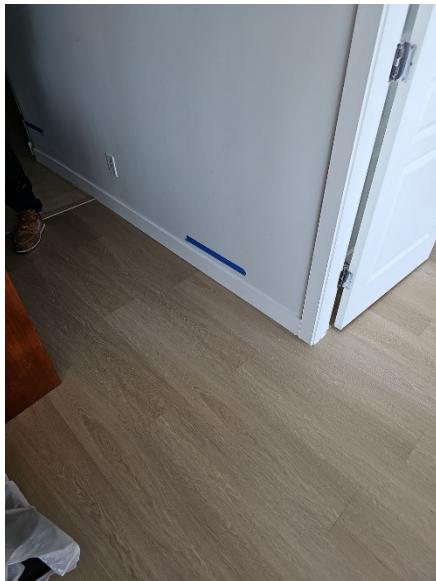
**Unit 1507- Hallway- Wall section removed**

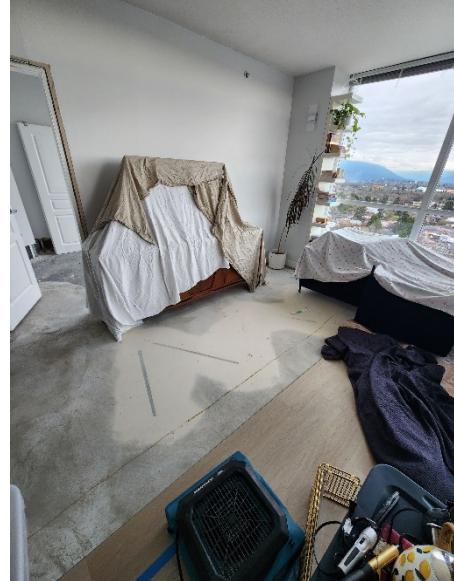
**Unit 1507- Spare bedroom- Floors being removed**

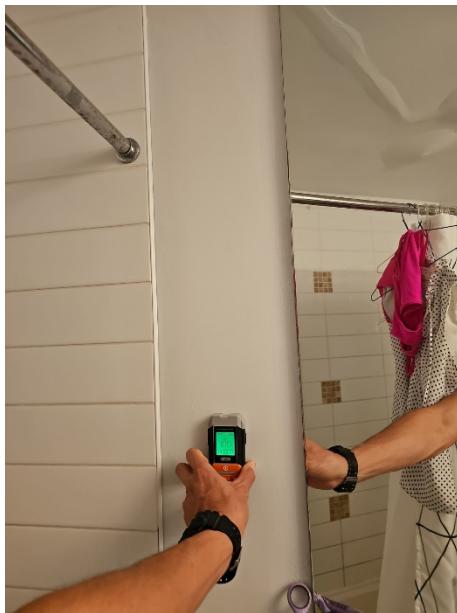
**Unit 1402- Washroom – Ceiling area  
damaged**

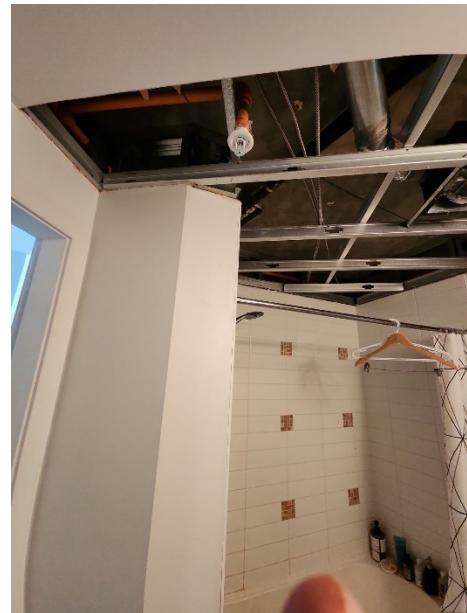
**Unit 1402- Washroom- moisture reading  
wall section**

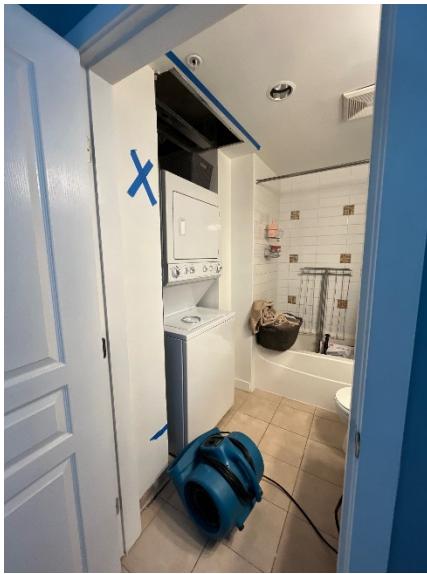
**Unit 1402- Washroom- Drywall removed**

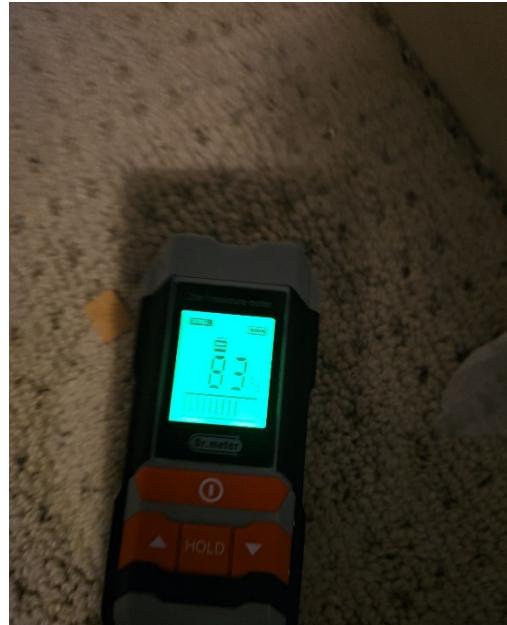
**Unit 1403- Storage closet-carpet being removed**

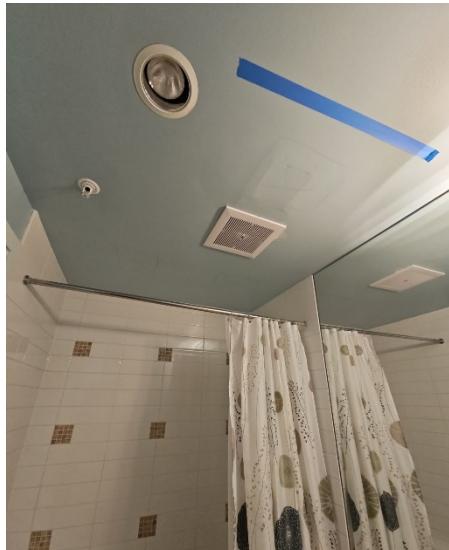
**Unit 1404- Washroom ceiling – Readings of ceiling**

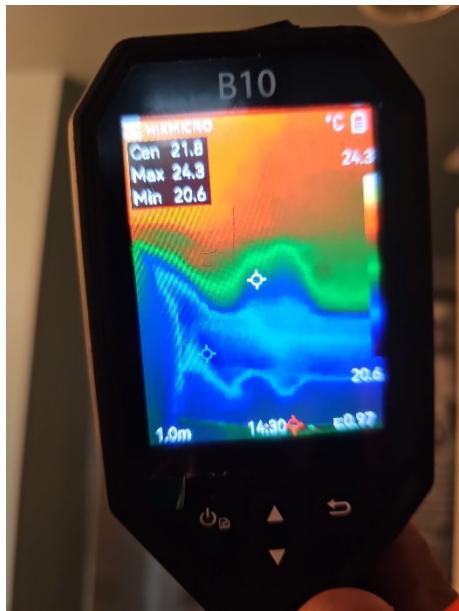
**Unit 1404-Main closet – moisture readings**

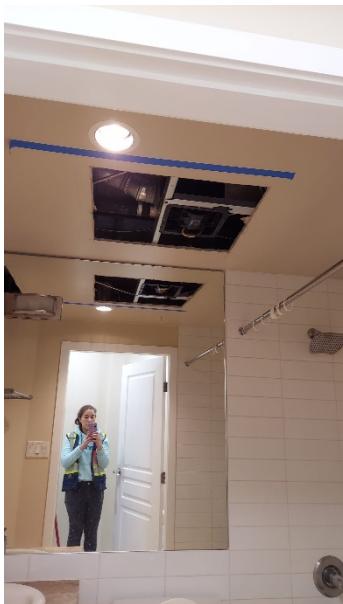
**Unit 1405- Master washroom- ceiling area removed**

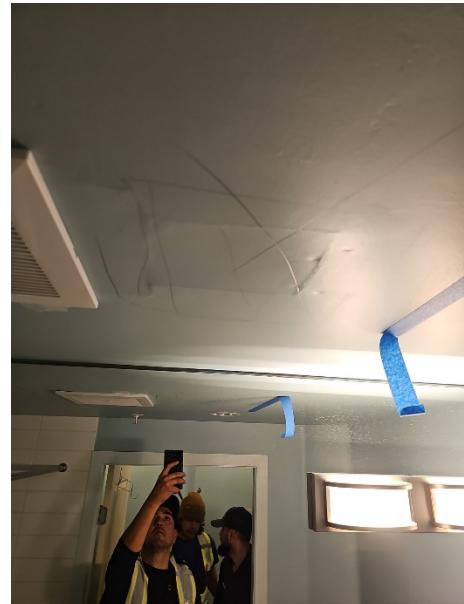
**Unit 1405-Washroom- Ceiling area removed**

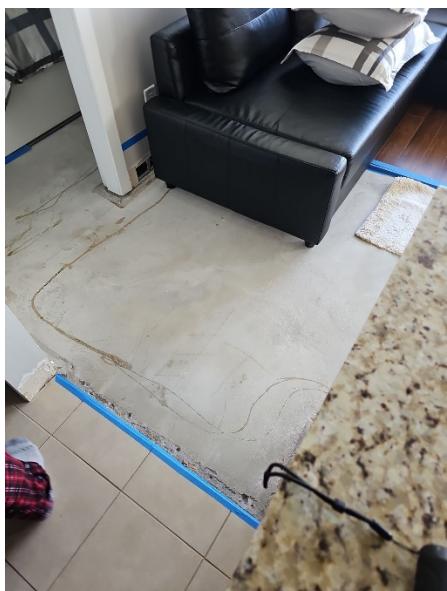
**Unit 1406- Living room- Floors damaged**

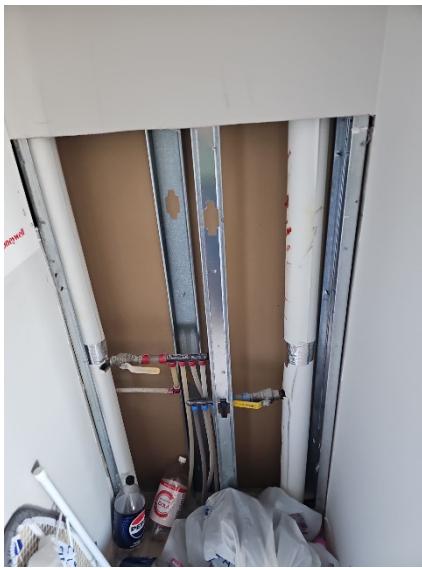
**Unit 1406- Master bedroom- Removal of floors**

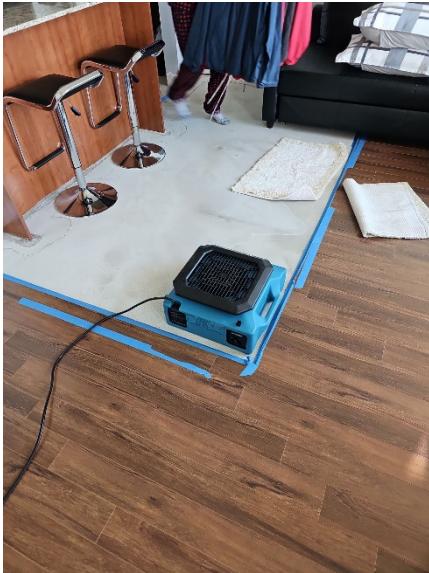
**Unit 1406 Master bedroom- floors removed**

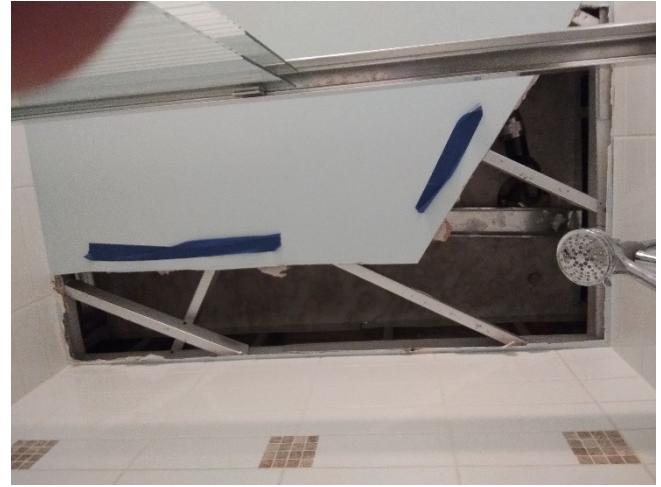
**Unit 1407- Washroom – Ceiling marked for removal**
