## SITE INSPECTION REPORT

**KingEdward Village 2**  
**4028 Knight Street**  
**Vancouver, V5N 5Y8**  
**c/o Rancho Property Management**  
**8<sup>th</sup> Floor – 1125 Howe Street**  
**Vancouver, BC, V6Z 2K8**

Source of Damages Caused:	Water Damage	Common area hallway from the 16th floor - leaking copper pipe that was on the hot water re circ line burst
Date & time call received:	03/30/2024	
Purpose:	Mitigate Damages	
Date and Time of Site Visit:	03/31/2024 – 04/12/2024, 04/17/24-04/19/24

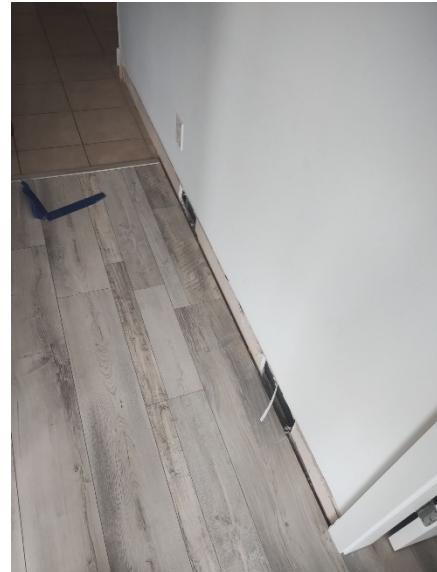
**Unit 1407 – Hallway- Moisture readings**

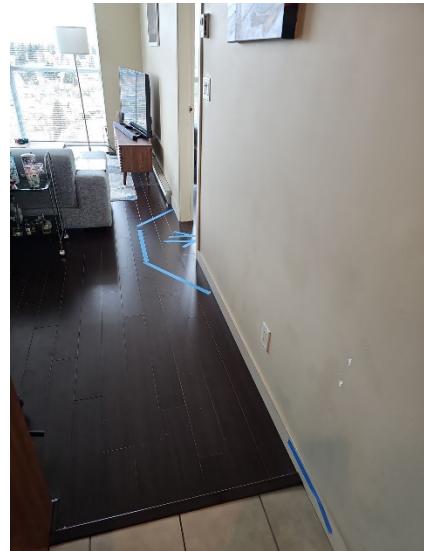
**Unit 1302-living floors damaged and marked leading to spare bedroom**

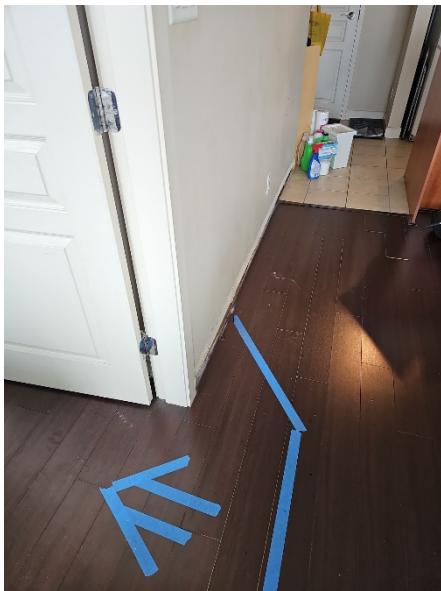
**Unit 1302- Hallway- baseboards marked for removal**

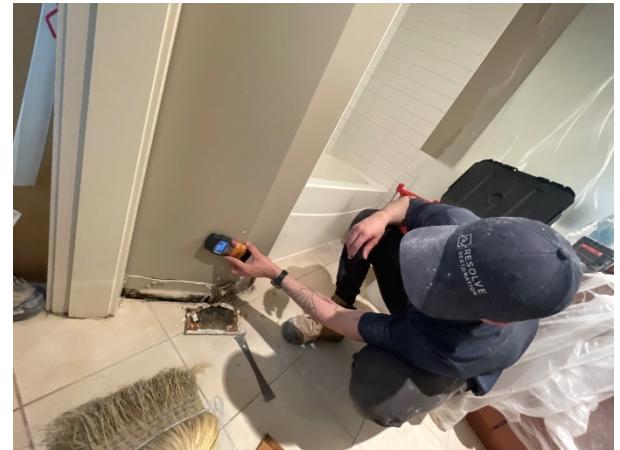
**Unit 1302- Hallway -baseboards removed and ventilation hole made**

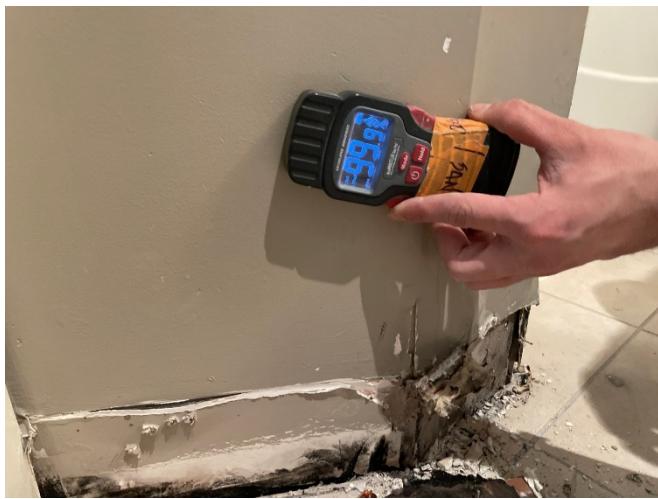
**Unit 1302- Washroom- moisture readings of wall section**

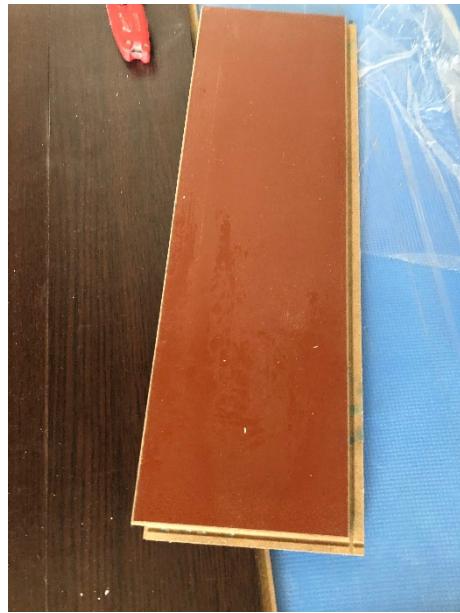
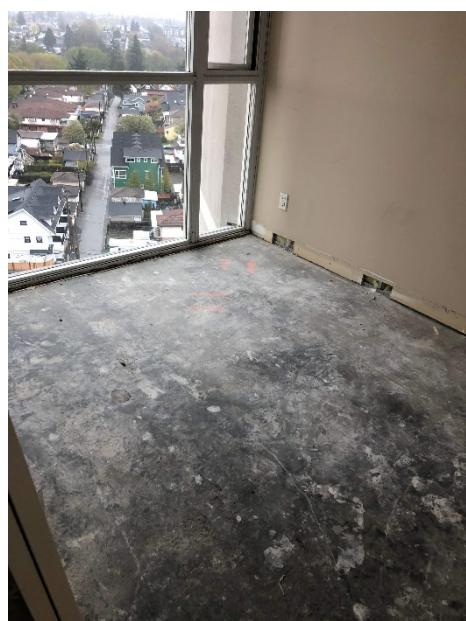
**Unit 1302- Spare bedroom- Laminate floors damaged**

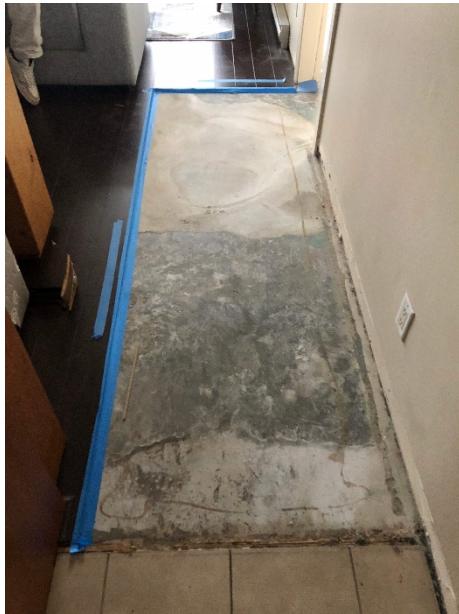
**Unit 1302-Spare bedroom-floors removed**

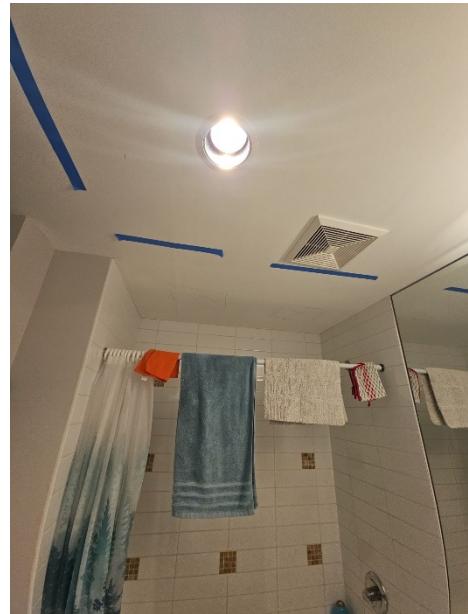
**1303-Washroom- damaged ceiling marked**

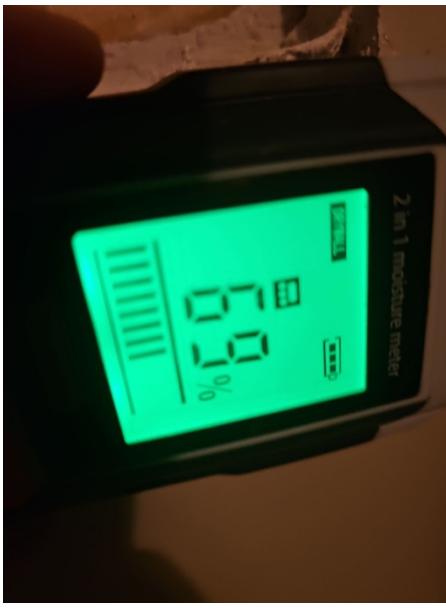
**Unit 1303-Living room/bedroom-floors removed**

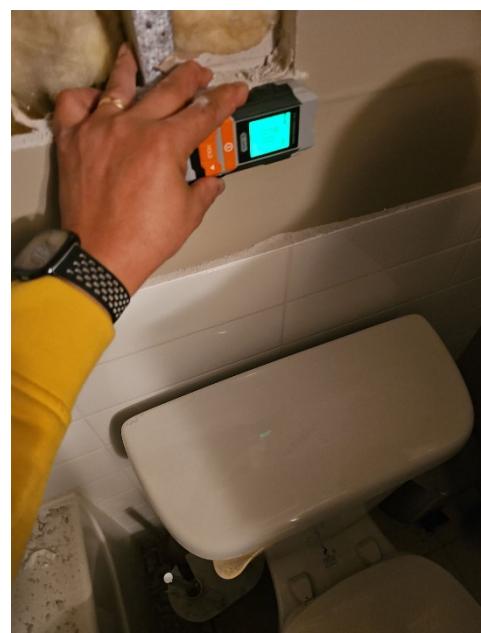
**Unit 1304- Washroom- wall section moisture readings**

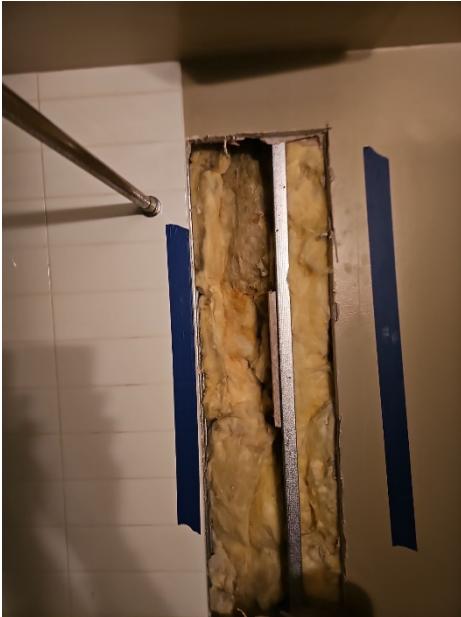
**Unit 1304- Washroom- wall section moisture readings**

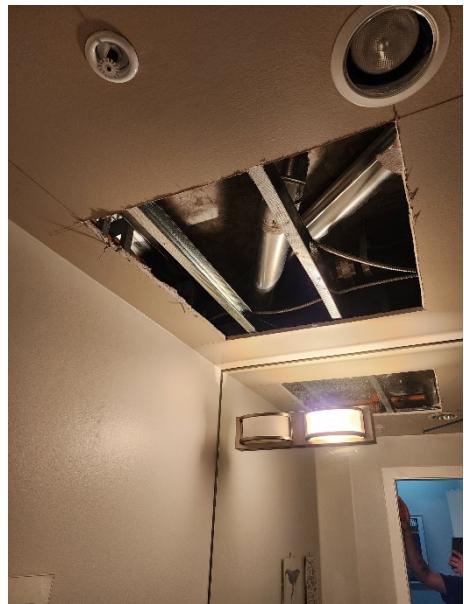
**Unit 1305- Washroom- Ceiling marked for removal**

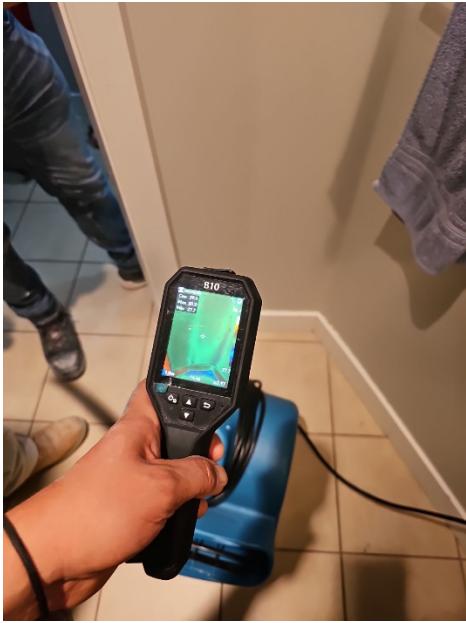
**Unit 1305- Washroom- Ceiling opened**

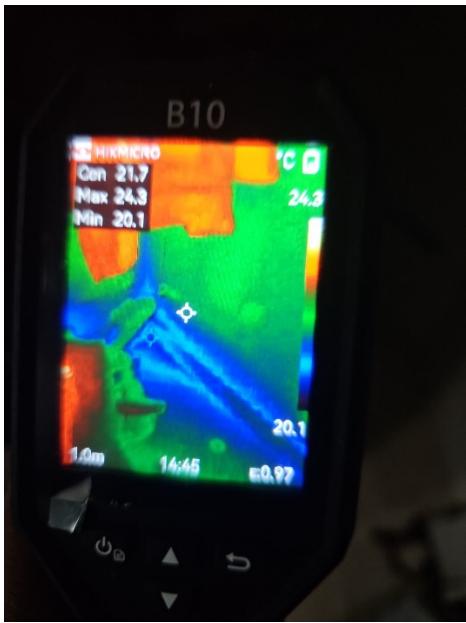
**- Unit 1305- Washroom- Wall section opened and EQ setup**

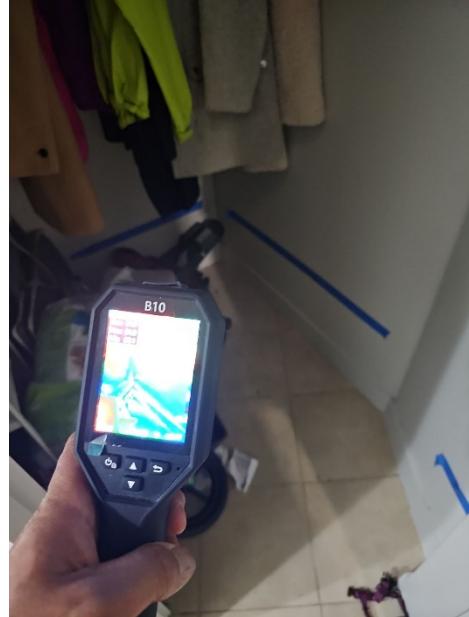
**Unit 1305- Main closet- Moisture readings**

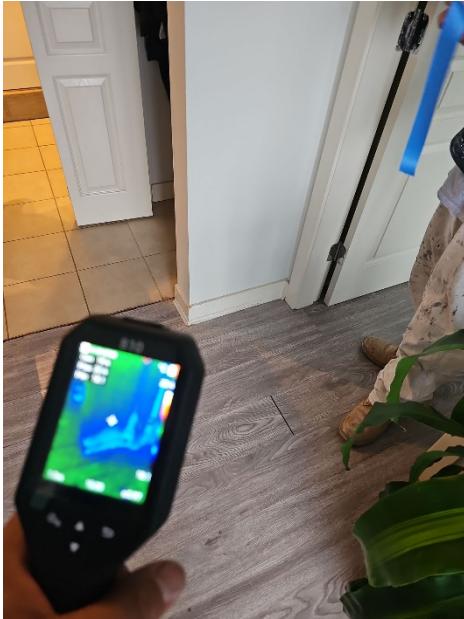
**Unit 1306- Living room- Readings of floors and wall**

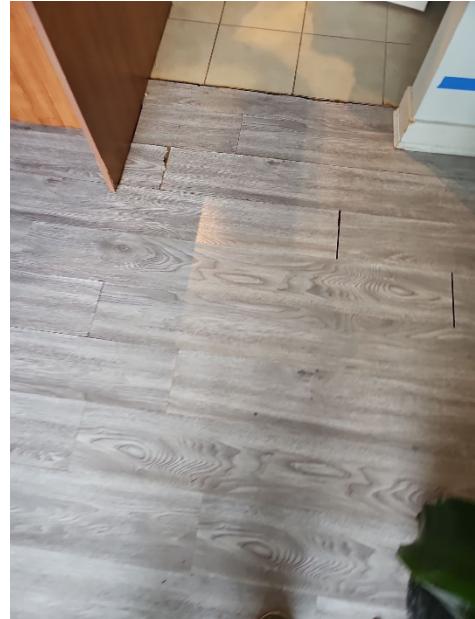
**Unit 1306- Living room- Floors damaged**

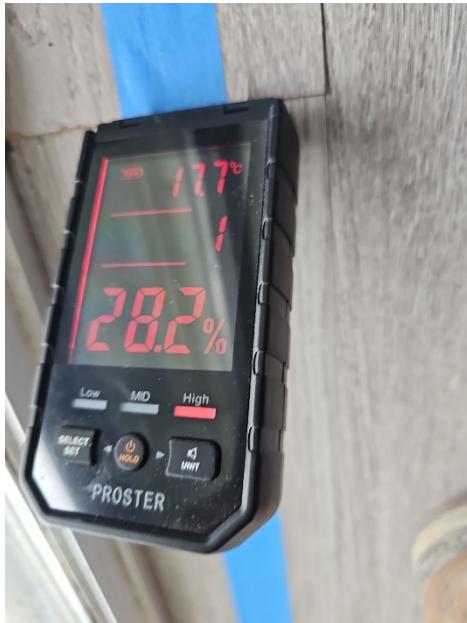
**Unit 1306- Bedroom- floors readings**

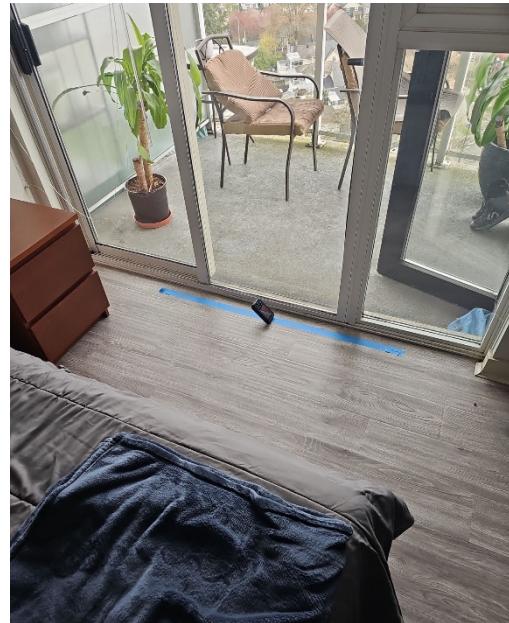
**Unit 1306- Bedroom- Floors readings**

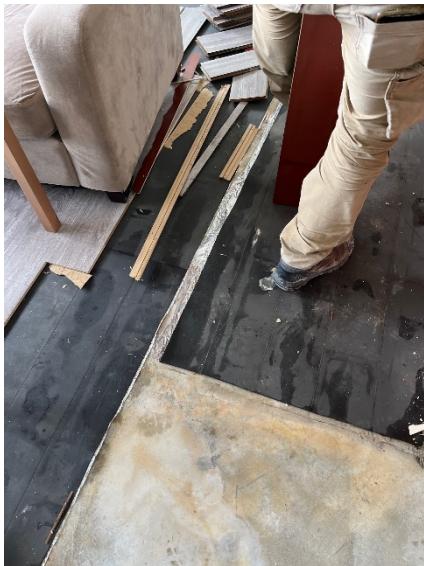
**Unit 1306- Living room- Floor being removed**

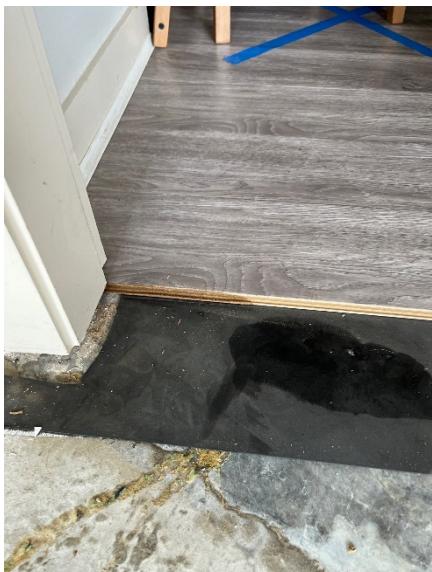
**Unit 1306- Section of floors showing damaged**

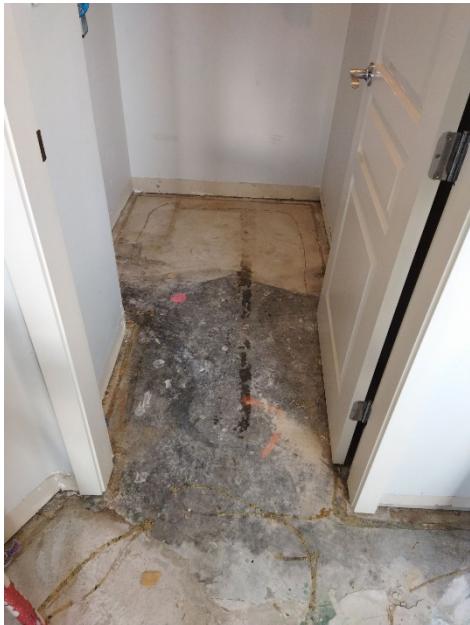
**Unit 1306- Section of floors removed**

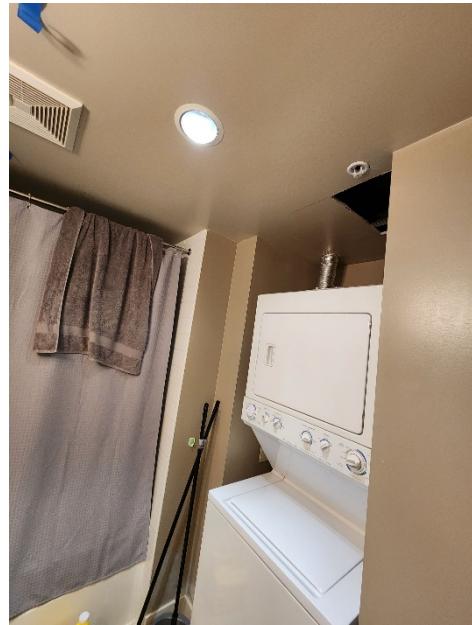
**Unit 1306- Washroom- Ceiling removed**

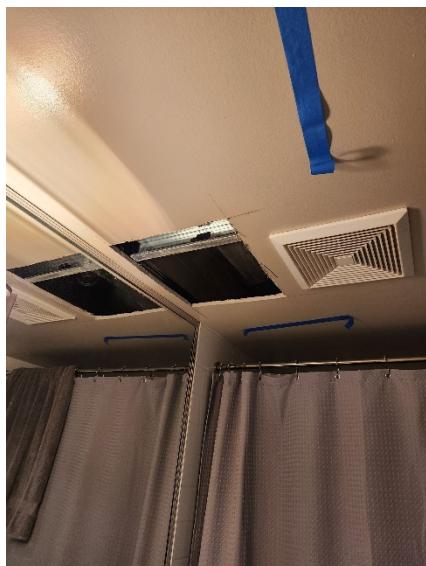
**Unit 1306- Washroom- Ceiling removed**

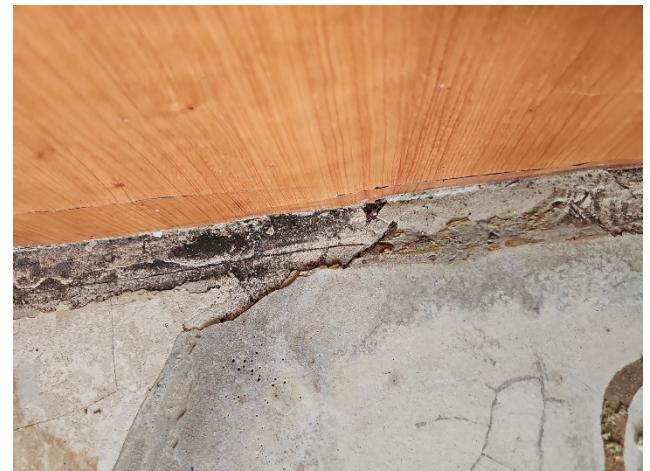
**Unit 1306- Kitchen island- damaged showing-**

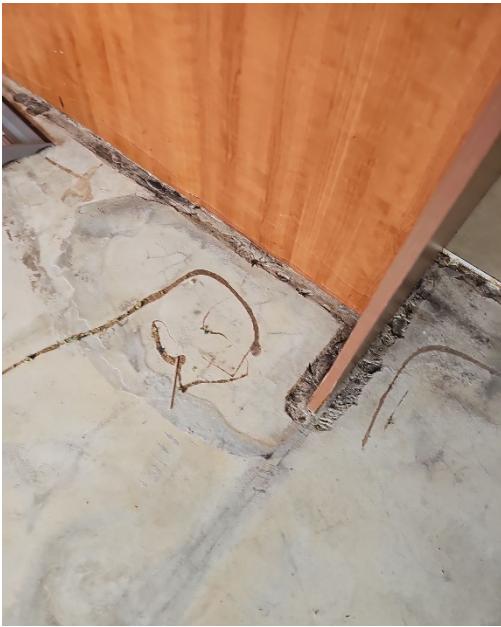
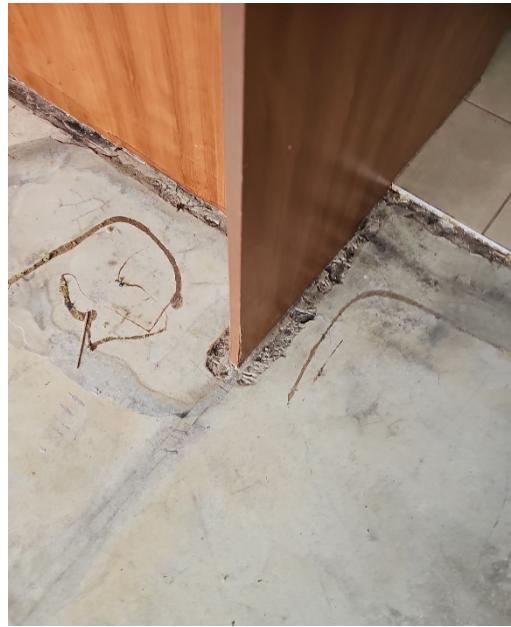
**Unit 1306- Kitchen island- damaged showing-**

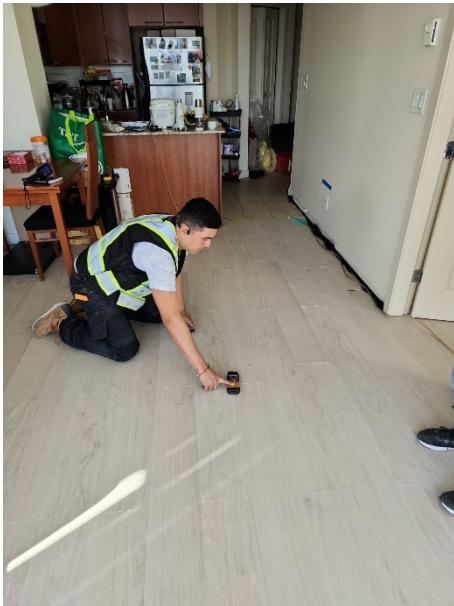
**Unit 1307- Living room- floors damaged taking readings**

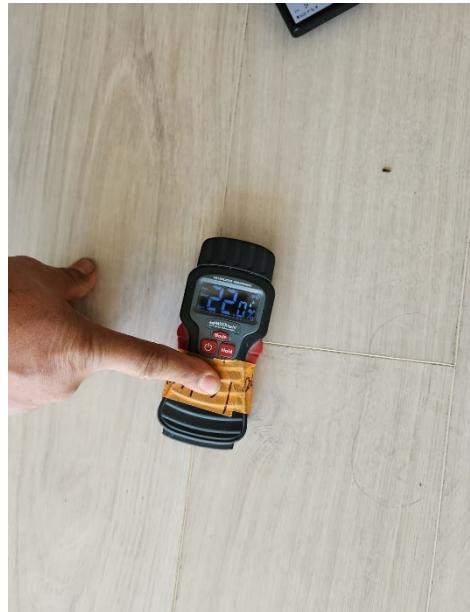
**Unit 1307- Living room- floors damaged taking readings**

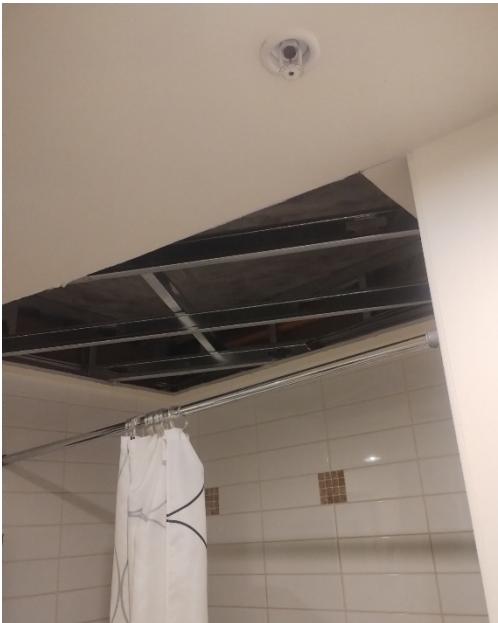
**Unit 1307-Washroom- Ceiling removed**

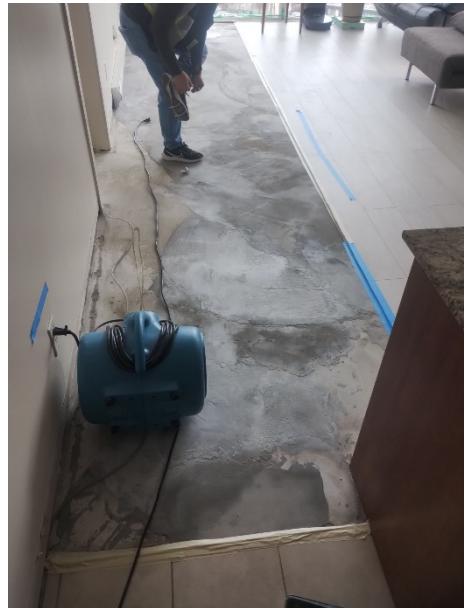
**Unit 1307-Living room- Floors removed/EQ setup**

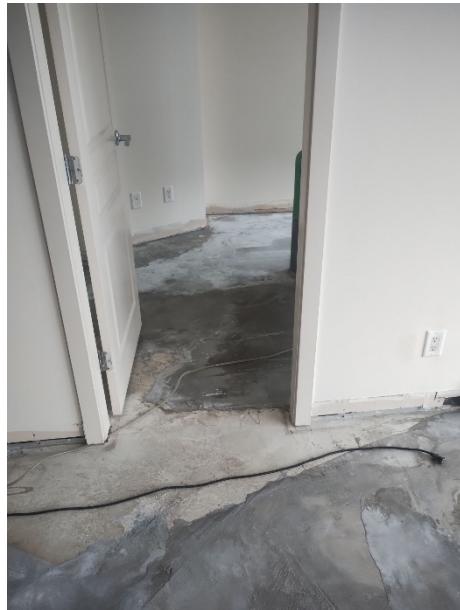
**Unit 1307- Sprae bedroom- Floors removed /baseboards removed.**

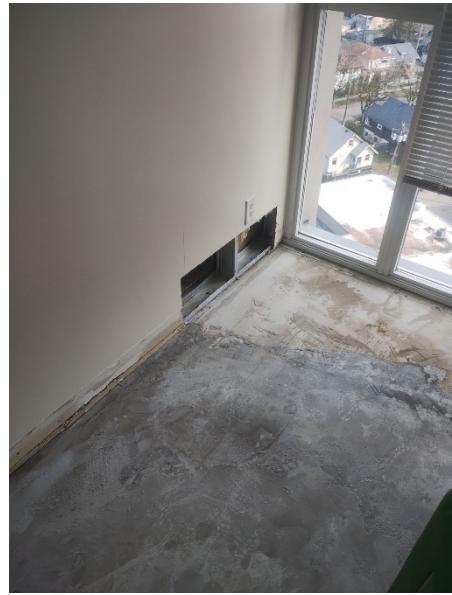
**Unit 1307- Sprae bedroom- wall section opened/baseboards removed**

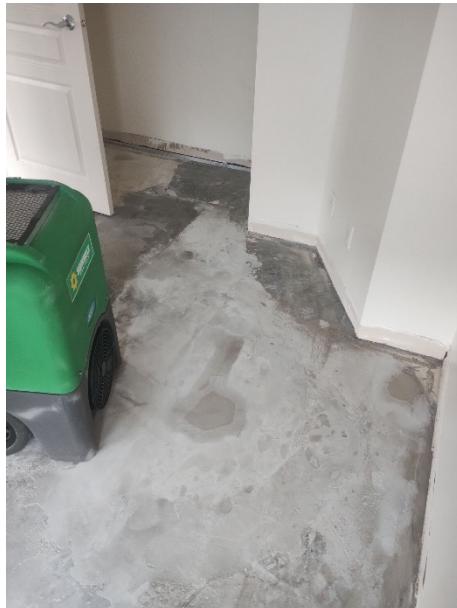
**Unit 1307- Spare bedroom- EQ Setup**

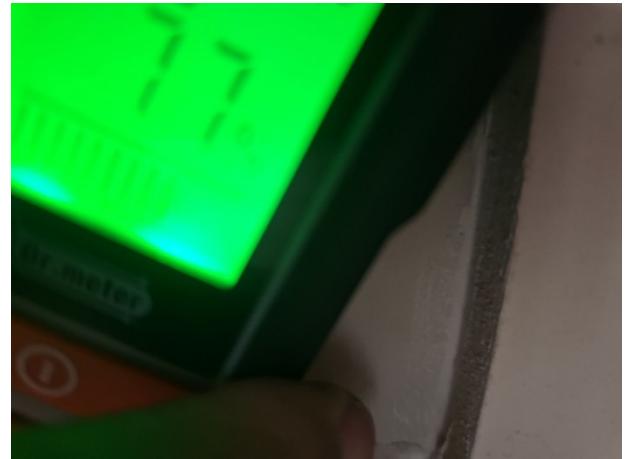
**Unit 1203- Storage closet- Moisture readings**

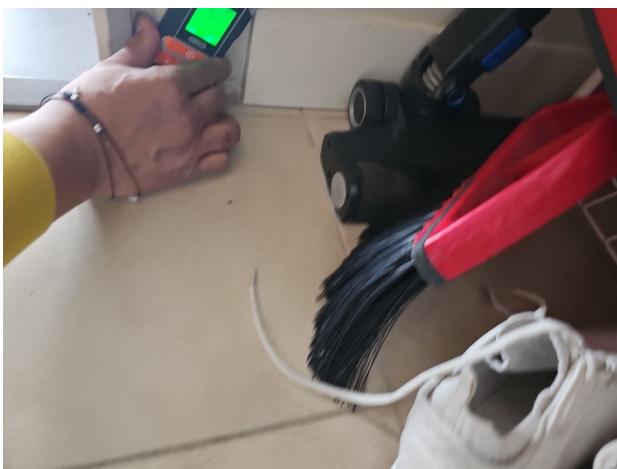
**Unit 1203- Storage closet- Moisture readings**

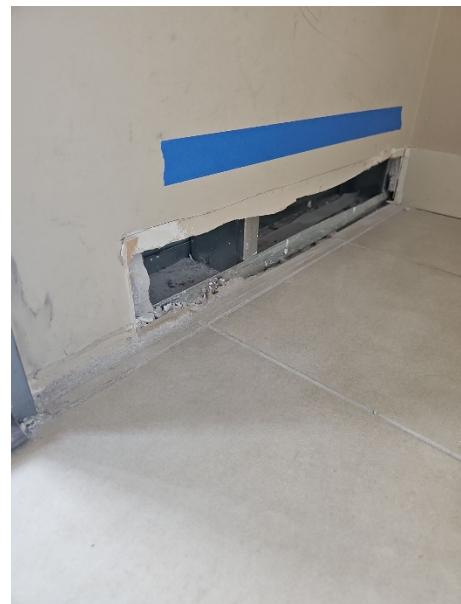
**Unit 1203- Master bedroom- Removal of floors**

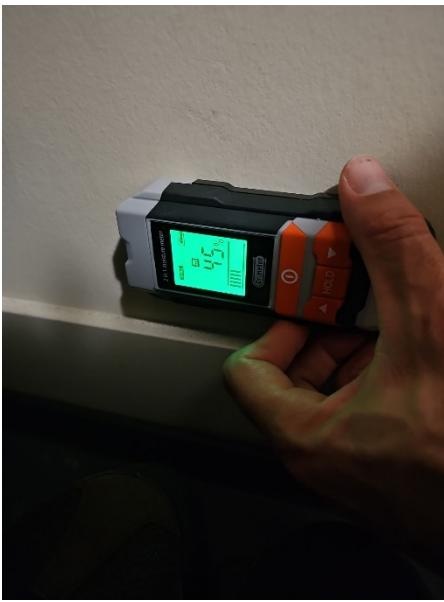
**Unit 1205- Main closet- Moisture readings**

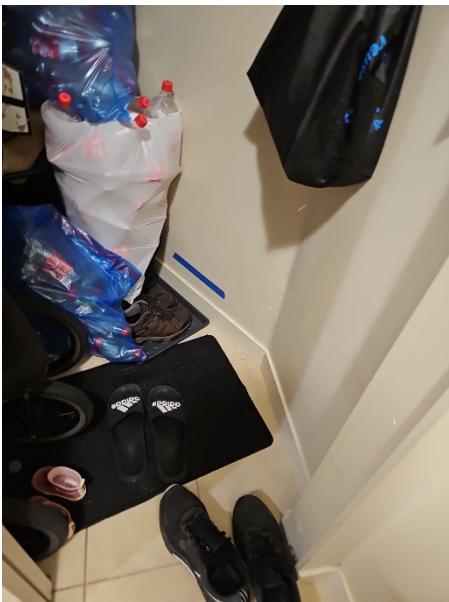
**Unit 1205- Main entrance – Readings of wall section**

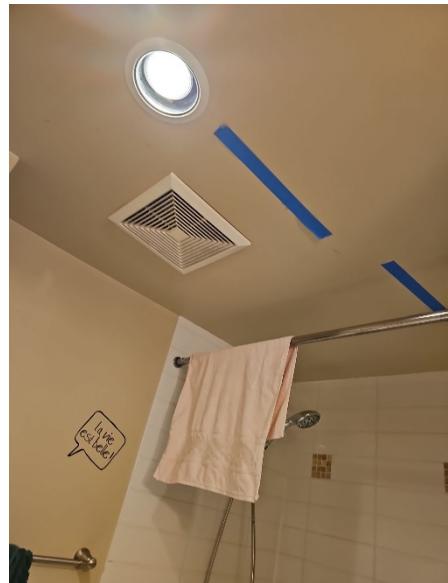
**Unit 1205-Washroom- Ceiling area marked for removal**

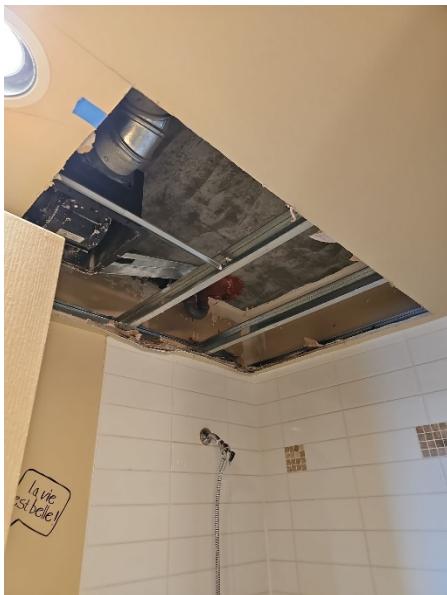
**Unit 1205- Washroom-Ceiling removed**

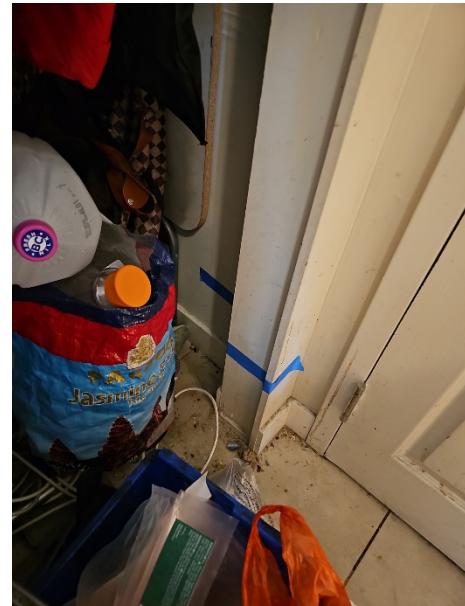
**Unit 1207- Main closet – Marked for removal**

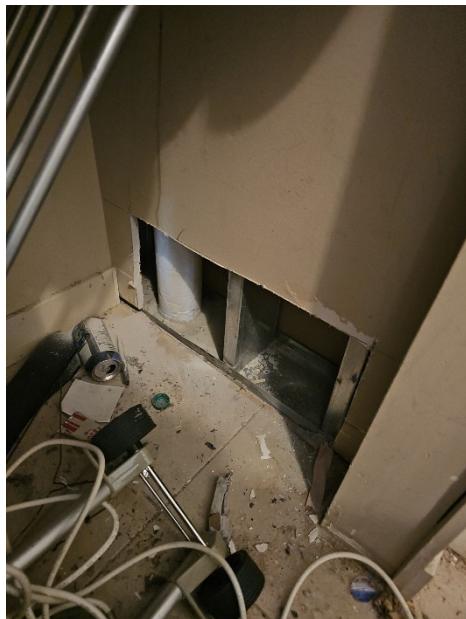
**Unit 1207- Main closet – drywall removed**

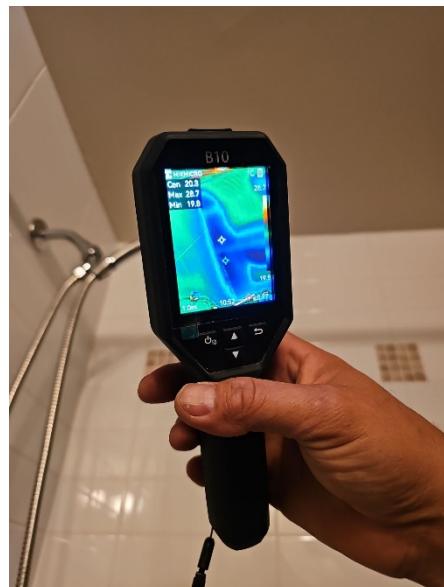
**Unit 1102- Washroom- Moisture readings of ceiling area**

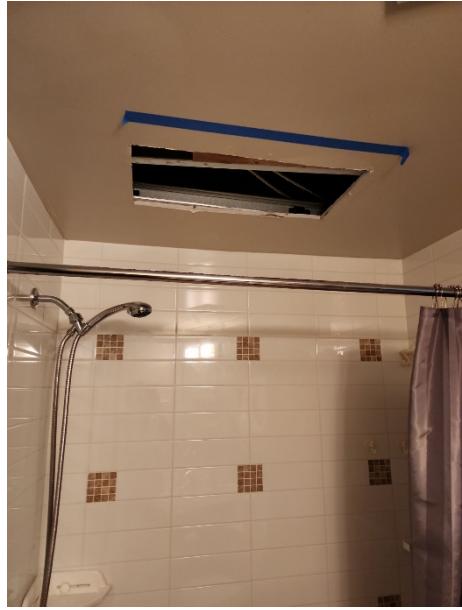
**Unit 1102- Washroom- Moisture readings of ceiling area**

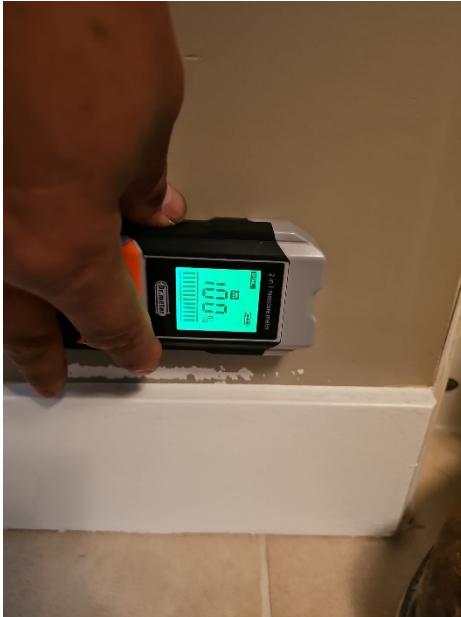
**Unit 1102- Washroom- Ceiling removed**

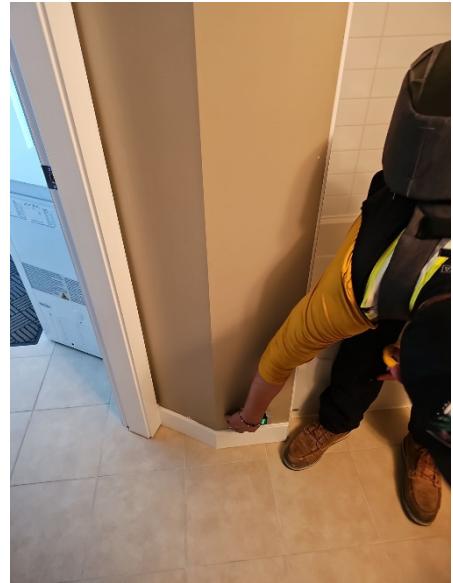
**Unit 1102- Washroom- Wall section moisture readings**

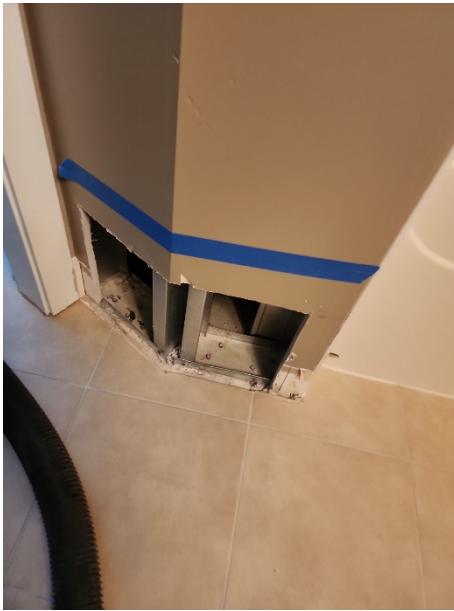
**Unit 1102- Washroom- Wall section moisture readings**

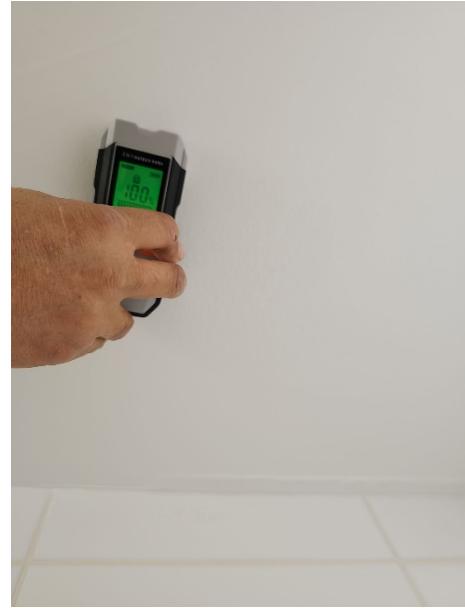
**Unit 1102- Washroom- Wall section opened**

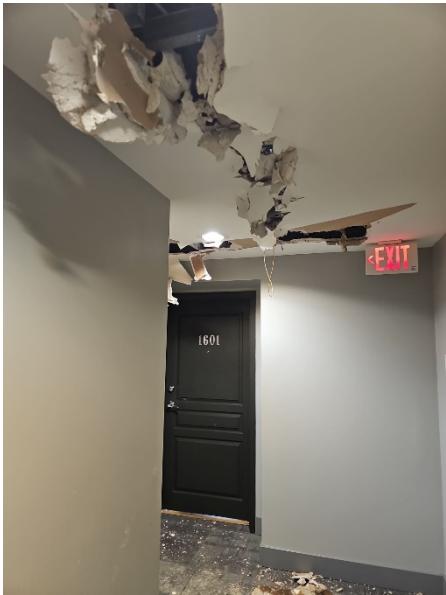
**Common level 16<sup>th</sup> – Area damage**

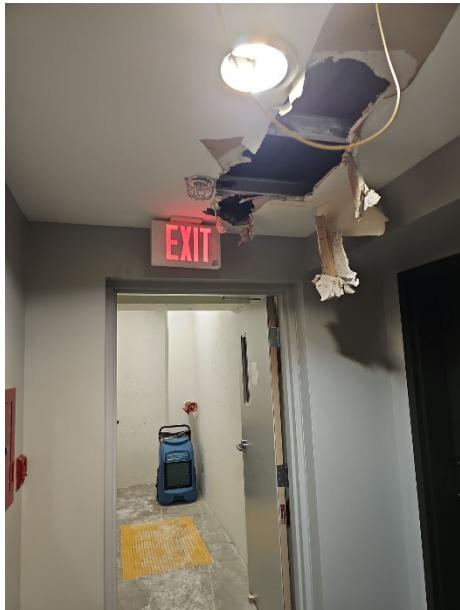
**Common level 16<sup>th</sup> – Area damage**

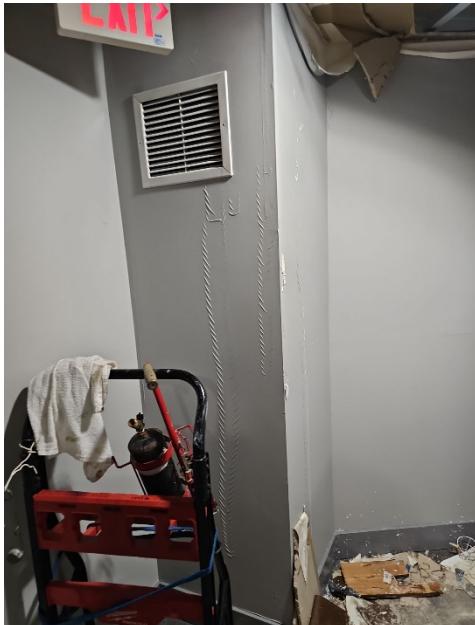
**Common level 16<sup>th</sup> – Area damage**

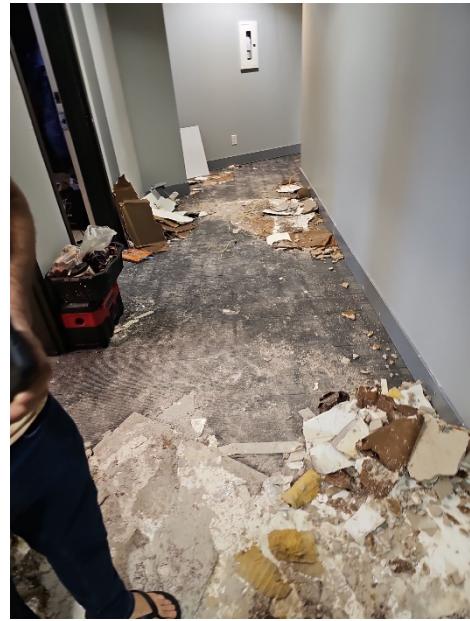
**Common level 16<sup>th</sup> – Area damage**

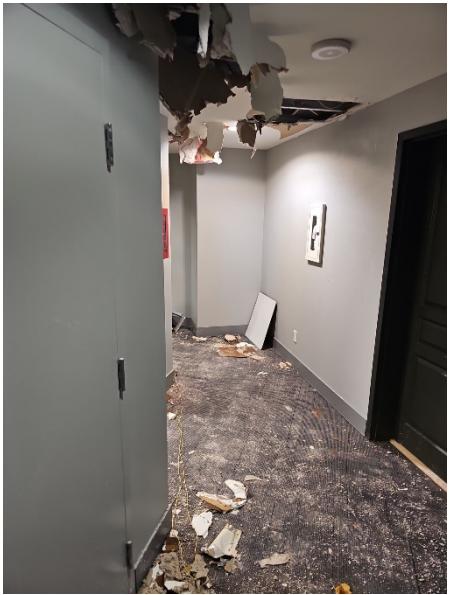
**Common level 16<sup>th</sup> – Area damage**

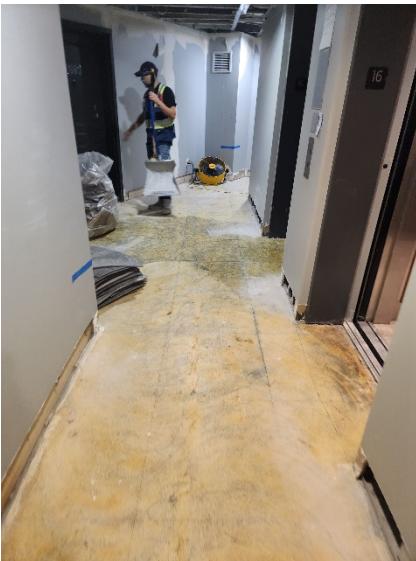
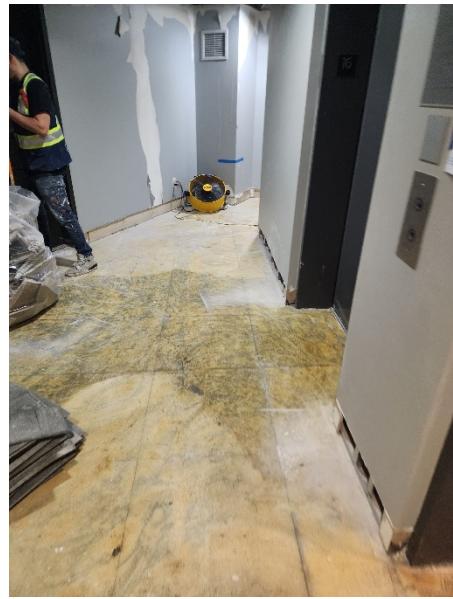
**Common level 16<sup>th</sup> – Carpet/ ventilation and walls cut**

**Common level 16<sup>th</sup> – Carpet / ventilation and walls cut**

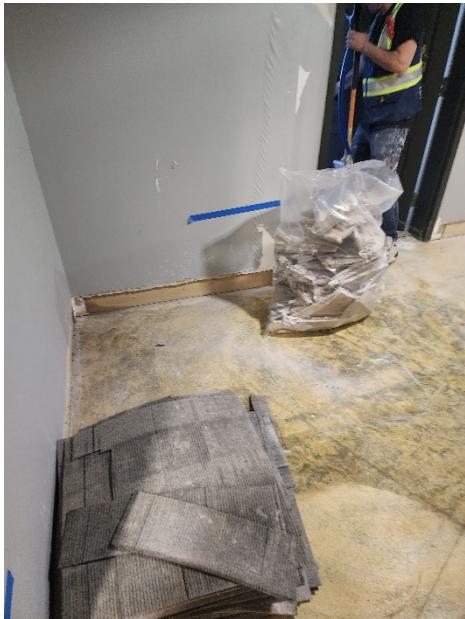
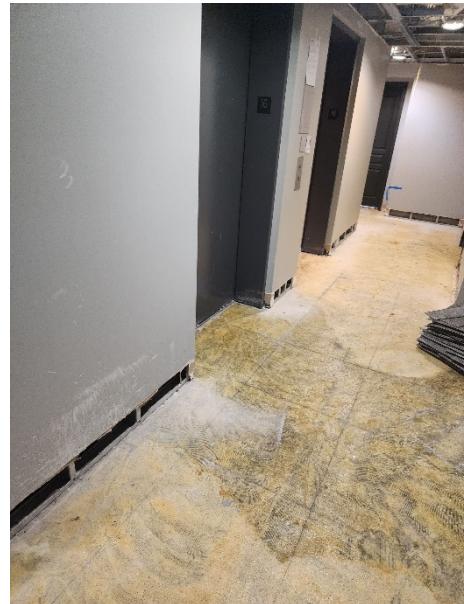
**Common level 16<sup>th</sup> – Carpet / ventilation and walls cut, and EQ setup**

**Common level 16<sup>th</sup> – Carpet ventilation and walls cut, and carpet removed**

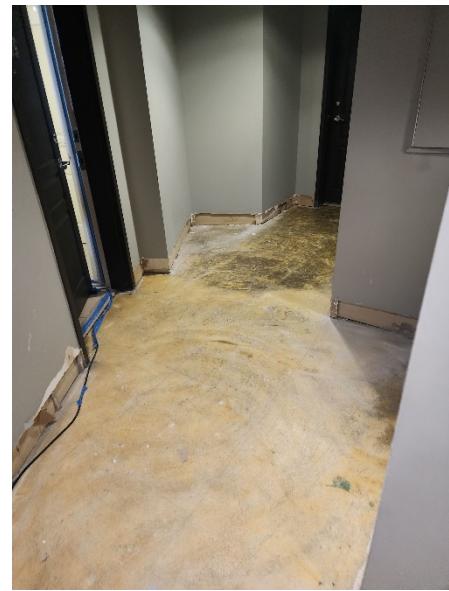
**Common level 16<sup>th</sup> – floors/ ventilation and walls cut**

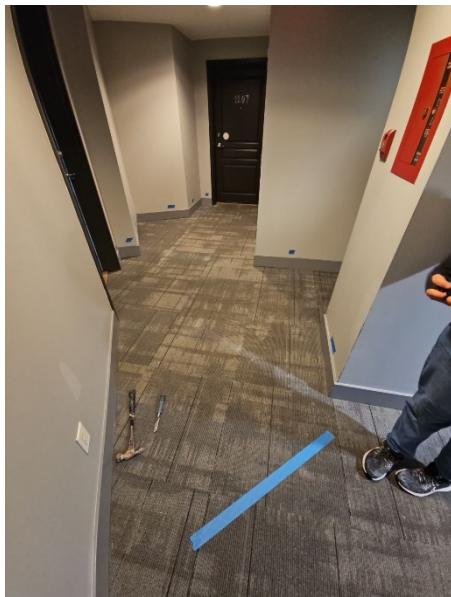
**Common level 16<sup>th</sup> – floors/ ventilation and walls cut**

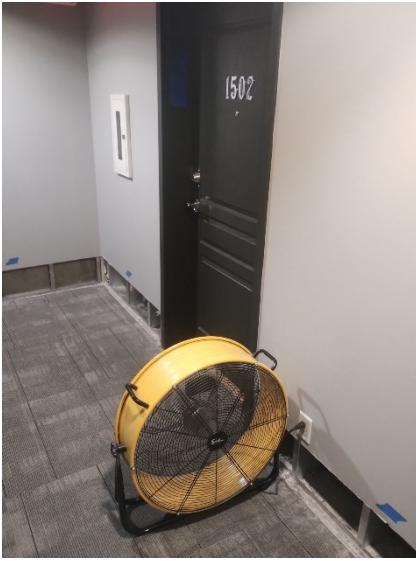
**Common level 15<sup>th</sup> – Carpet damaged/wall marked, and EQ setup**

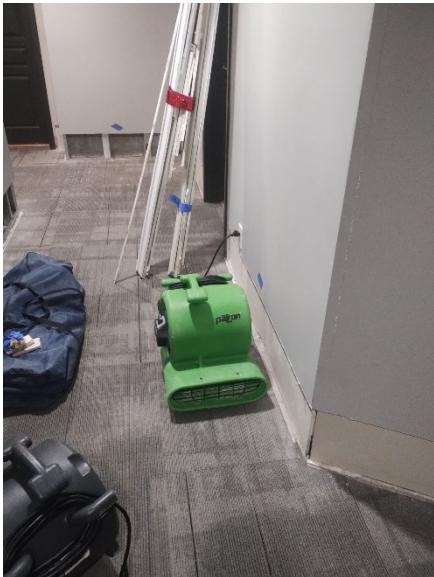
**Common level 15<sup>th</sup> – Carpet damaged/wall marked, and EQ setup**

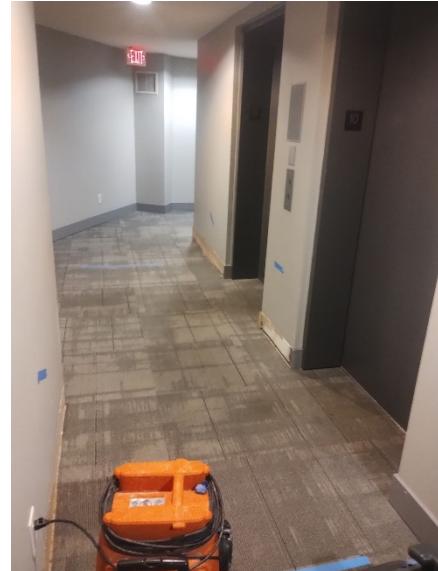
**Common level 10<sup>th</sup> – Carpet damaged/wall marked, and EQ setup**

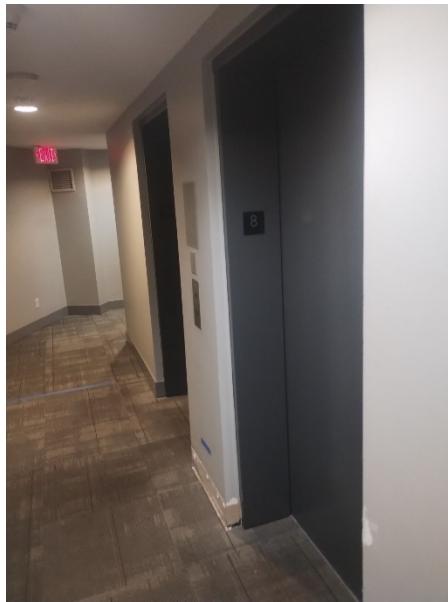
**Common level 9<sup>th</sup> – Carpet damaged/wall marked, and EQ setup**

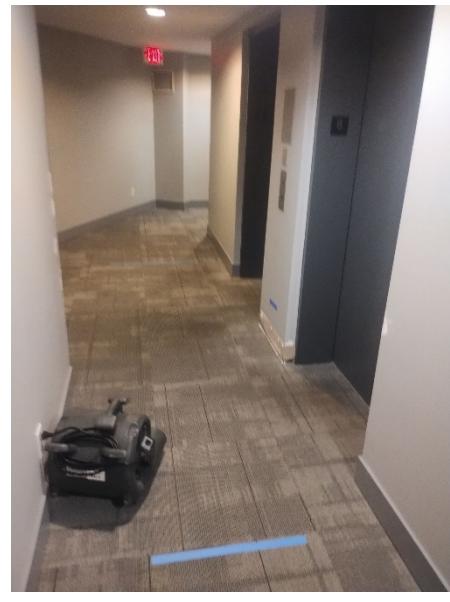
**Common level 8<sup>th</sup> – Carpet damaged/wall marked, and EQ setup**

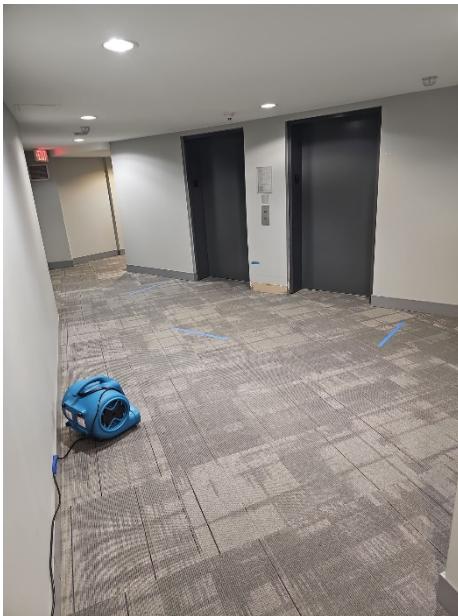
**Common level 8<sup>th</sup> – Carpet damaged/wall marked, and EQ setup**

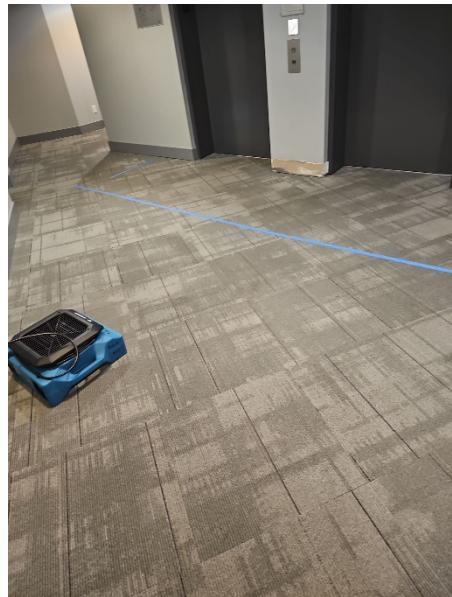
**Common level 4<sup>th</sup> – Carpet damaged/wall marked, and EQ setup**

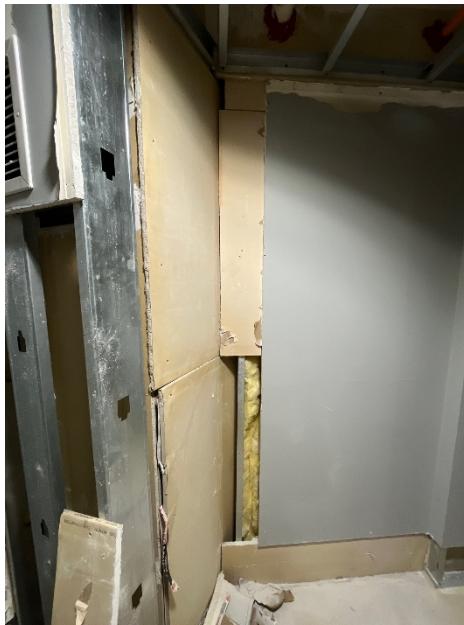
**Common level 16<sup>th</sup> – damaged wall removed**

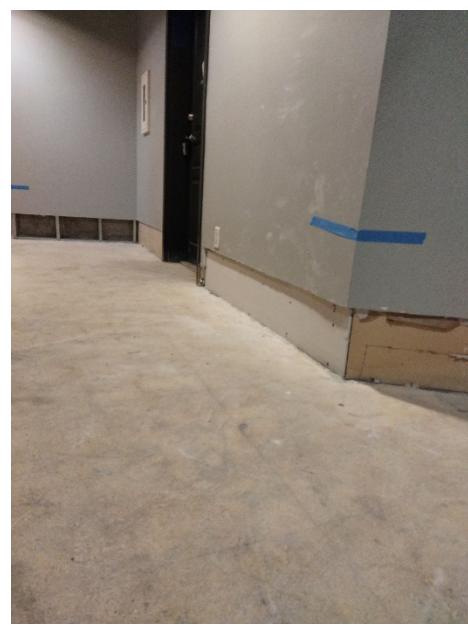
**Common level 16<sup>nd</sup> – Damaged wall section removed**

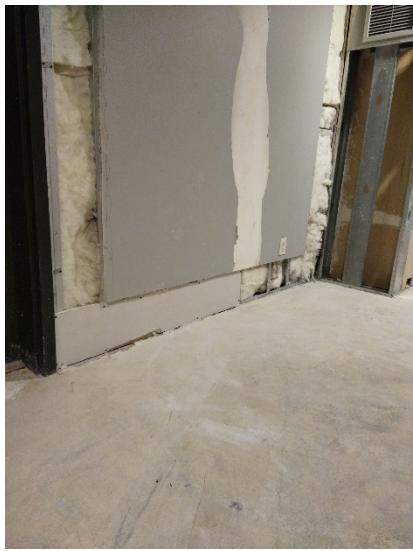
**Common level 16<sup>nd</sup> – Damaged wall section removed**

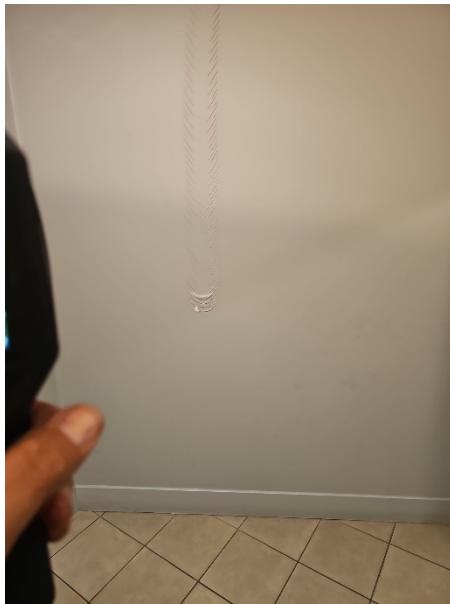
**Gym Washroom- Moisture reading of wall section**

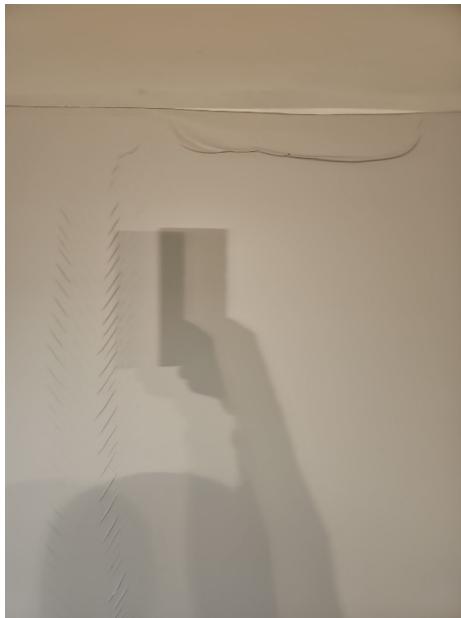
**Gym Washroom- Wall section damaged**

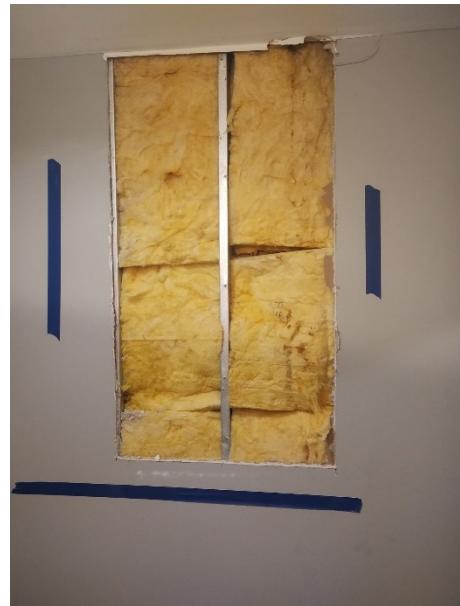
**Gym Washroom- Wall section damaged**

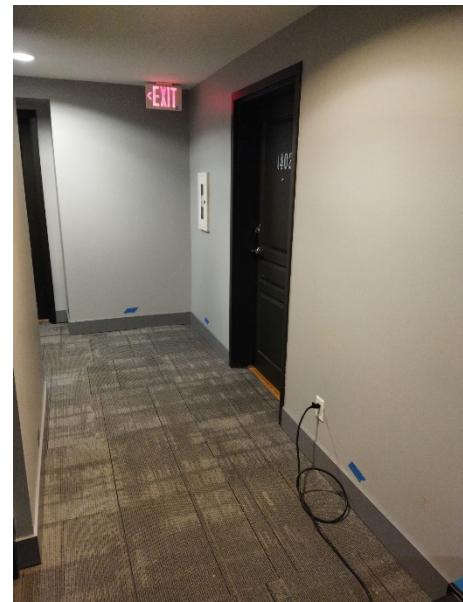
**Common level 14<sup>nd</sup> – EQ setup, and areas marked**

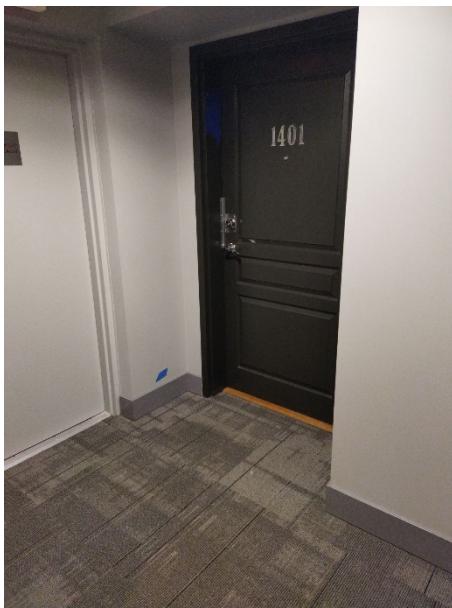
**Common level 14<sup>nd</sup> – EQ setup, and areas marked**

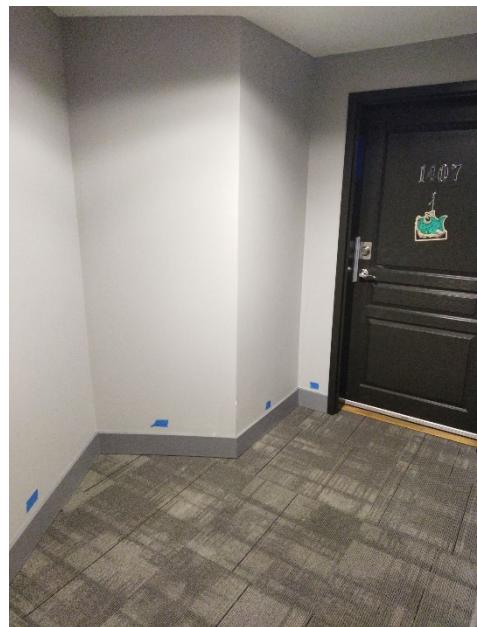
**Common level 14<sup>th</sup> – Areas marked**

**Common level 14<sup>th</sup> –Areas marked**

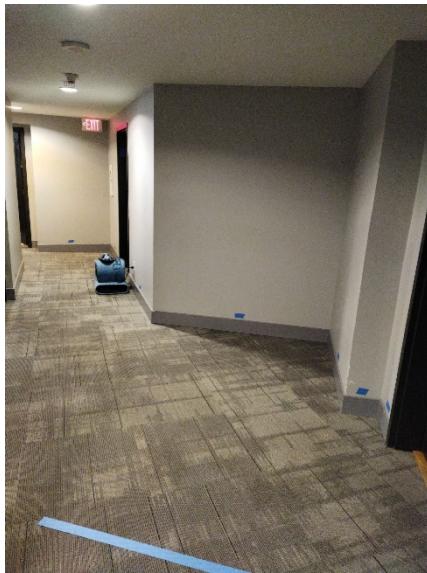
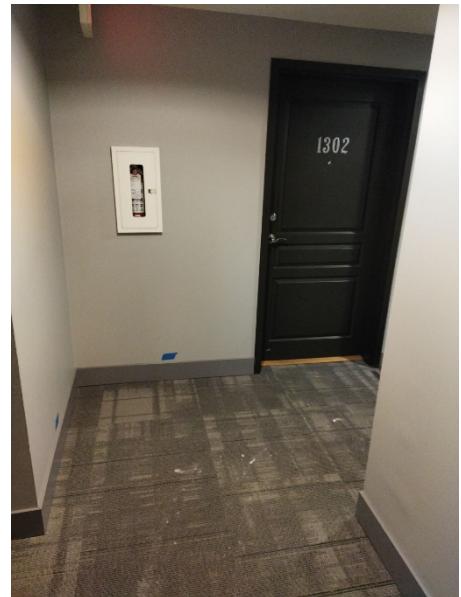
**Common level 14<sup>th</sup> – Areas marked**
