## SITE INSPECTION REPORT

**KingEdward Village 2**  
**4028 Knight Street**  
**Vancouver, V5N 5Y8**  
**c/o Rancho Property Management**  
**8<sup>th</sup> Floor – 1125 Howe Street**  
**Vancouver, BC, V6Z 2K8**

Source of Damages Caused:	Water Damage	Common area hallway from the 16th floor - leaking copper pipe that was on the hot water re circ line burst
Date & time call received:	03/30/2024	
Purpose:	Mitigate Damages	
Date and Time of Site Visit:	03/31/2024 – 04/12/2024, 04/17/24-04/19/24

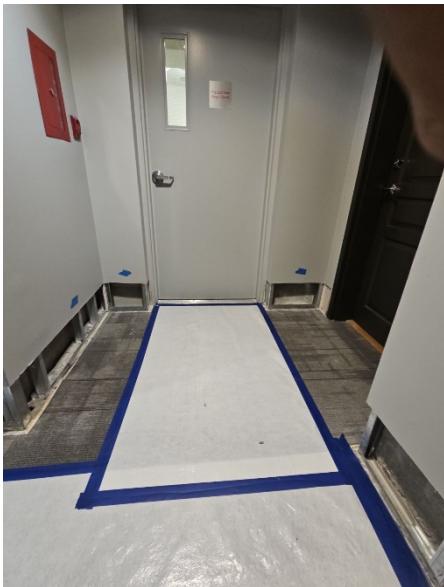
**Common level 13<sup>th</sup> – Areas marked**
