SITE INSPECTION REPORT

Date: November 24, 2023

R00763

**Clarke & Como EPS7495
567 Clarke & Como Rd. Coquitlam BC
RANCHO Strata Plan EPS 41731
c/o Rancho Property Management
8th Floor – 1125 Howe Street
Vancouver, BC, V6Z 2K8**

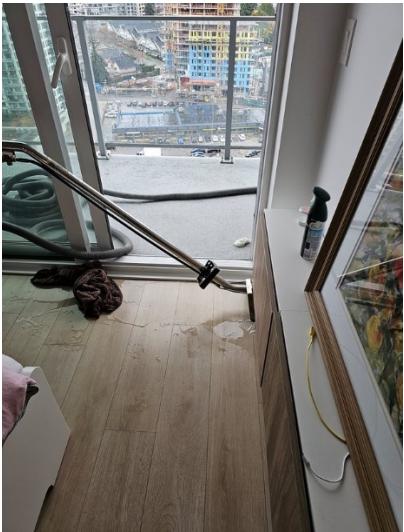
Unit 1508- Water been extracted

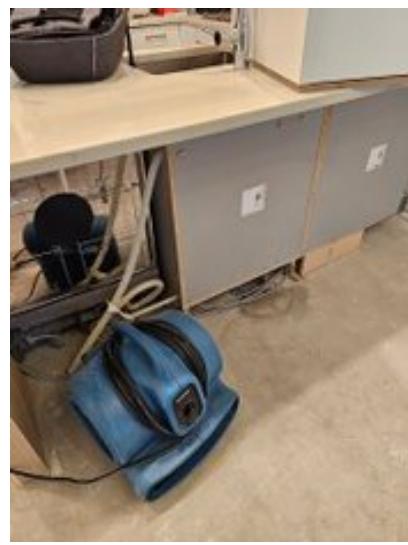
Unit 1508- water seeping under floors

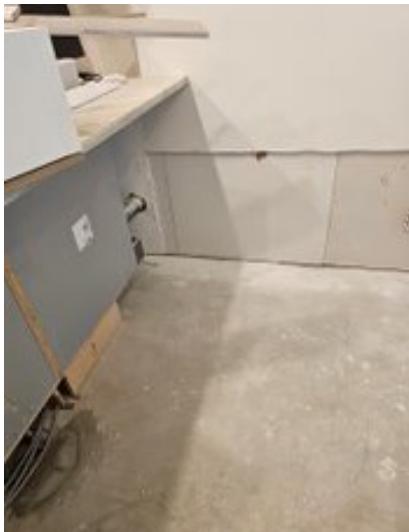
Unit 1508- EQ setup

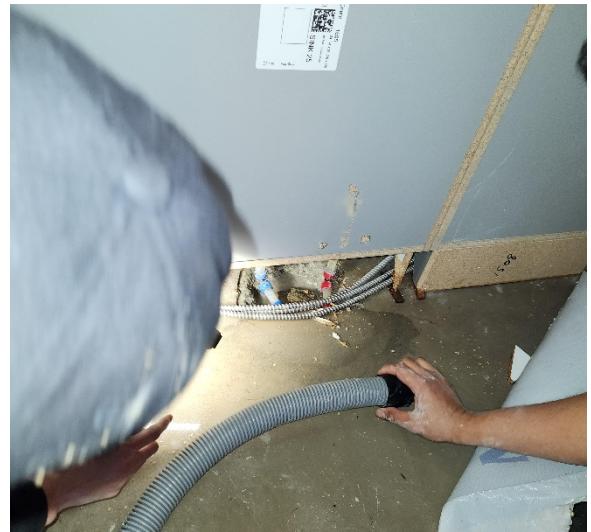
Unit 1508- Drywall cut 16 inches up

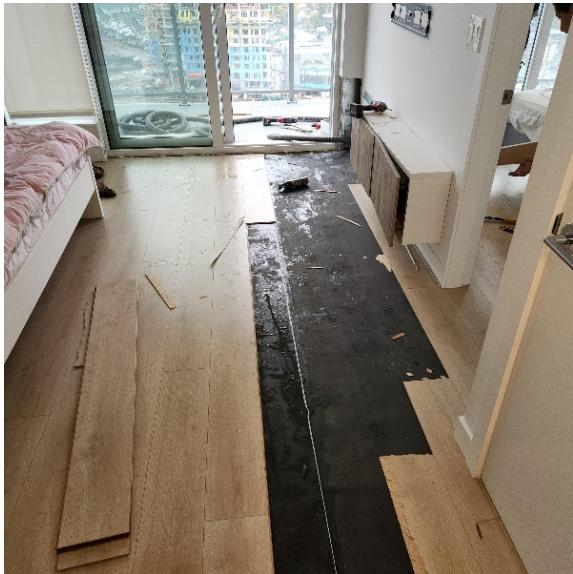
Unit 1508- Laminate floors damaged

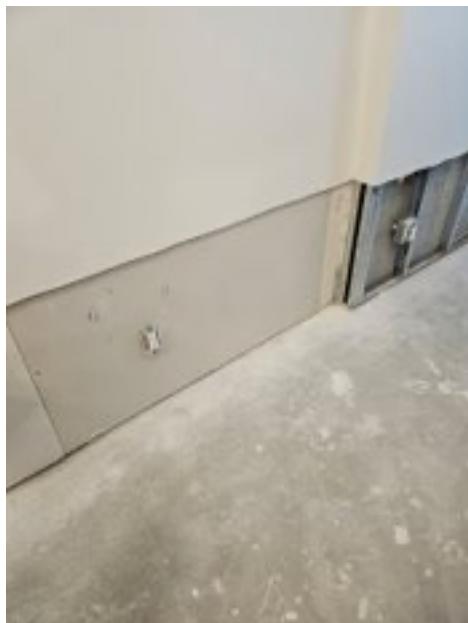
Unit 1508- drywall removed

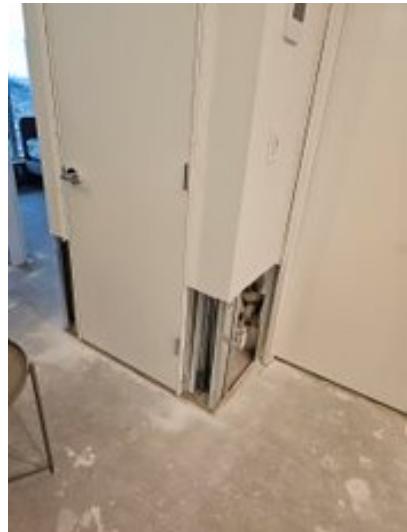
Unit 1508- Enter laminated floors removed

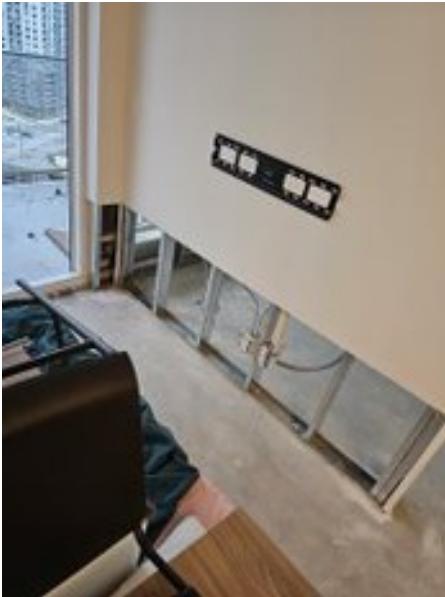
Unit 1508- Drywall section removed

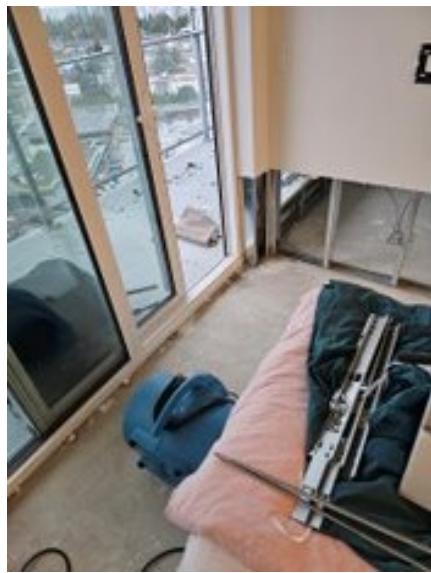
Unit 1508- Living room area drywall

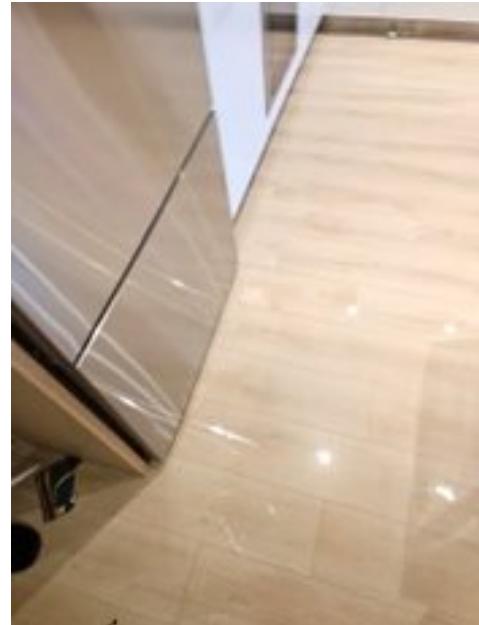
Unit 1507- laminate floors damaged

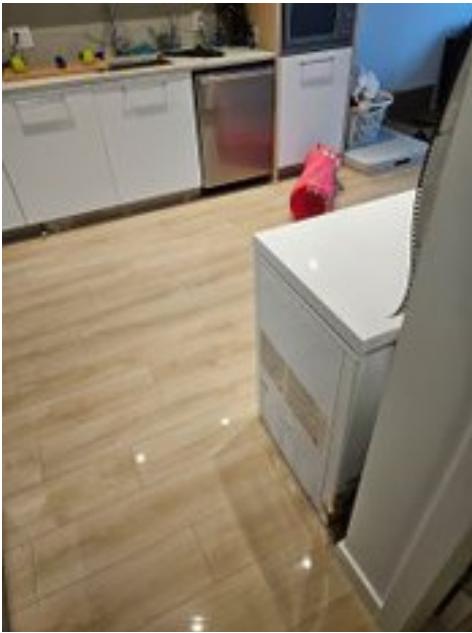
Unit 1507- Kitchen floors flood

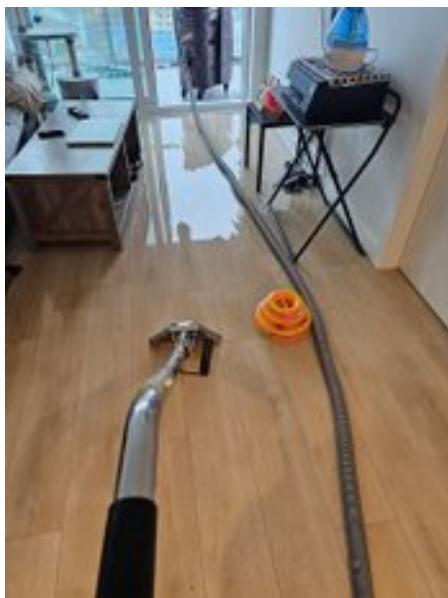
Unit 1507- living room area floors flooded

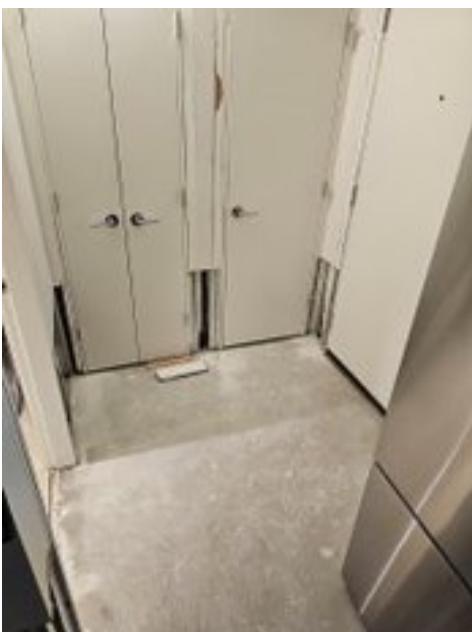
Unit 1507-Water extraction

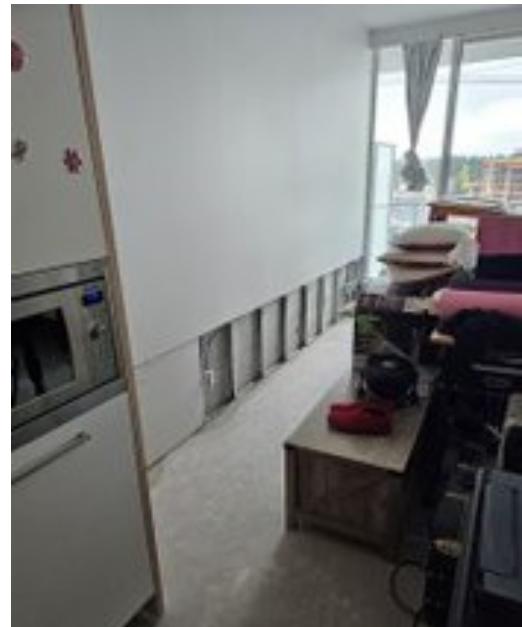
Unit 1507-Living wall cut open

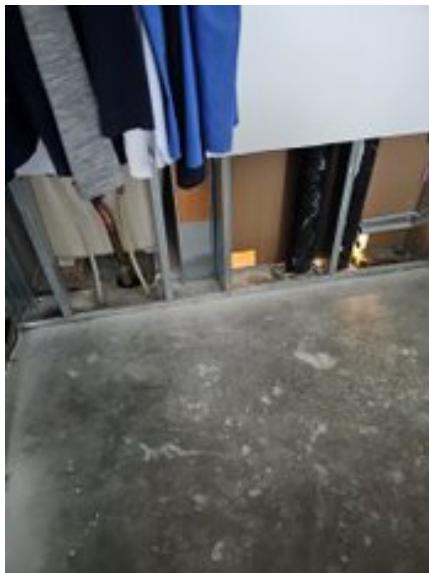
Unit 1507- Water been extraction form living room area

Unit 1507- More section of walls opened

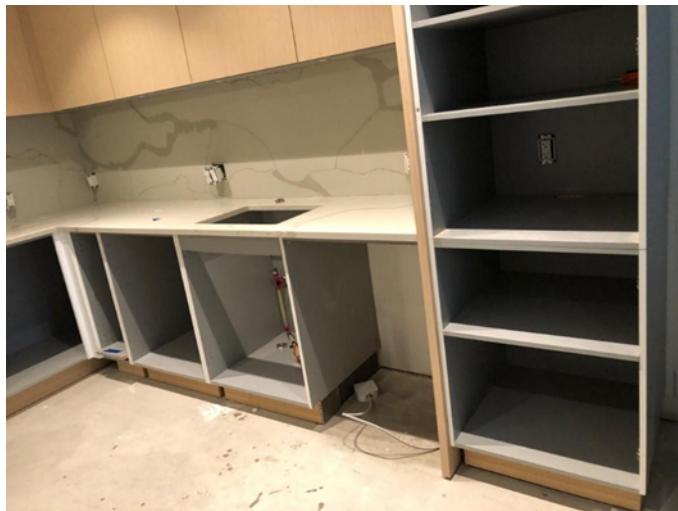
Unit 1507- Kitchen cabinets marked for removal

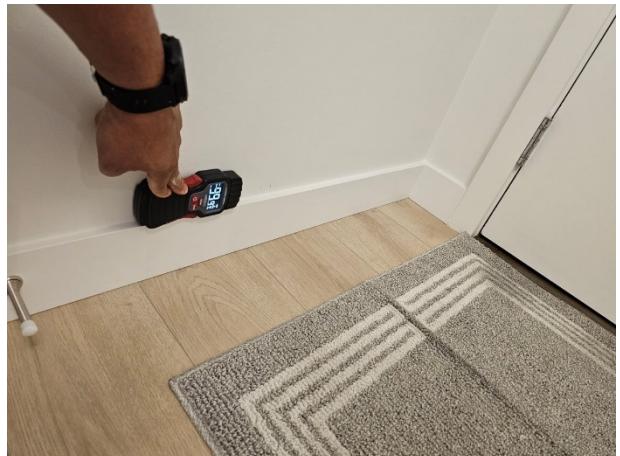
Unit 1506- Moisture reading of the main hallway wall.

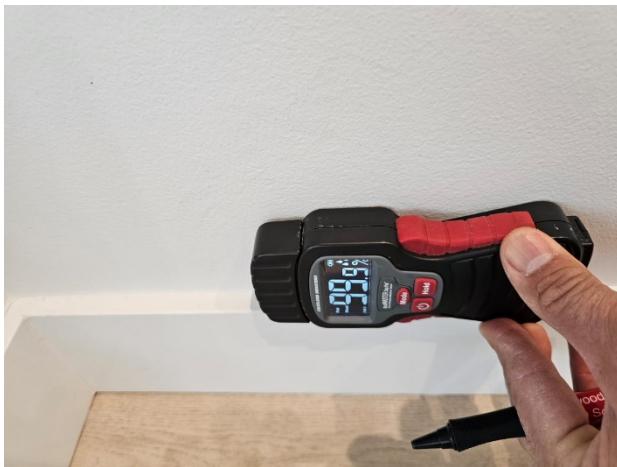
Unit 1506- Close up of reading

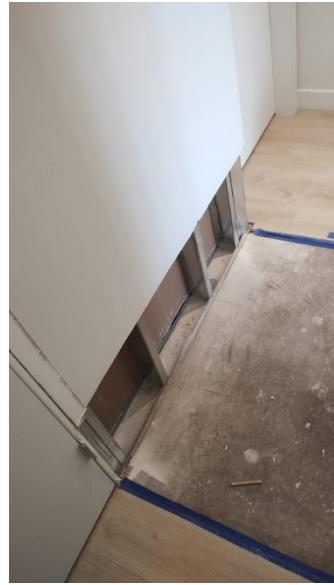
Unit 1506- Removed damaged drywall section

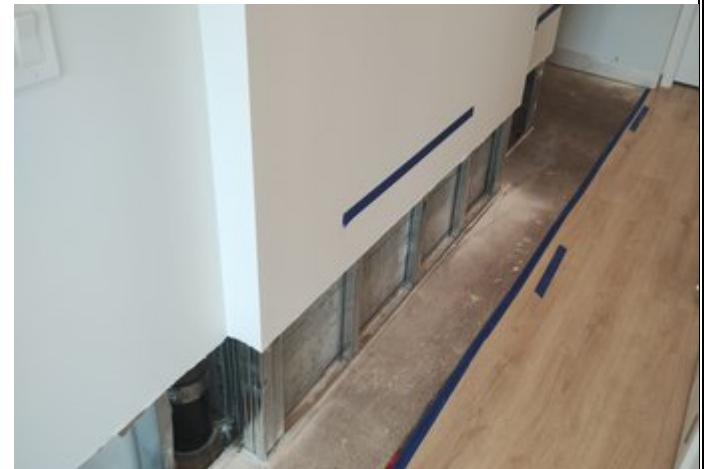
Unit 1506- Kitchen/living damaged floors removed

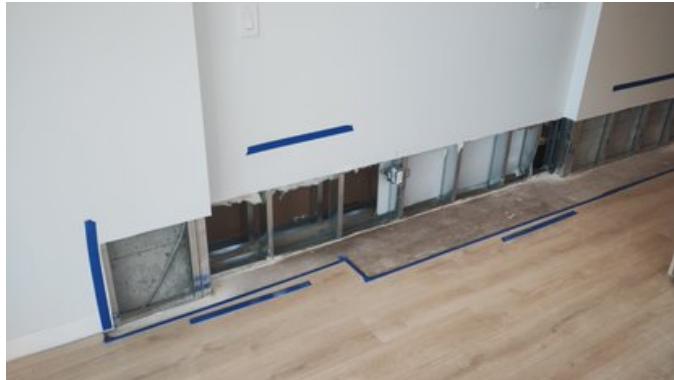
Unit 1506- Living/ Kitchen area drywall and flooring removed

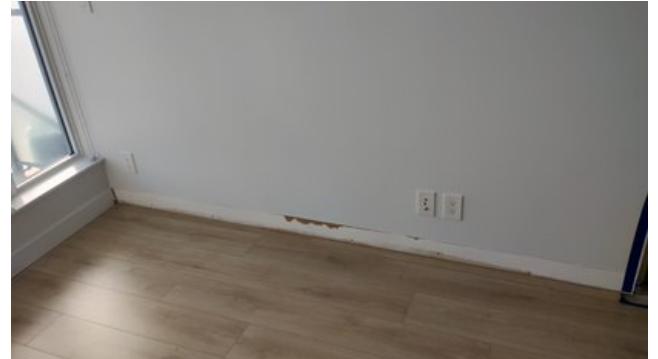
Unit 1506- Damaged wall marked for removal

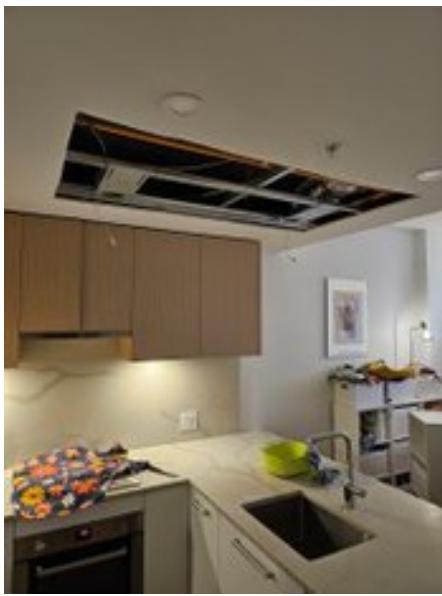
Unit 1408- ceiling area removed

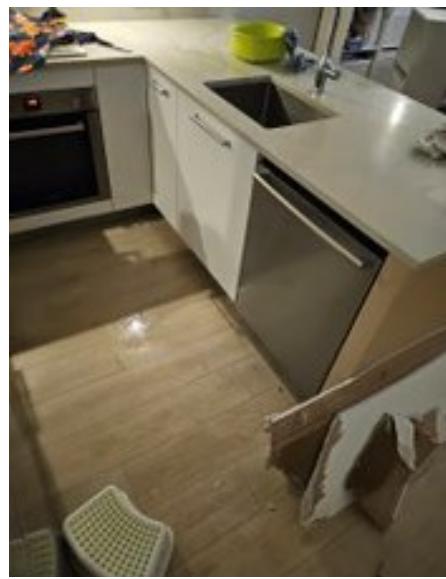
Unit 1408- floors damaged

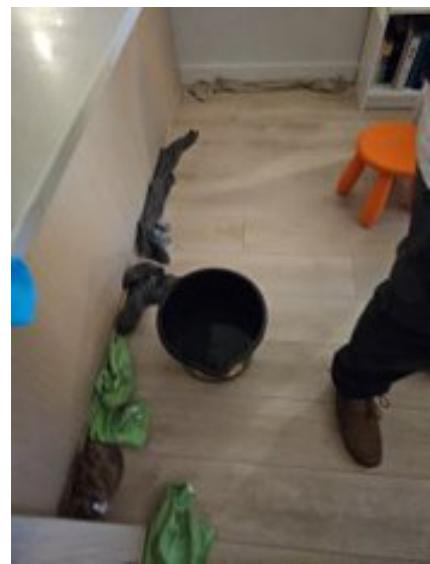
Unit 1408- Living floors damaged

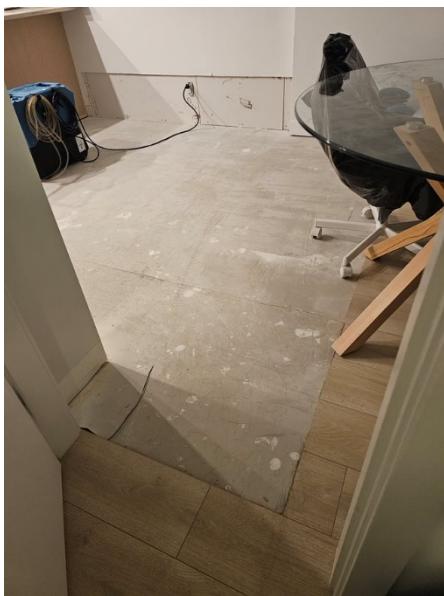
Unit 1408- EQ setup- floors removed

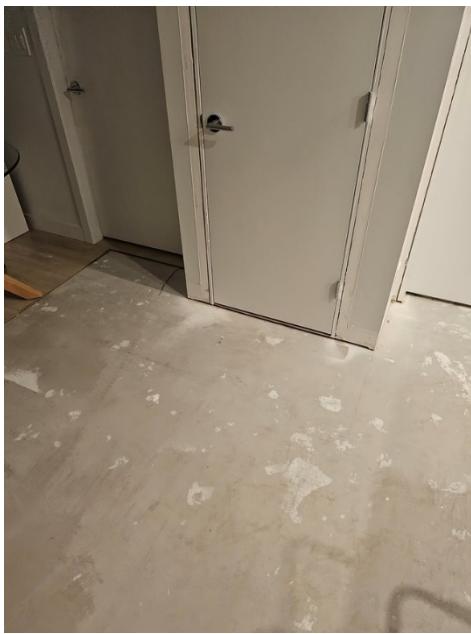
Unit 1408- Living room area EQ setup

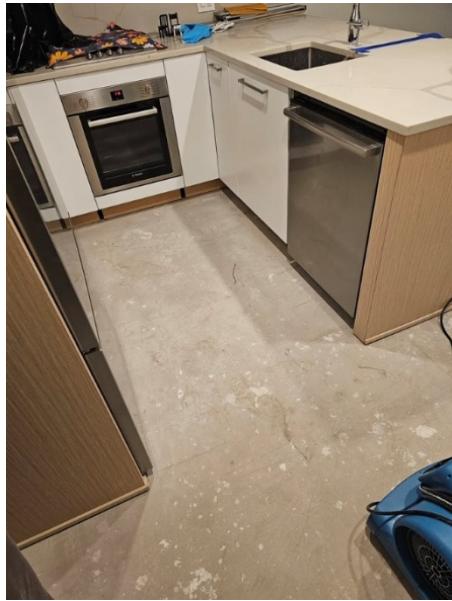
Unit 1408- kitchen

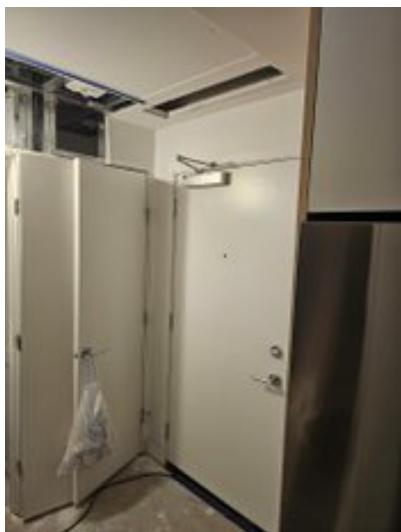
Unit 1407- Ceiling area opened

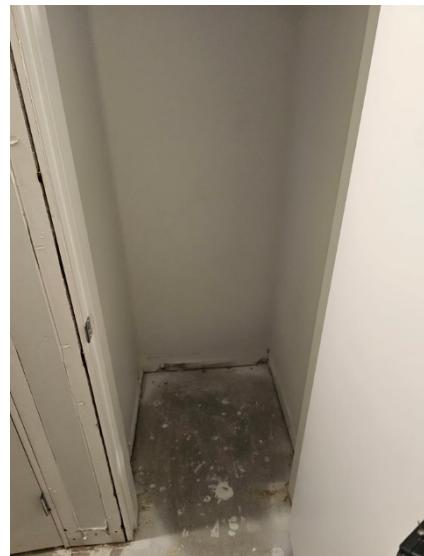
Unit 1407- Main hallway ceiling opened

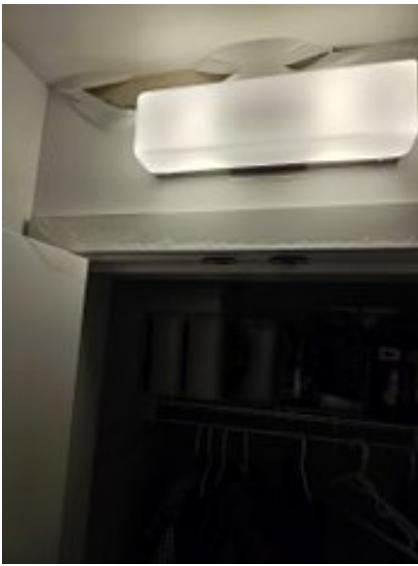
Unit 1407- Outside closet wall damaged

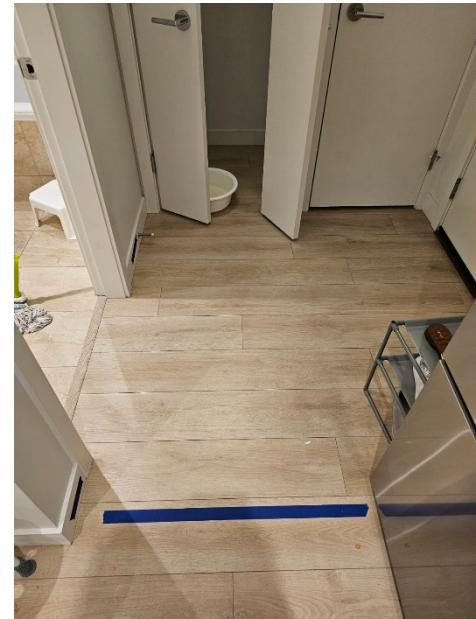
Unit 1407- Main hallway, baseboards, and wall damaged

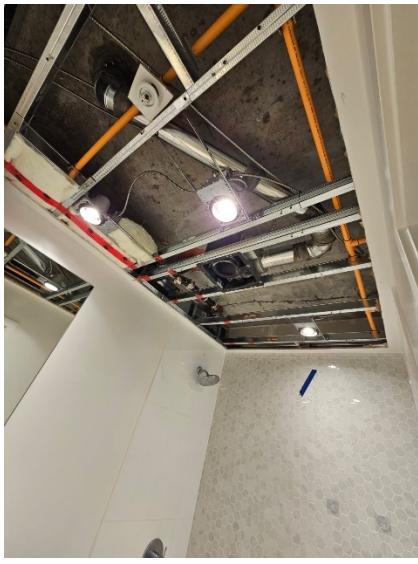
Unit 1407- Washroom ceiling removed

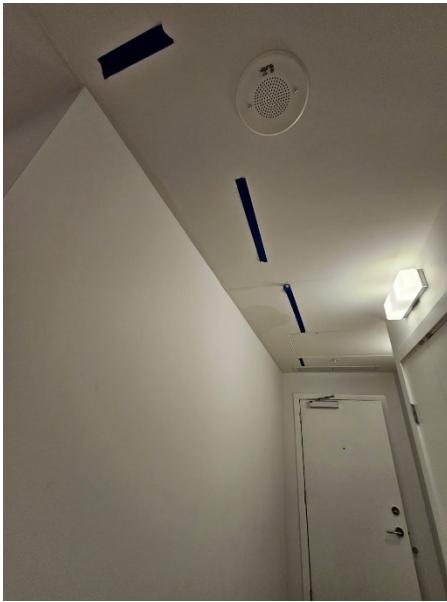
Unit 1406- Ceiling area damaged- main hallway

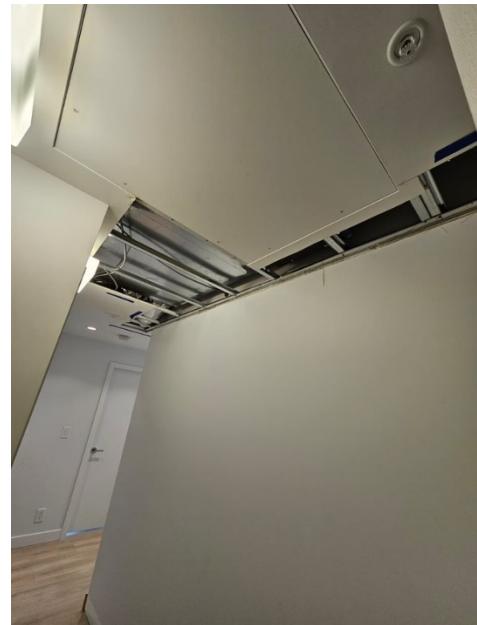
Unit 1406- Main hallway ceiling-EQ setup

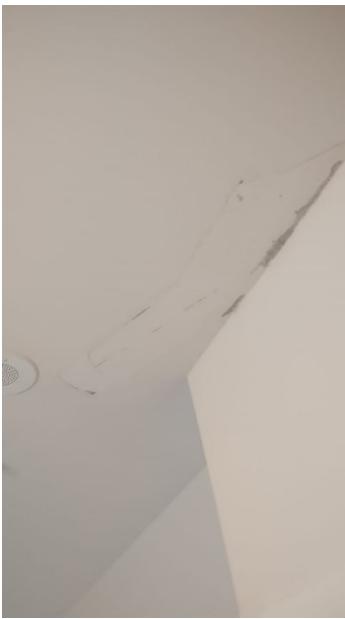
Unit 1308- Ceiling area damaged

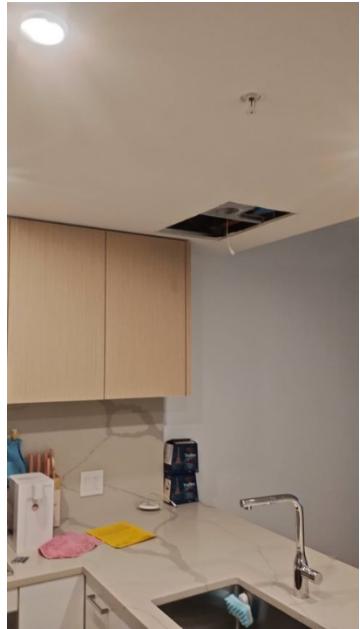
Unit 1308- Ceiling of kitchen area

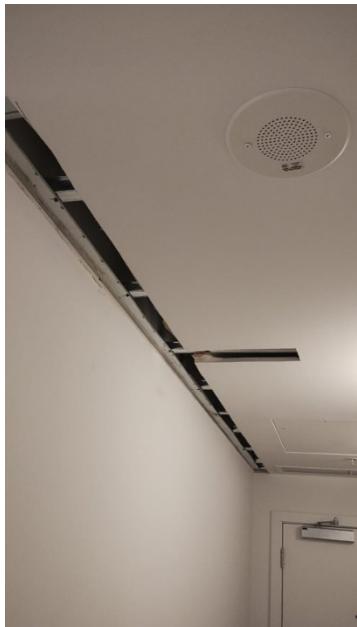
Unit 1306- Main hallway wall opened 2' up

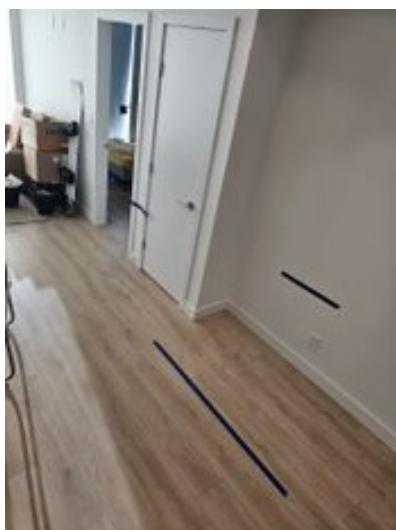
Unit 1307- Kitchen/living room area marked floors drywall to be removed

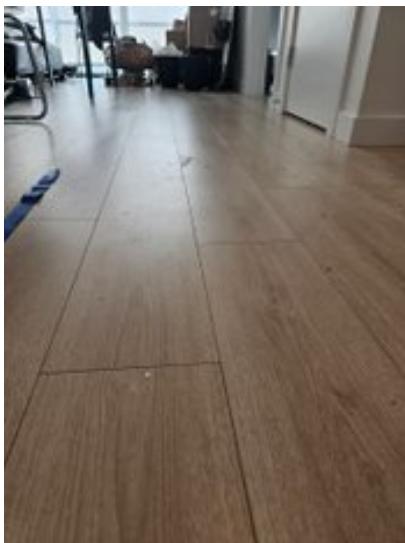
Unit 1307- Floors damaged, marked to be removed

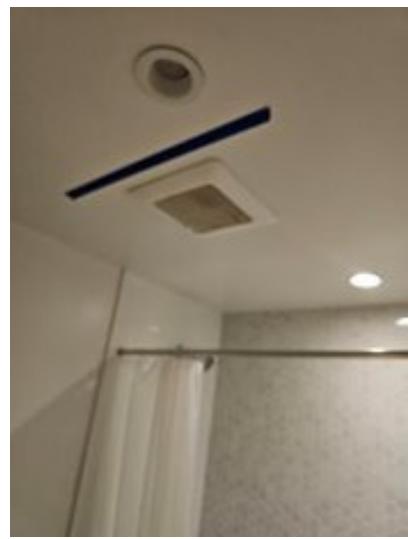
Unit 1307- ceiling washroom, marked to be removed

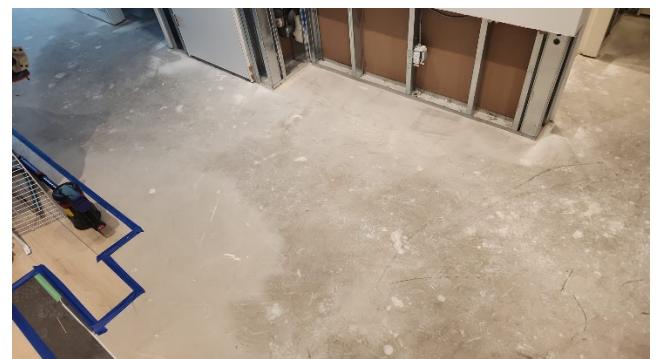
Unit 1307- Kitchen/living room area floors removed

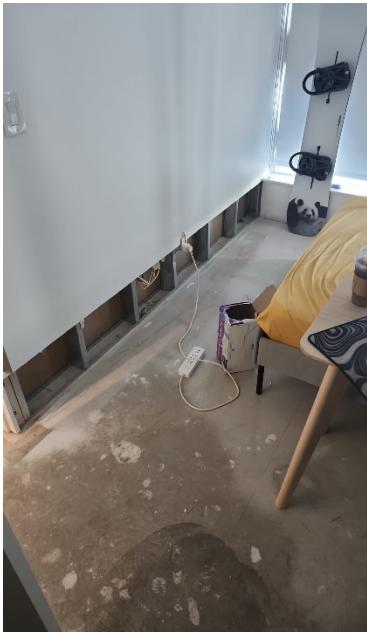
Unit 1307- Floors damaged, drywall wall cut opened

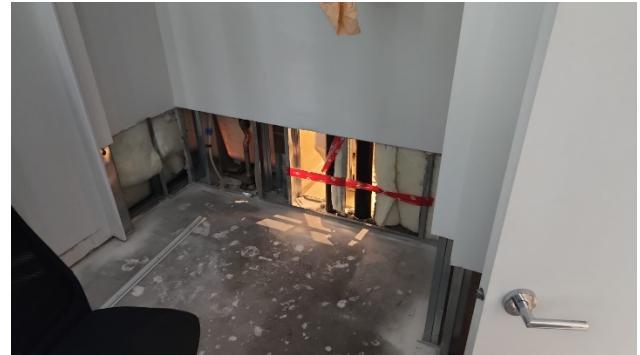
Unit 1307- Bedroom closet, drywall cut opened

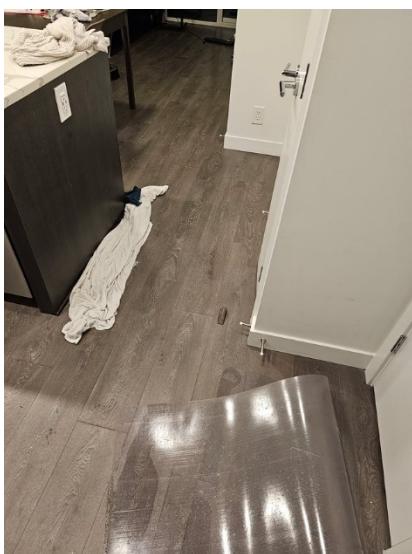
Unit 1209- Main hallway floors damaged

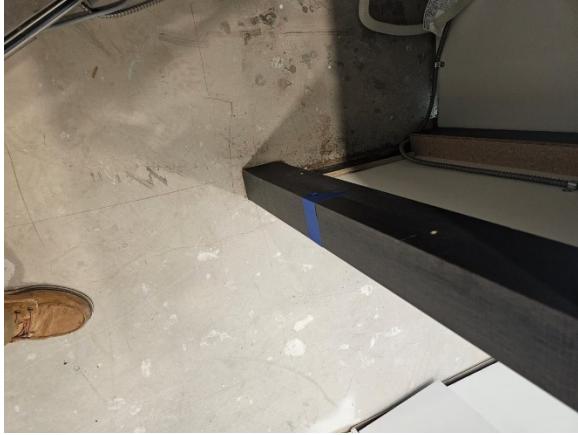
Unit 1209- Countertops gable damaged

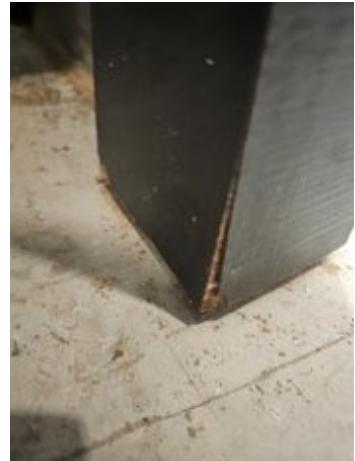
Unit 1209- close up of gable damaged

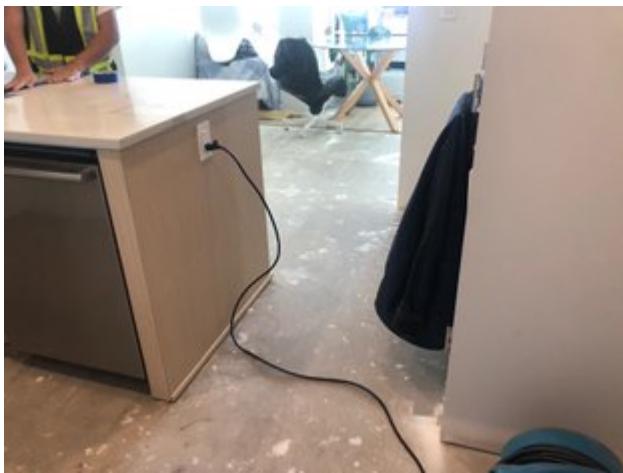
**Unit 1209- Kitchen/living room floors
damaged and removed**

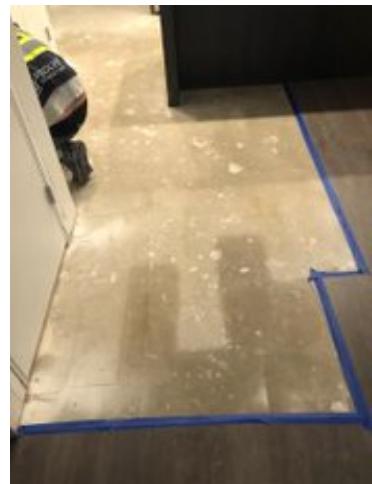
**Unit 1209- living room area floors
removed**

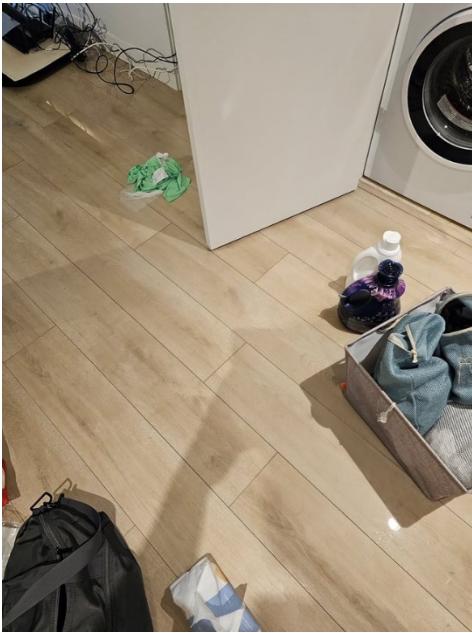
Unit 1208- kitchen/living floors damaged

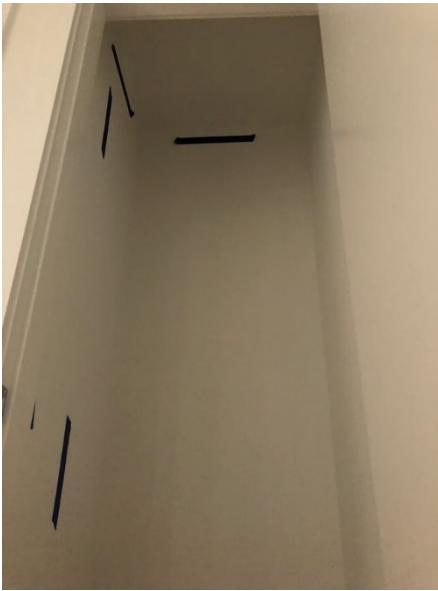
Unit 1208- inside closet wall damaged

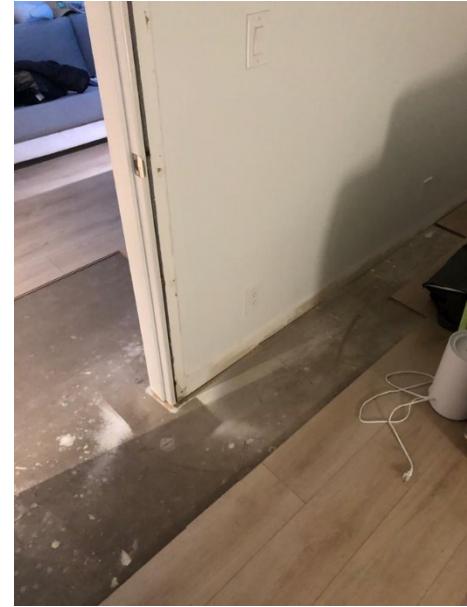
Unit 1208- area marked for removal

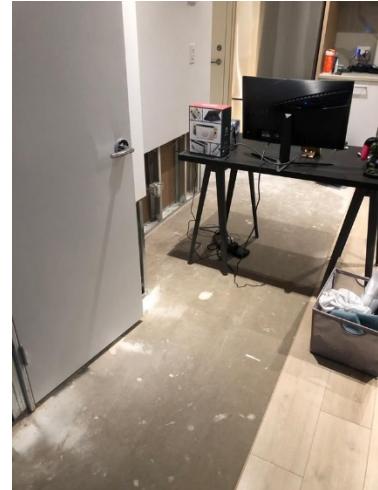
Unit 1208- Bedroom floors removed

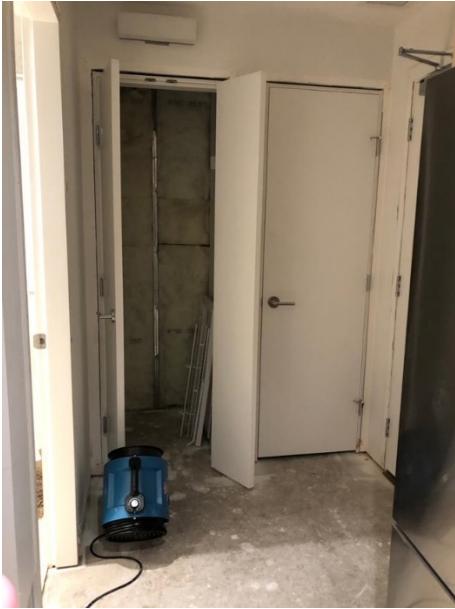
**Unit 1208- living area- floors, walls,
baseboards removed**

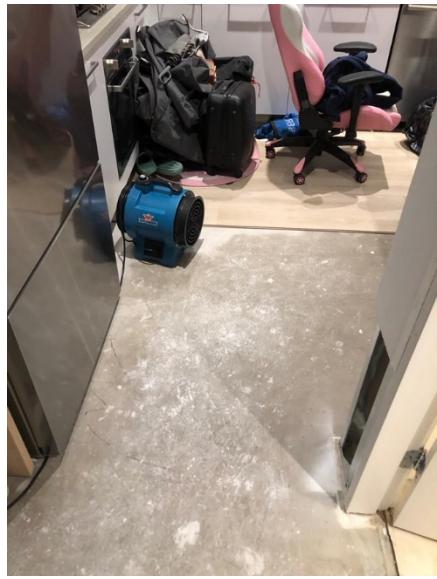
Unit 1208- EQ setup- inside closet, main hallway- floors, drywall removed

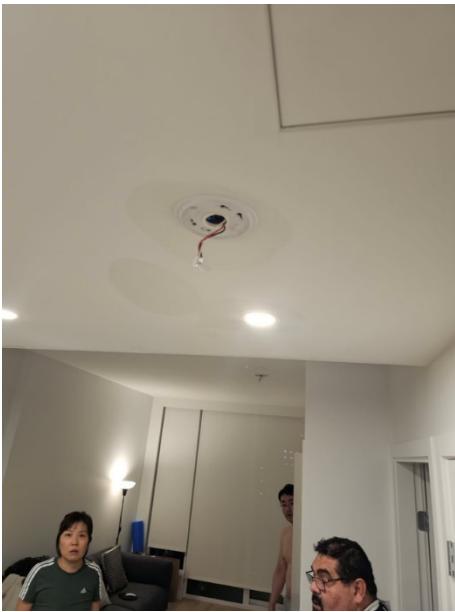
Unit 1109- Ceiling area damaged

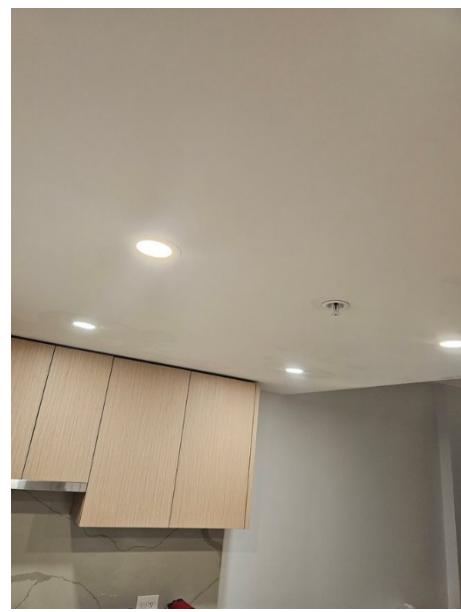
Unit 1109- kitchen ceiling damaged

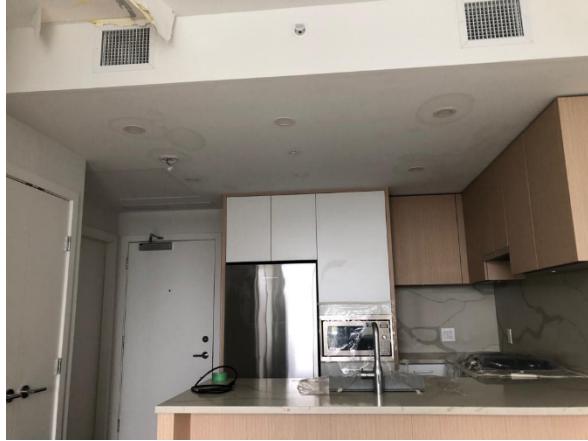
Unit 1109- kitchen and living ceiling damaged

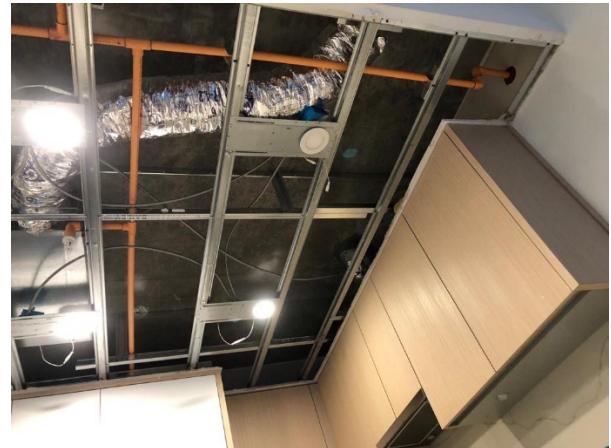
Unit 1109- Kitchen ceiling removed

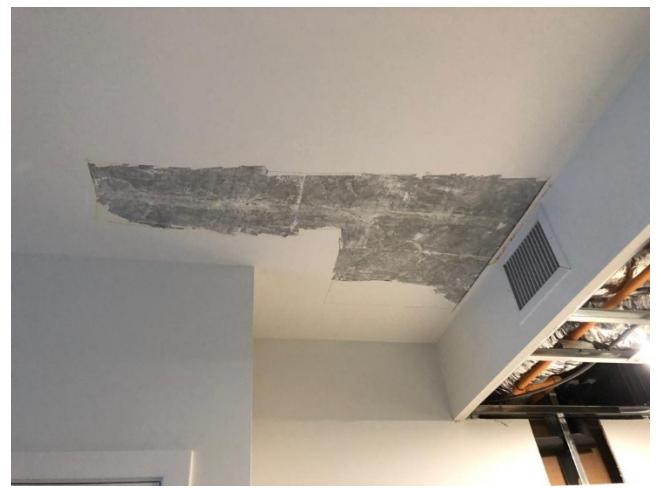
Unit 1109- living ceiling- damaged removed

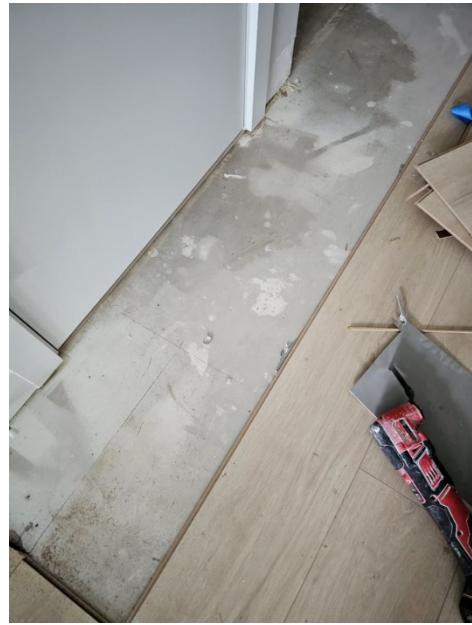
Unit 1108- floors removed behind fridge area

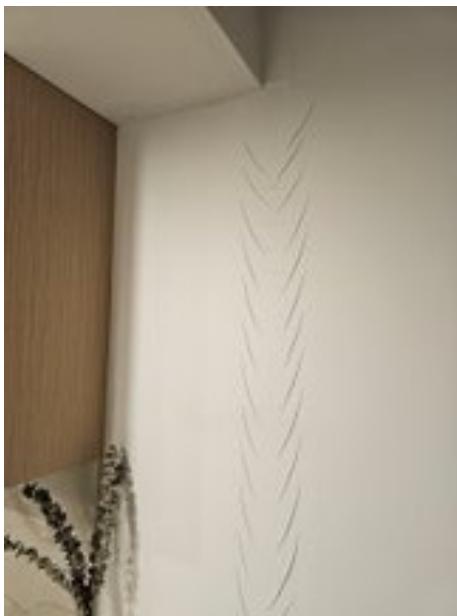
Unit 1009-Living room wall damaged

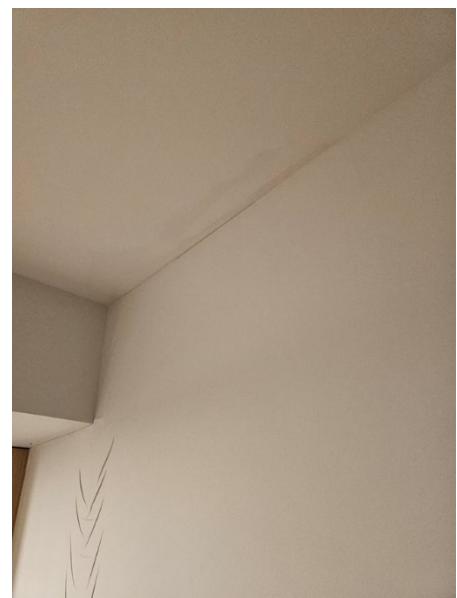
Unit 1009- Living ceiling damaged

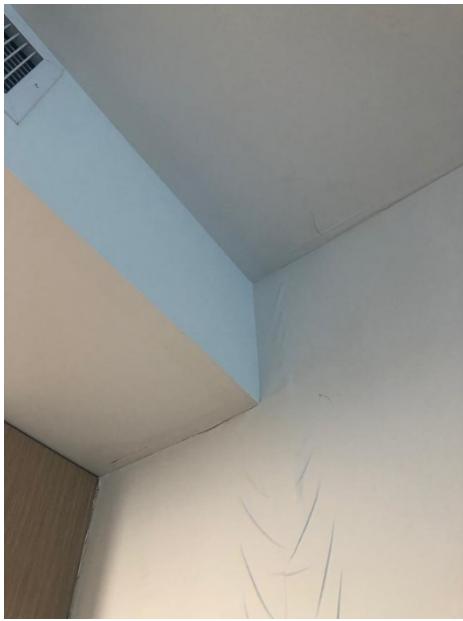
Unit 1009- Living room- more damaged found

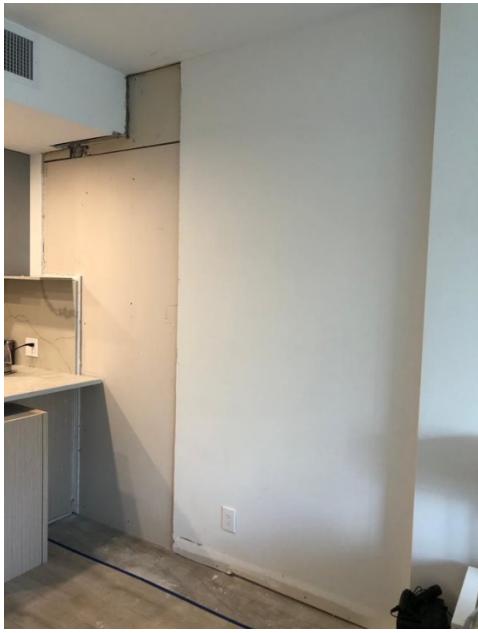
Unit 1009-Living room drywall removed

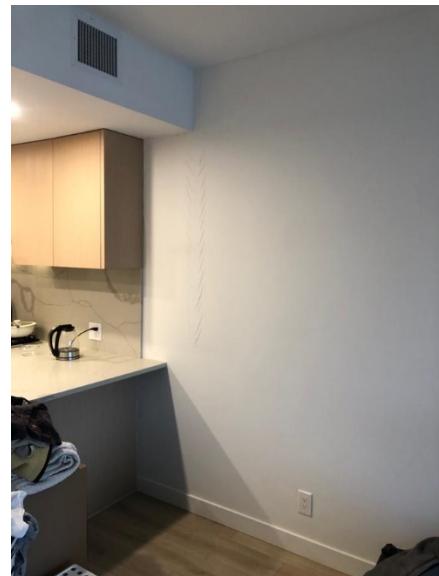
Unit 1009-Kitchen area- top section of cabinet removed

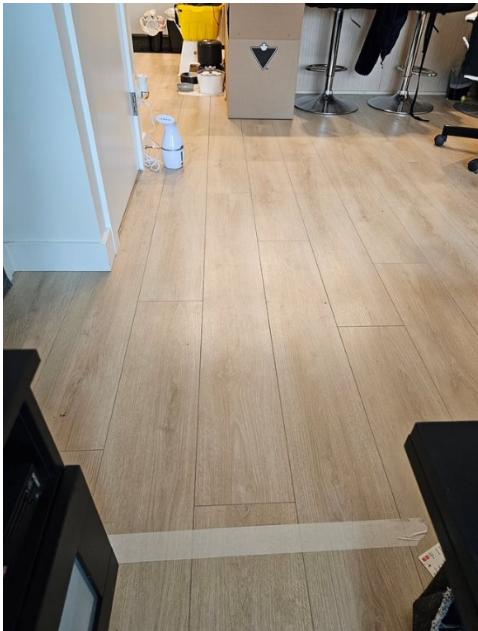
Unit 809- Living room floors, damaged

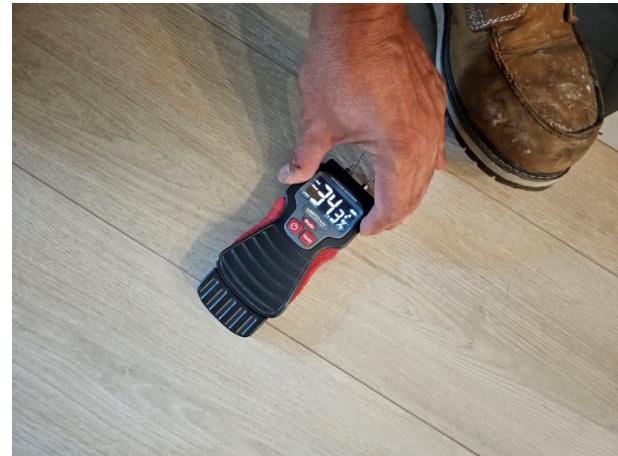
Unit 809-Living room floors reading

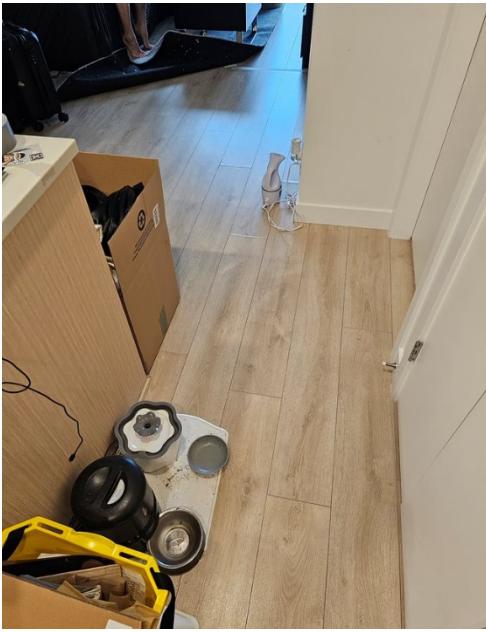
**Unit 809- Main entrance hallway floors
damaged**

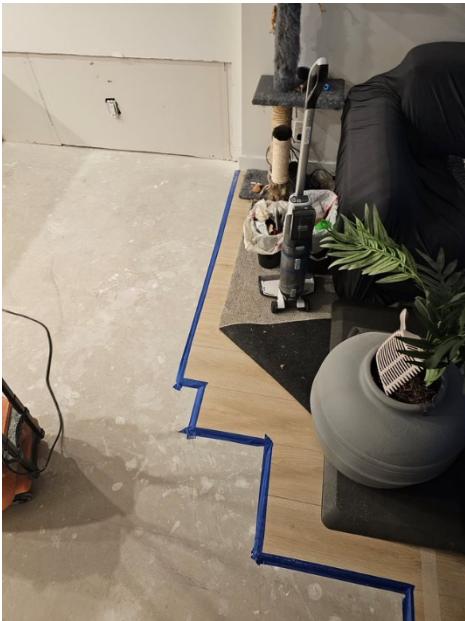
Unit 1009- Living room area- EQ set

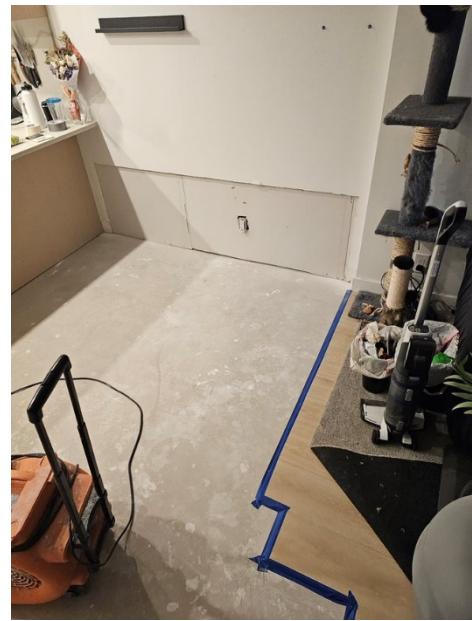
**Unit 1009- Living room floors removed,
drywall removed**

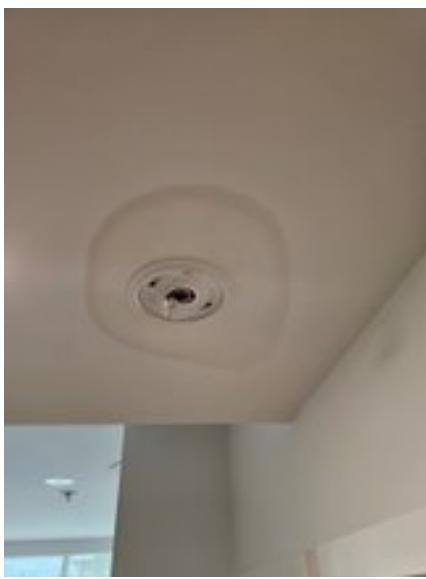
Unit 709- Kitchen ceiling-smoke alarm damaged

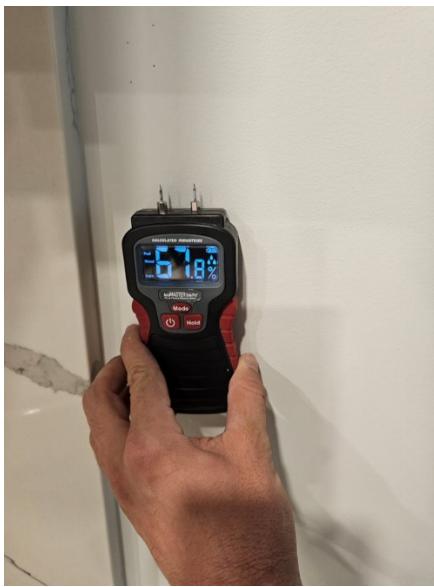
Unit 909- Moisture reading of wall beside kitchen cabinet.

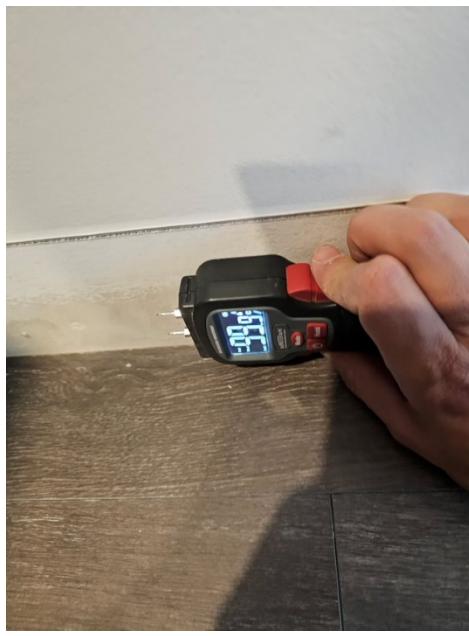
Unit 909-Close up of reading.
